Building Information - Nordonia Hills City (50047) - Ledgeview Elementary

Program Type	Expedited Local Partnership Program (ELPP)
Setting	Suburban
Assessment Name	Ledgeview Elementary School (2021 Update) DRAFT
Assessment Date (on-site; non-EEA)	2019-09-11
Kitchen Type	Full Kitchen
Cost Set:	2021
Building Name	Ledgeview Elementary
Building IRN	20065
Building Address	9130 Shepard Rd
Building City	Macedonia
Building Zipcode	44056
Building Phone	330-467-0583
Acreage	12.00
Current Grades:	K-4
Teaching Stations	32
Number of Floors	1
Student Capacity	415
Current Enrollment	476
Enrollment Date	2000-10-01
Enrollment Date is the date in which the current enrollment was taken.	
Number of Classrooms	30
Historical Register	NO
Building's Principal	Ms. Kristen Cottrell
Building Type	Elementary

Building Pictures - Nordonia Hills City(50047) - Ledgeview Elementary(20065)

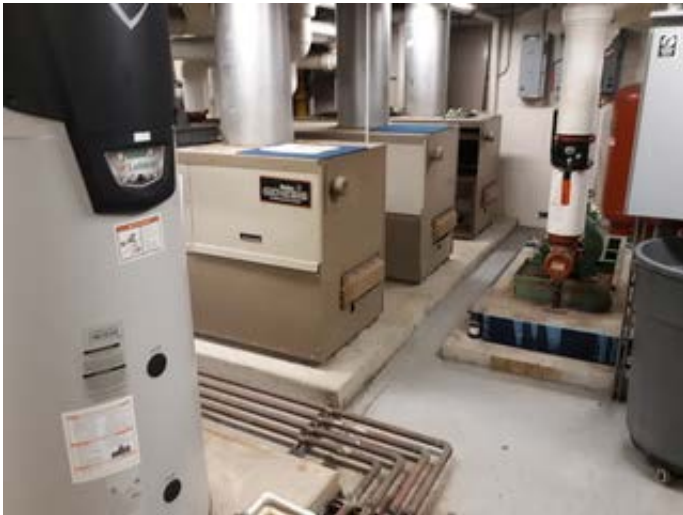
Description: The elementary school is heated with three (3) gas-fired hot water boilers with air handling units and unit ventilators with hot water coils, VAV boxes with hot water coils and perimeter cabinet unit heaters. Most equipment was replaced when the addition was built in 2001. This 18-year-old equipment is in average condition. Hot water is distributed through a steel piping system from a pump with a standby pump at the main boiler system. The rooftop air handling units include refrigerant coils for cooling. The building contains an older central building automation system. It monitors unit ventilators, rooftop air handling units and VAV boxes. The VAV boxes have factory mounted controls that are independent. The 15 CFM per person fresh air requirement of the Ohio Building Code, Mechanical Code and Ohio School Design Manual, OSDM, is satisfied. The floor to roof height is low and cannot accommodate a central system with ductwork. The site does not contain an underground fuel tank. The overall heating system is evaluated as being in a safe working order. The system is also inefficient with non-condensing boilers and much of the system should be replaced for long life expectancy. 11/10/21 update: Two boilers were recently replaced. Lines to boilers ran underground in 2000, deteriorated and were recently replaced, ran through building.

Rating: 3 Needs Replacement

Boiler room

Recommendations: Provide for the complete replacement of the building's entire HVAC system due to age & condition. 12/8/21 update: 2001 addition already has RTU's with ductwork, does not need to be converted to ducted system.

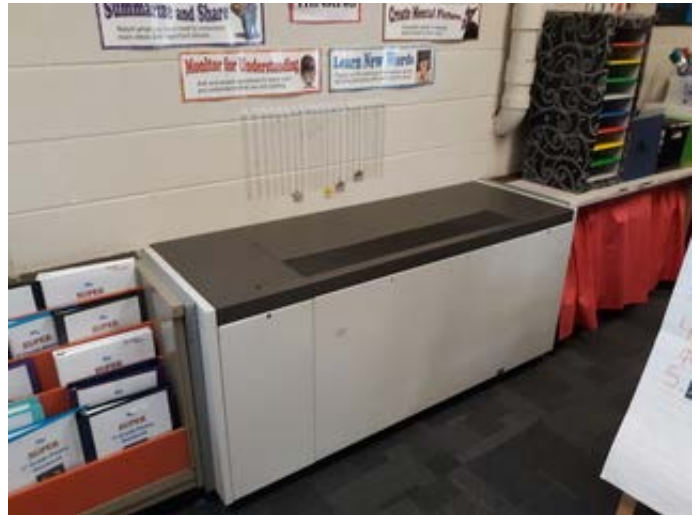
Unit ventilator

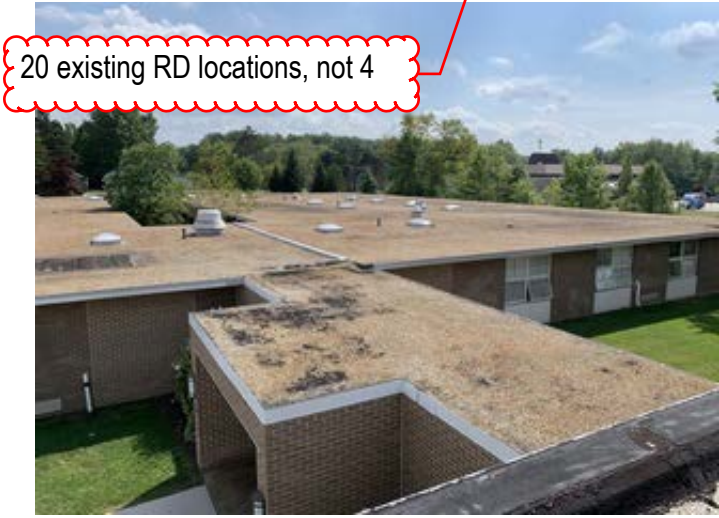
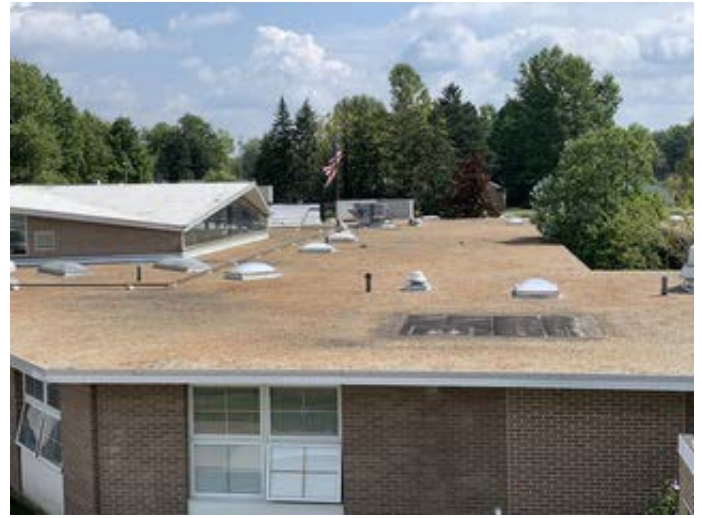
Description: The roof over the overall facility is a ballasted membrane that was installed over 7 years ago, and is in fair condition. There are District reports of current leaking. Signs of past leaking were observed during the physical assessment. Access to the roof was gained by an access ladder that is in good condition. Fall safety protection cages are not provided. There were no observations of standing water on the roof. Metal cap flashings are in good condition. Roof storm drainage is addressed through a system of roof drains, which are properly located, and in fair condition. The roof is not equipped with overflow roof drains. Provide for additional roof insulation to meet LEED Silver Certification Energy Requirements.

Rating: 3 Needs Replacement

Ballasted Membrane Roofing

Recommendations: The roof over the overall facility requires replacement to meet Ohio School Design Manual guidelines for age of system and due to condition. Roof overflow drains are also required. Provide for additional roof insulation to meet LEED Silver Certification Energy Requirements. 12/7/21 update: Will need to add parapet, coping, and fascia to meet minimum slope requirements when replacing roof insulation on original building. New exterior soffits needed for entire building in conjunction with new parapet to accommodate new insulation. Need to add roof drains around cafeteria and gym roof, remove scuppers on gym roof and add scupper low on 2001 addition wall to prevent staining. Install Z furring and spray foam with metal soffit at perimeter tectum deck soffit locations.

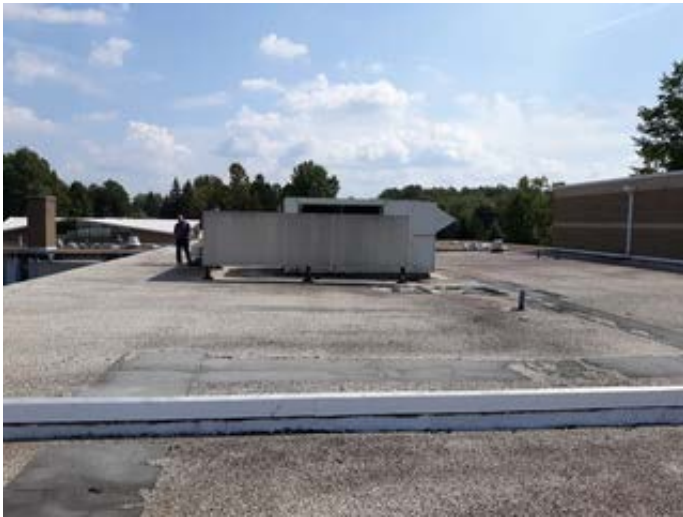
Description: The 2001 Addition, gym and Media Center are air conditioned with rooftop air handling units. These units are now 18 years old and in average condition. Controls at classroom VAV boxes are past their useful life. The ventilation in remaining areas use air handling units and unit ventilators to bring in code required fresh air. These unit ventilators have economizers which provide "free" cooling on mild days. Operation of VAV boxes in classrooms provide the required minimum amount of fresh air for occupants. The newer systems can provide simultaneous heating and cooling with the VAV system and is compliant with OSDM requirements. The ventilation system does not incorporate an energy recovery system. Individual toilet exhaust fans, on the roof, operate in conjunction with their associated zone units, but do not recover this lost energy. The technology server room is not separately cooled. There is a large, NFPA, grease hood in the Kitchen along with a dishwasher hood. Toilet exhaust fans and other building ventilation fans are on the flat roof areas.

Rooftop VAV unit

Recommendations: Replace VAV boxes and controllers. Add air conditioning to the unit ventilators with refrigerant coils and self-contained condensing units. Replace old rooftop units and add a kitchen make-up air unit. Add ductless split air conditioning system to the technology server room. Costs for this work are included in Item A: Heating.

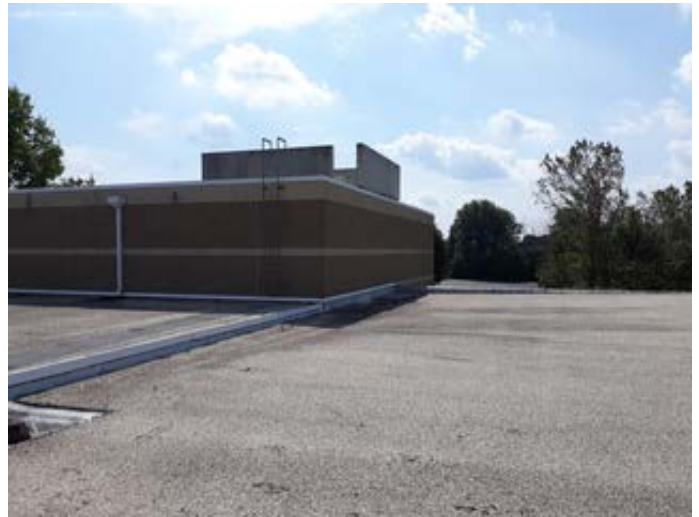
Gym HVAC unit

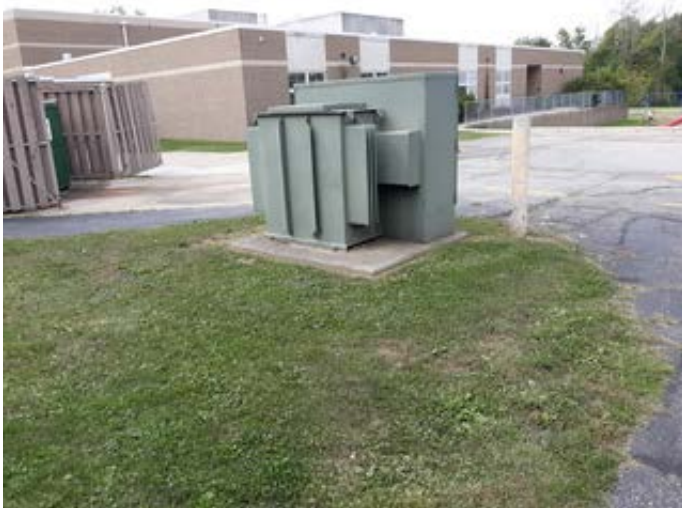
Rating: 3 Needs Replacement

Transformer

Recommendations: Electrical system existing conditions require replacement at the present time. 12/8/21 update: System replacement not required in 2001 addition.

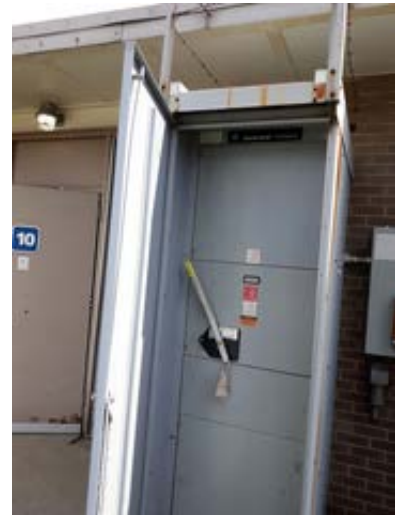
Electric service

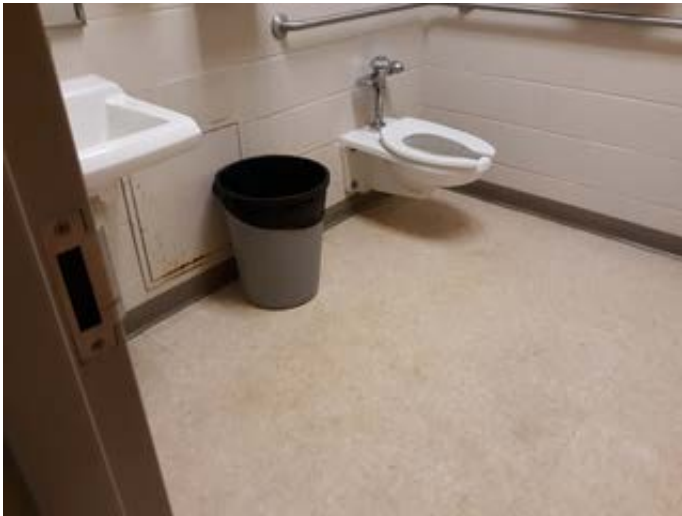
Description: The school plumbing system meets requirements for plumbing fixtures and backflow prevention. There is a 3" domestic water meter in an underground pit near Shepard Road. The water service entering the building is original galvanized steel. There is a pressure reducing valve and backflow preventer inside with copper piping properly distributed. The domestic hot water system operates at 95 degrees F. The water heater has been recently replaced with a gas-fired condensing water heater. The electric water heater in the 2001 addition is original, 18 years old. Lavatories and wash fountains do not have individual mixing valves. The toilet facilities include handicapped fixtures with flush valves and sensor operated faucets used in Public facilities. Elsewhere fixtures are manually operated. Fixtures are not low flow, which does not meet OSDM guidelines. Water closets and urinals in the newer addition are wall mounted with flush valves. Floor mounted fixtures were located in older 1963 portions of the building. Most sanitary piping is cast iron at the end of useful life. The school contains large group restrooms for boys and large group restrooms for girls. There are no locker rooms or shower facilities. The Kitchen has gas fired appliances and a staff toilet room. There is an in floor cast iron grease interceptor that is periodically cleaned. There is a brick gas house with meter inside that distributes natural gas in steel piping underground to boilers, domestic water heater and kitchen appliances. There is a mechanical gas shut off valve for appliances under the kitchen hood. Roof drains collect rainwater and are conveyed to the city sewer thru cast iron drain piping. The newer systems use PVC piping. The cast iron drain piping is now over 50 years old. Additional roof drains were added to the flat roof because there were very few roof drains in the original building. These drains are exposed in classrooms, with uninsulated PVC pipe that drop to outdoor splash blocks or underground drain tile.

Rating: 3 Needs Replacement

Staff toilet

Recommendations: Replace water closets, urinals and their flush valves with low flow fixtures. Replace the brass (high lead content) faucets with lead free faucets. Add mixing valves at each lavatory and replace master mixing valve to deliver 140 degree F. domestic hot water thru piping loop. Replace recirculating pumps. Replace the old water heater. Replace all cast iron drain piping which has reached the end of its useful life. 11/16/21 update: Water heaters are both newer, do not need replacement. 2001 addition only needs replacement of faucets & flush valves with low flow.

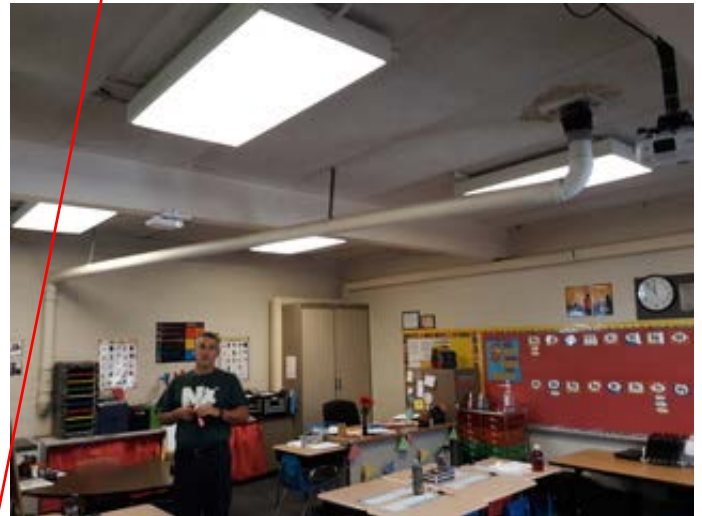
Added roof drain

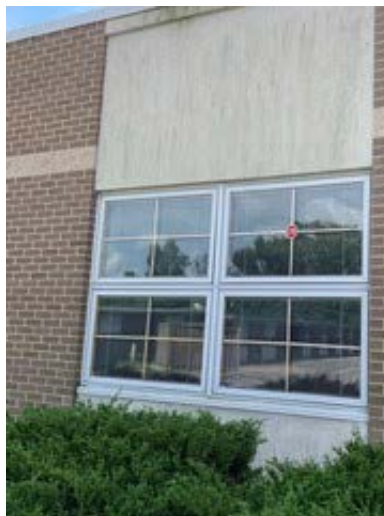
Description: The overall facility is equipped with aluminum and wood frame windows with single glazed window system, which was in fair condition. Window system seals are in fair condition, with moderate air infiltration being experienced. Window system hardware is in fair condition. The window system features surface mounted blinds, which are in fair condition. The window system is not equipped with insect screens on operable windows. 11/16/21 update: Multiple windows were found to be experiencing water infiltration and show mold growth.

Rating: 3 Needs Replacement

Typical Window Unit

Recommendations: Provide a new insulated window system with integral blinds to meet with Ohio School Design Manual requirements.

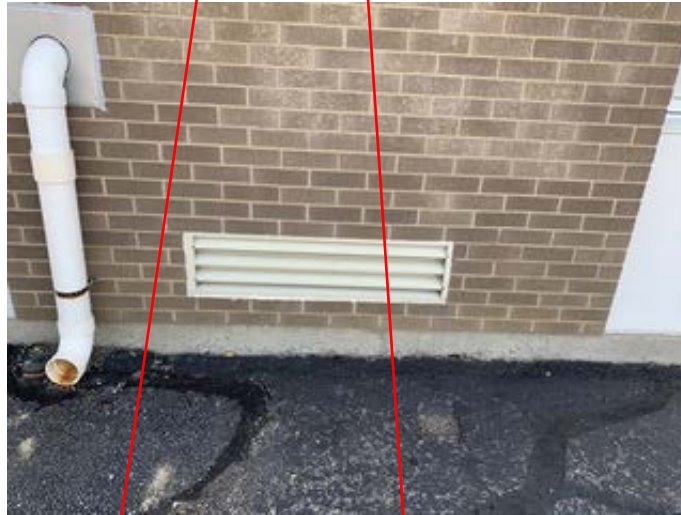
Description: The overall facility has a brick veneer on a masonry bearing wall system, which displayed minor locations of deterioration, and is in fair condition. The exterior masonry appears to have appropriately spaced and adequately caulked control joints in fair condition. Control joints are provided at lintel locations at doors and windows and are in fair condition. The exterior masonry has not been cleaned and sealed in recent years, and shows evidence of minor mortar deterioration. Interior walls are concrete masonry units and are in fair condition. Interior masonry appears to have adequately spaced and caulked control joints.

Rating: 2 Needs Repair

Masonry Infill at Unit Ventilators

Recommendations: Provide tuckpointing in all areas of mortar deterioration as required. Provide masonry cleaning, sealing, caulking as required through the overall facility. 12/8/21 update: Wrap exposed steel lintels above windows in original building with insulation and cladding. Repair some/recoat all EIFS.

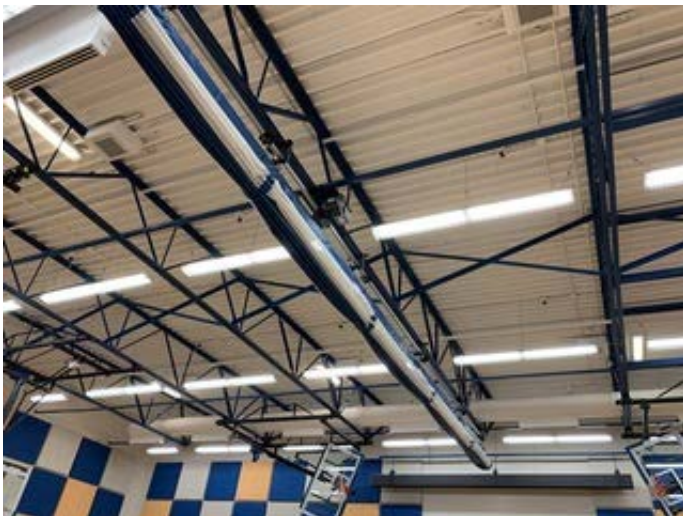
Description: The floor construction of the base floor of the overall facility is concrete slab on grade construction, and is in good condition. There is no crawl space. There are no intermediate floors in this single-story structure. Ceiling to structural deck spaces are insufficient to accommodate HVAC, electrical, and plumbing scopes of work in required renovations. The roof construction of the overall facility is tectum and steel deck construction, and is in good condition.

Steel Joists at Gym

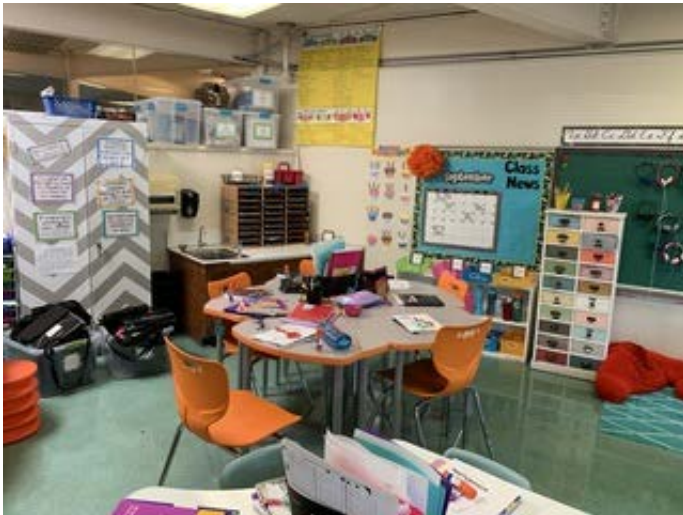
Description: The overall facility features conventionally partitioned Classrooms with VCT, VAT and carpet flooring. Suspended ceilings, as well as painted wall finishes, and they are in fair condition. The overall facility has Corridors with terrazzo and VCT flooring, suspended ceilings, as well as painted wall finishes, and they are in good condition. The overall facility has Restrooms with ceramic tile flooring, plaster ceilings, as well as ceramic tile wall finishes, and they are in good condition. Toilet partitions are plastic and are in good condition. Classroom casework in the overall facility is wood construction with plastic laminate tops. The Art program does have a properly vented kiln. The facility is equipped with wood louvered and non-louvered interior doors that are flush mounted and partially recessed with and without proper ADA hardware and clearances. The doors are in fair condition. The Gymnasium space has VCT flooring, open ceilings, as well as painted wall finishes, and they are in good condition. Gymnasium basketball backboards are fixed type, and are in good condition. The Media Center, located in the 2001 Addition, has carpet flooring, suspended ceilings, as well as painted wall finishes, and they are in good condition. Student Dining has VAT flooring, open ceilings, as well as painted wall finishes, and they are in fair condition. The existing Kitchen is full service, is undersized based on current enrollment, and the existing Kitchen equipment, installed in 1963, is in fair condition. The Kitchen hood is in fair condition, and is equipped with the required UL 300 compliant wet chemical fire suppression system.

Rating: 3 Needs Replacement

Typical Classroom Setup

Recommendations: Provide complete replacement of finishes and casework due to installation of systems outlined in Items A, C, D, E, K, L, M, N, T, and U. Also, a full replacement of Kitchen equipment is required. 12/8/21 update: Add insulation to exterior walls of original building.

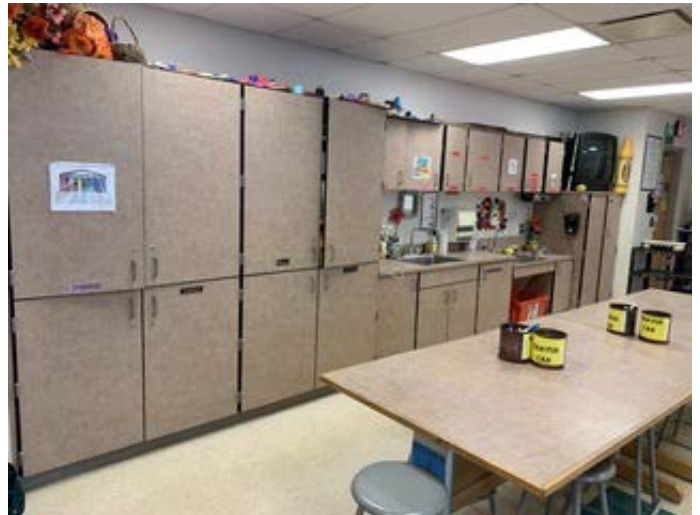
Art Room Casework

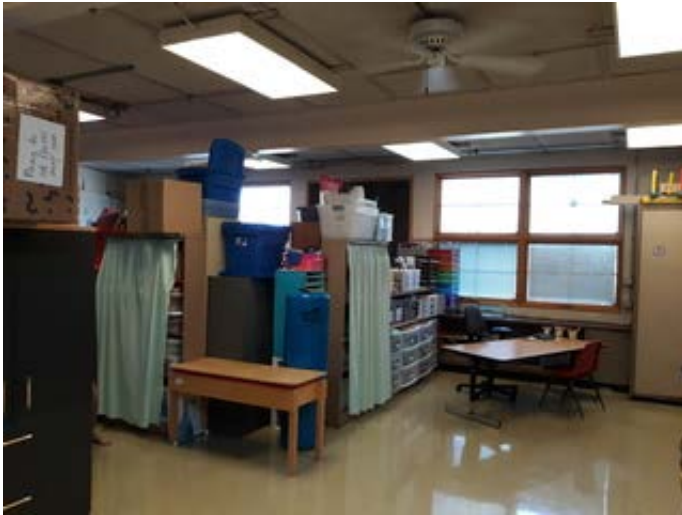
Rating: 3 Needs Replacement

Classroom Lighting

Recommendations: Replace light sources with LED lamps to provide longer life systems and reduce energy consumption. Revise classroom lighting to meet 50 foot candle requirement of OSDM. Revise Gymnasium lighting to reach 60 foot candles recommended in OSDM. Provide classrooms lighting with dual level switching and occupancy sensors. Provide added controls in Cafeteria to make use of daylight harvesting.

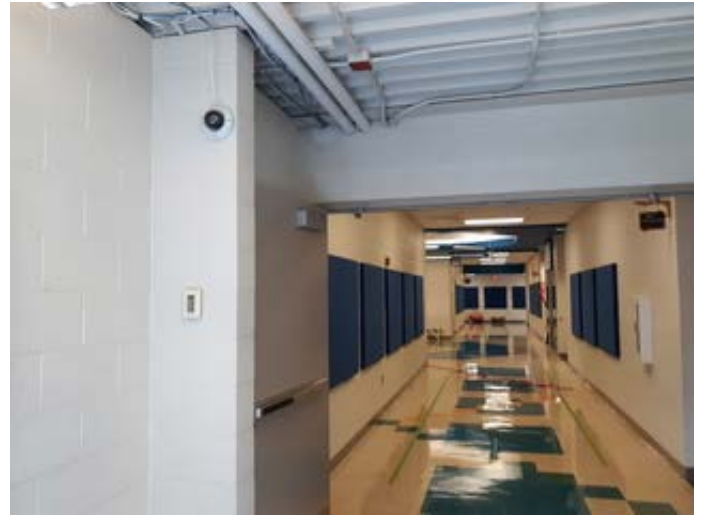
Corridor lighting

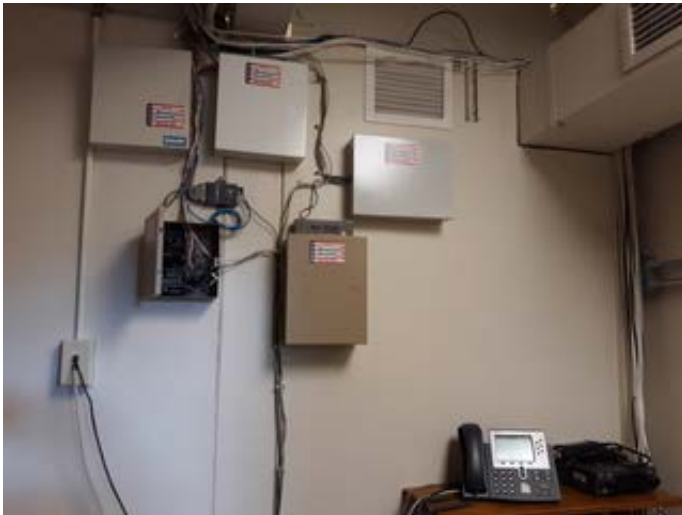
Rating: 3 Needs Replacement

Security system

Recommendations: Provide for a complete replacement of the building's security system in order for it to be fully OSDM compliant. Exterior security lighting should have lamp sources changed to LED for prolonged maintenance life.

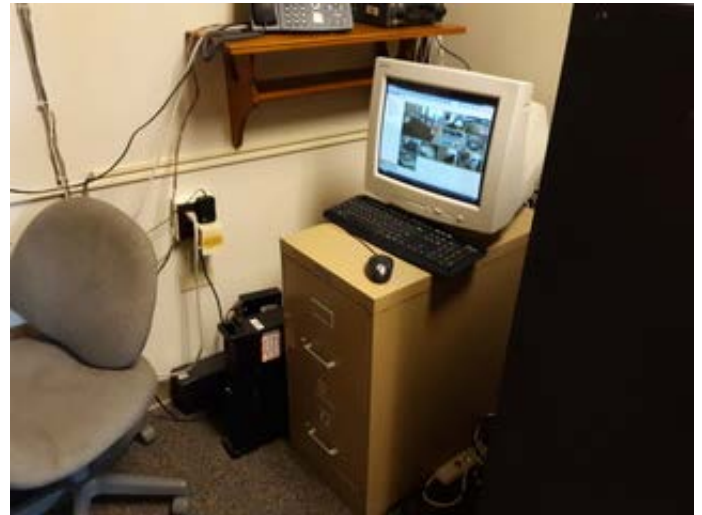
Security monitor

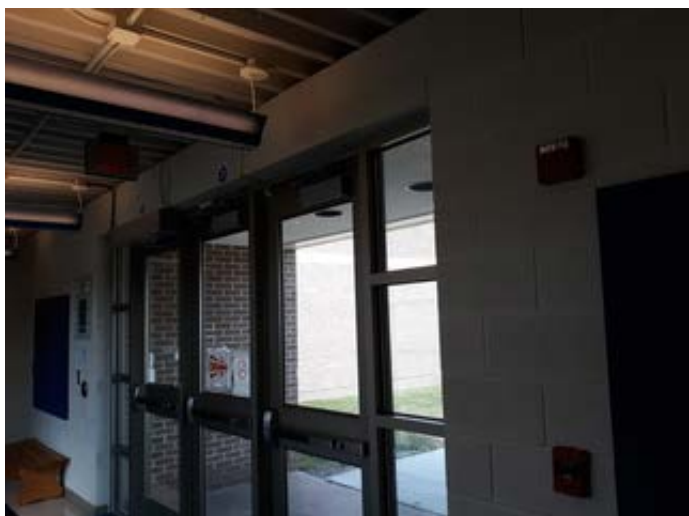
Rating: 3 Needs Replacement

Exit sign

Recommendations: The exit lights and egress lights should be changed to LED for longer life.

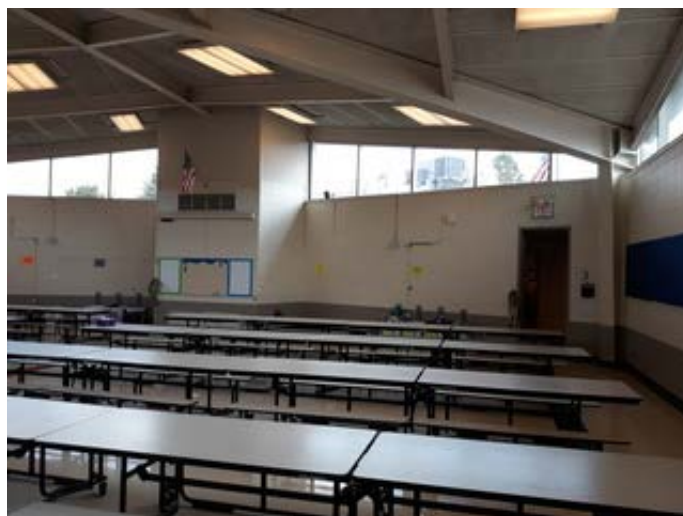
Cafeteria exit lights

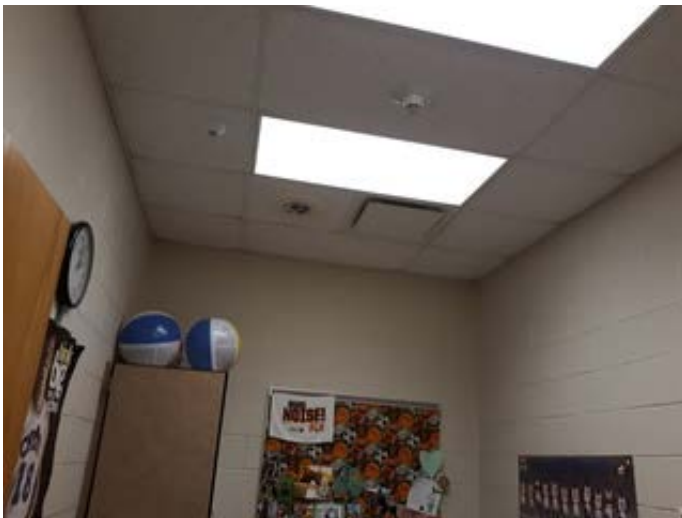
Description: The fire alarm system is older with a non-addressable EST system. The system includes smoke detectors, heat detectors, pull stations, and sprinkler alarms. Audio and visual devices are not found in classrooms. They are missing from conference rooms and are thus not in compliance with OSDM guidelines.

Rating: 3 Needs Replacement

Smoke detector

Recommendations: The fire alarm system should be updated with a fully addressable system and additional A/V devices added to all classrooms and conference rooms.

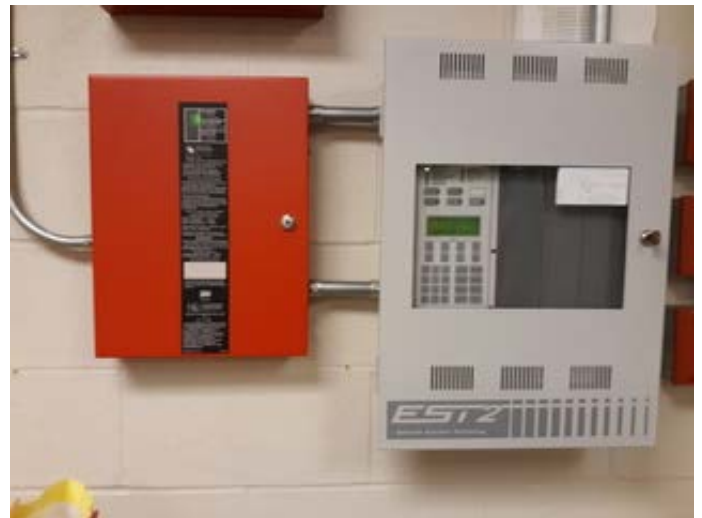
Fire alarm panel

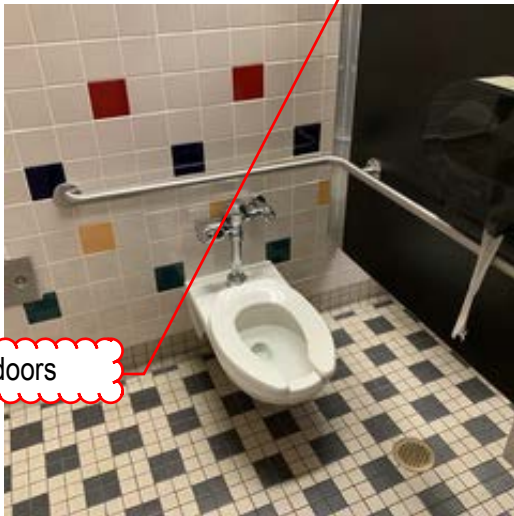
Rating: 2 Needs Repair

ADA Toilet

Recommendations: Provide ADA-compliant signage, toilets, sinks, urinals, toilet accessories, doors and frames, door hardware, in the overall facility to facilitate the school's meeting of ADA requirements. 12/8/21 update: Add ADA hardware to 27 doors.

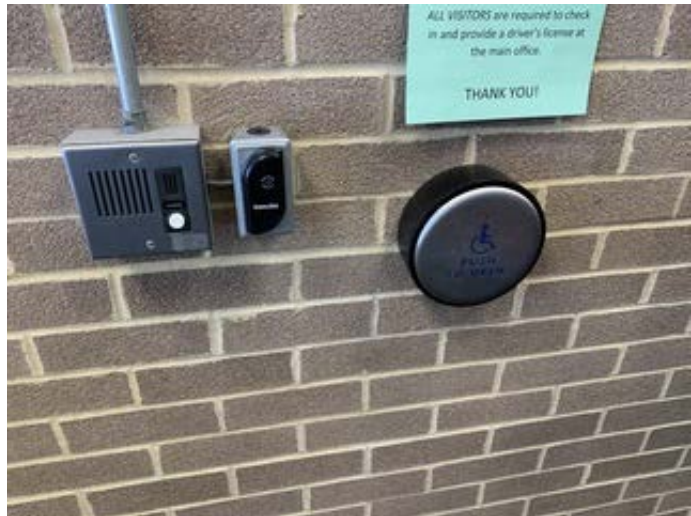
Main Door Control

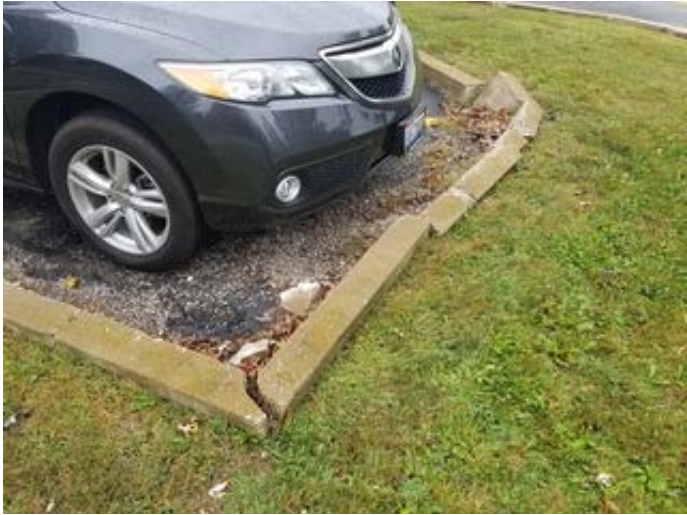
Rating: 2 Needs Repair

Damaged Curb

Recommendations: The asphalt and much of the curb on site are in need of repair. Also, some doors exiting the building do not have sidewalk access to parking lots. With this, some of the existing sidewalk needs replaced. Dumpster pads are needed for those sitting on the asphalt. There is a small erosion issue along the north boundary of the site where a storm pipe releases into a swale behind the curb bounding the teachers parking lot. Finally, ADA access should be provided for door 11. 12/8/21 update: Fully replace asphalt. Replace a portion of the site retaining wall in 2001 addition.

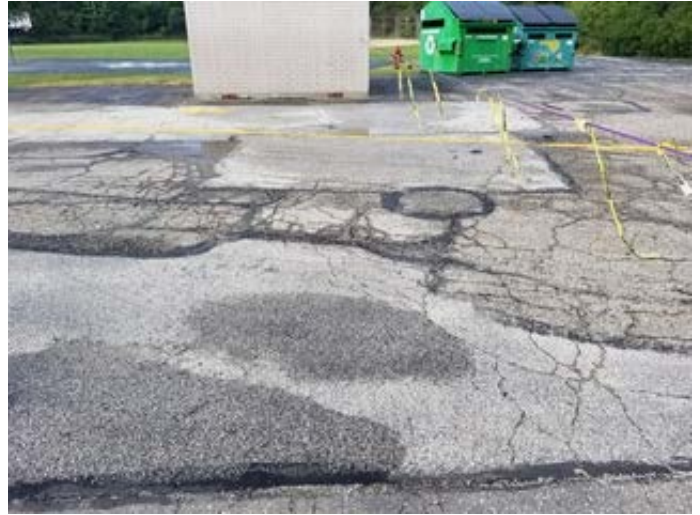
Cracking Asphalt

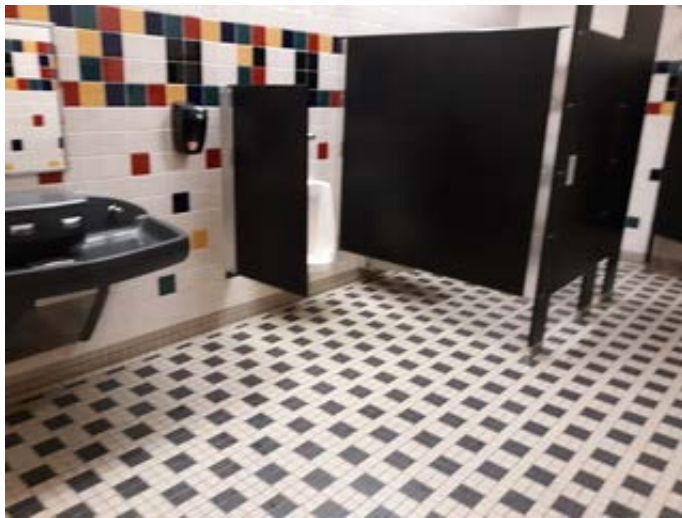
Boys Restroom

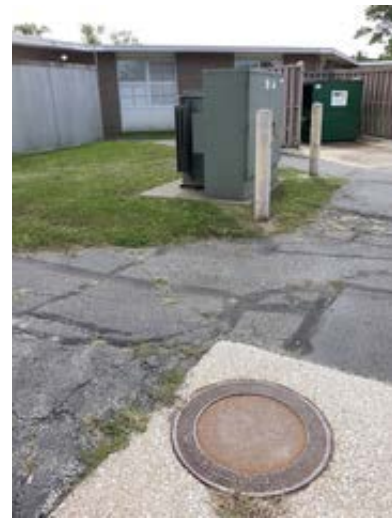
Description: The school sewage system is connected to the municipal sewer system and is in average condition. The kitchen grease waste interceptor is regularly emptied.

Rating: 3 Needs Replacement

Building Sewer

Recommendations: Existing site conditions require replacement of the original cast iron sanitary and storm piping system.

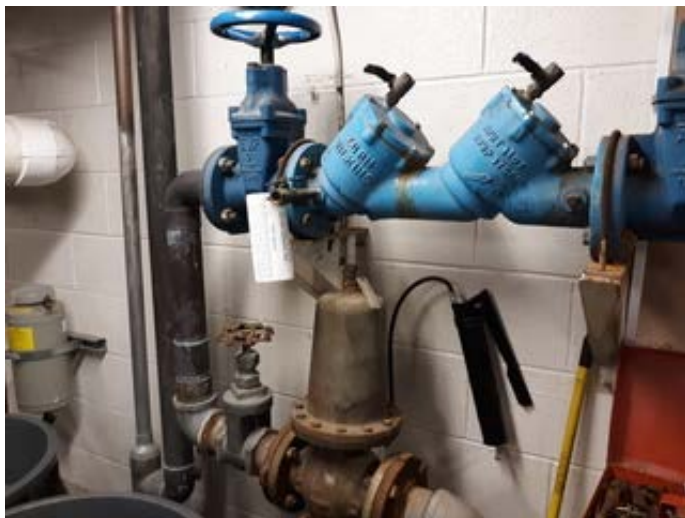
Backflow preventer

Recommendations: Existing site conditions require that a new service line be installed for the new sprinkler system. See Item U for new water line and backflow preventer.

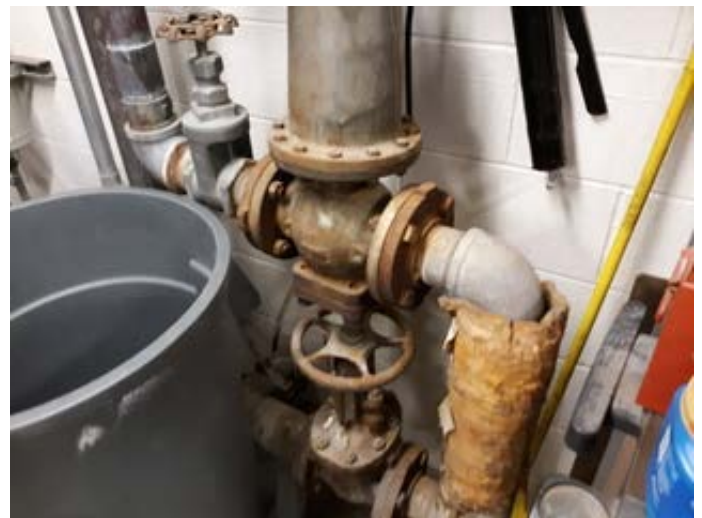
Water supply

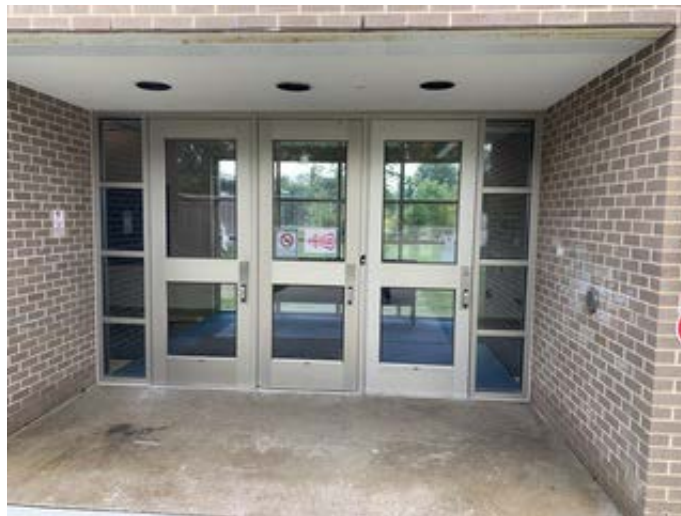
Description: Typical exterior doors in the overall facility are aluminum construction, installed on aluminum frames, and in good condition. Typical exterior doors feature insulated vision panels. 12/8/21 update: All existing doors in need of replacement.

Rating: 3 Needs Replacement

Main Entry Doors

Recommendations: Replace those exterior doors as noted below due to poor condition. 12/8/21 update: Added 7 additional doors to replace all existing doors.

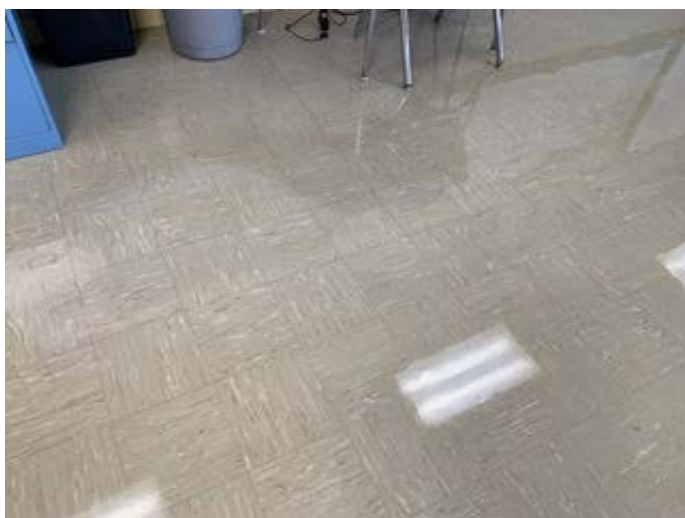
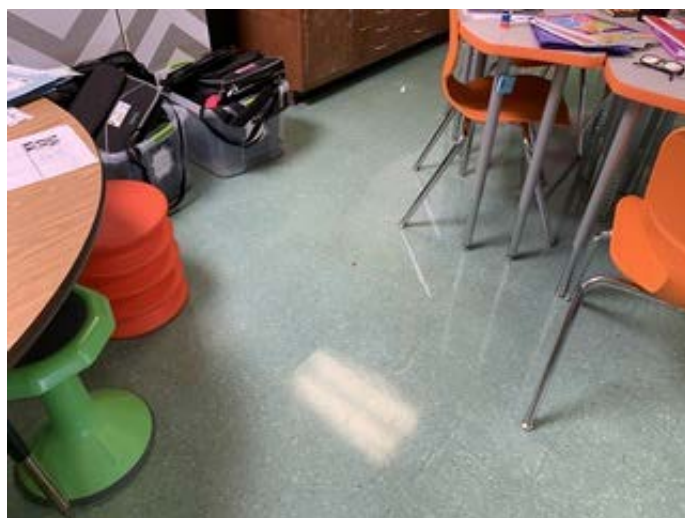
Description: The School District provided the AHERA three year reinspection reports, prepared by Demshar Environmental, Inc., dated December 27, 2016, documenting known and assumed locations of asbestos and other hazardous materials. OFCC to provide independent EEA with scope & budget to be included in assessment findings.

Rating: 2 Needs Repair

VAT in a Clasroom

VAT in a Classroom

Recommendations: Remove all hazardous materials, inclusive of asbestos-containing materials in the overall facility, as noted in the attached Environmental Hazards Assessment. OFCC to provide independent EEA with scope & budget to be included in assessment findings.

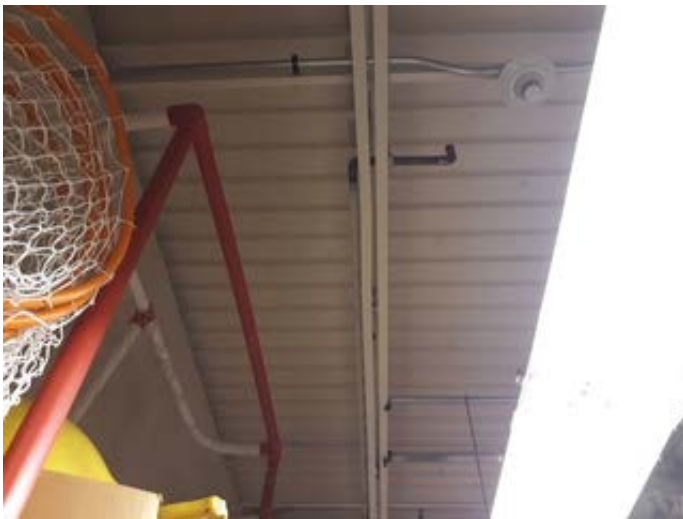
Rating: 3 Needs Replacement

Limited area sprinkler head

Recommendations: Add a complete sprinkler system and remove the old limited area sprinkler systems. Add an emergency generator with automatic transfer switch and connect to life safety fixtures. The cost for the generator is included in Plate D. Emergency lighting should be replaced with LED lamp sources to prolong life expectancy. Provide a new water service line to secure additional capacity for the new sprinkler system. Also provide for a new backflow preventer for this system.

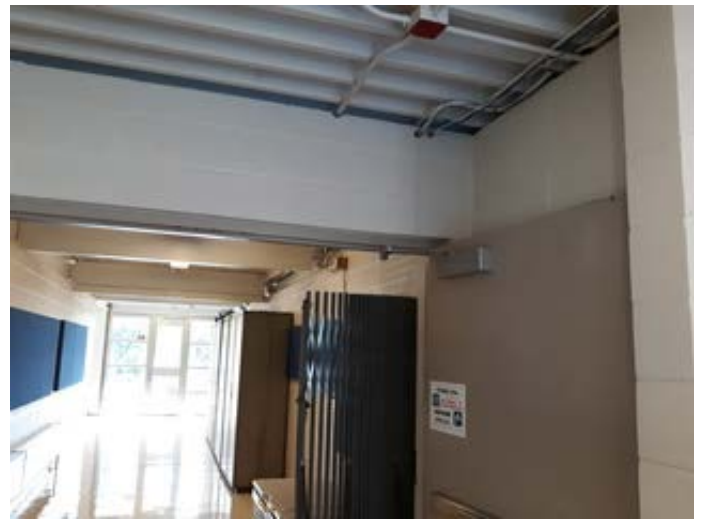
Corridor door hold-opens

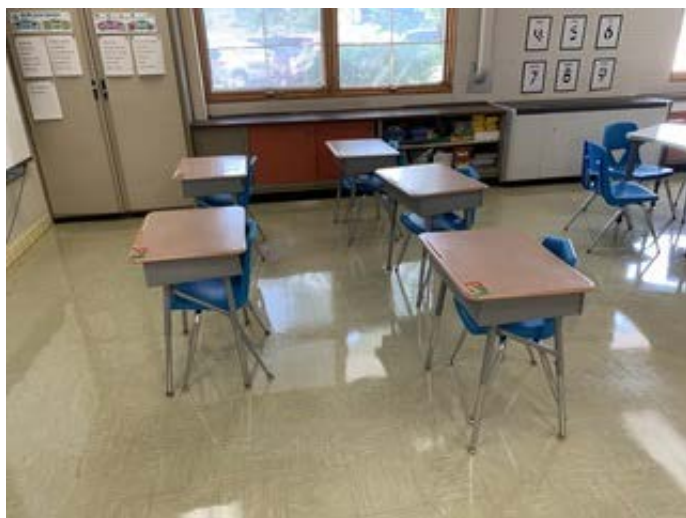
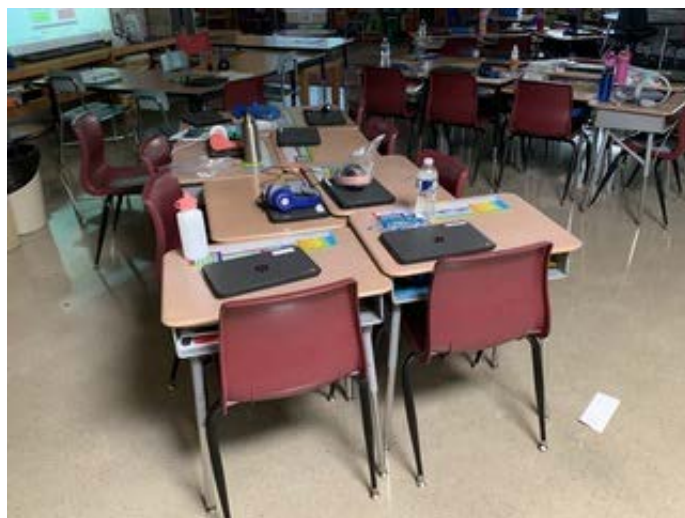
Description: The typical Classroom furniture is mismatched, and in generally fair condition. The facility's furniture and loose equipment were evaluated in item 6.17 in the CEFPI section of this report, and on a scale of 1 to 10 the overall facility received a rating of 5 due to observed conditions, and due to the fact that it lacks some of the Design Manual required elements. 11/29/21 update: Changed CEFPI rating from 4 to 5 to 0 to 3.

Rating: 3 Needs Replacement

Classroom Desks

Recommendations: Provide for replacement of outdated or inadequate furniture. 12/8/21 update: CEFPI rating changed from 4 to 5 to 0 to 3.

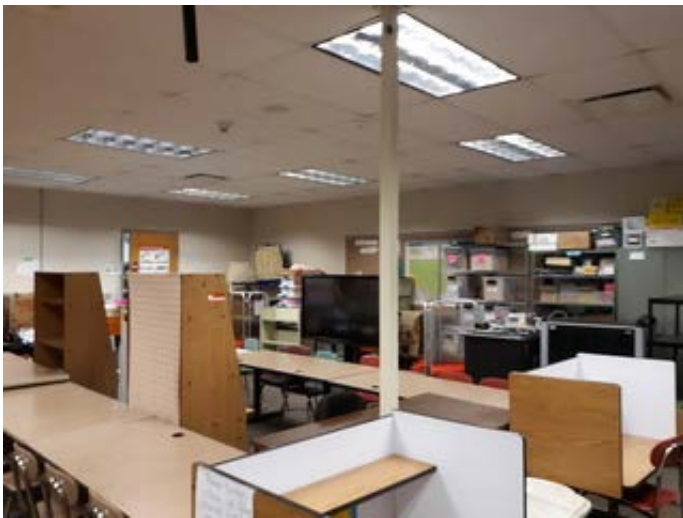
Description: The school is equipped with an older technology system. Smart Boards have replaced the old TV's in classrooms. The classrooms are equipped with an adequate amount of data ports to meet OSDM compliance. Data outlets should be added at necessary locations to meet future requirements. There is an intercom system that includes wall mounted outdoor and indoor speakers. The facility is equipped with a centralized clock system that is not operational. Sound systems are adequately provided in Gym and Student Dining. OSDM compliant computer network infrastructure is provided. Classrooms are equipped with telephones.

Rating: 3 Needs Replacement

Computer lab

Recommendations: Provide complete replacement of technology systems to meet OSDM guidelines, and to sustain the capacity to keep pace with technology development.

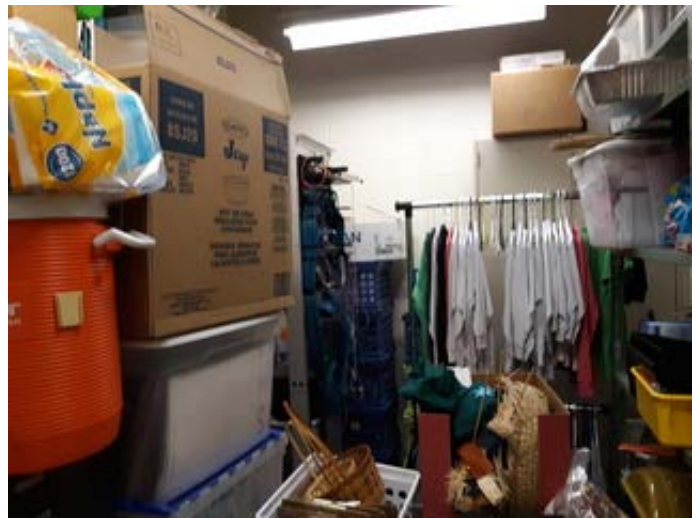
Technology closet
