Building Information - Nordonia Hills City (50047) - Nordonia High

Program Type	Expedited Local Partnership Program (ELPP)
Setting	Suburban
Assessment Name	Nordonia High School (2021 Update) DRAFT
Assessment Date (on-site; non-EEA)	2019-09-06
Kitchen Type	Full Kitchen
Cost Set:	2021
Building Name	Nordonia High
Building IRN	27334
Building Address	8006 S Bedford Rd
Building City	Macedonia
Building Zipcode	44056
Building Phone	330-468-4601
Acreage	47.00
Current Grades:	9-12
Teaching Stations	64
Number of Floors	1
Student Capacity	1118
Current Enrollment	1220
Enrollment Date	2019-09-06
Enrollment Date is the date in which the current enrollment was taken.	
Number of Classrooms	53
Historical Register	NO
Building's Principal	Mr. Casey Wright
Building Type	High

Building Pictures - Nordon Hills City(50047) - Nordon High(27334)

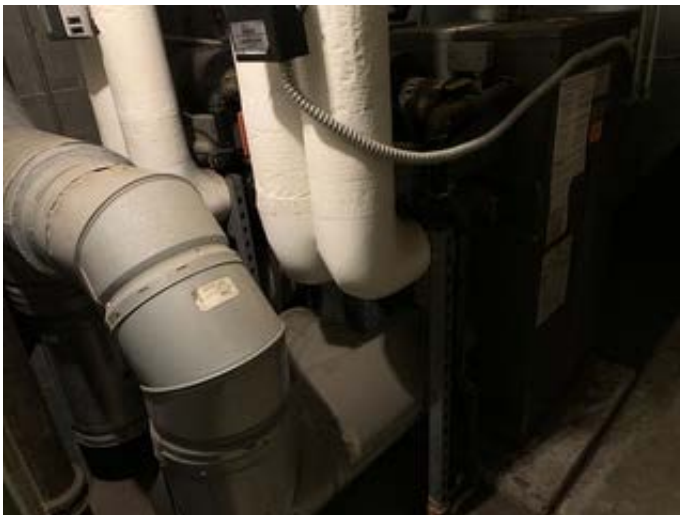
Description: The high school is heated with thirteen (13) gas-fired hot water boilers with classroom fan coils, air handling units with hot water coils, VAV boxes with hot water coils and perimeter cabinet unit heaters. Most equipment was installed when the school was remodeled in 2001. This 18 year old equipment is in poor condition and rust is beginning to deteriorate the cabinets. Hot water is distributed through a plastic piping system from multiple pumps, each with a standby pump. The air handling units include refrigerant coils for cooling. The building contains an older central building automation system. It monitors air terminal units, handling units and VAV boxes. The VAV boxes have factory mounted controls that are independent. The 15 CFM per person fresh air requirement of the Ohio Building Code, Mechanical Code and Ohio School Design Manual, OSDM, is satisfied. The floor to floor height is low in older portions of the building and cannot accommodate air handling unit ductwork. However, several classroom wings were originally built with air tunnels under the floor at perimeter walls. An ingenious system has been installed to run ductwork in these tunnels when remodeling occurred in 2001. These ducts are connected to cooling only rooftop VAV units that supply 55°F air to large fan coils in classrooms which have reheat coils to provide winter heat. These rooftop units have hot water coils for morning warm-up and cold winter weather. The site does not contain an underground fuel tank. The overall heating system is evaluated as being in a safe working order. The system is also inefficient with non-condensing boilers and much of the system should be replaced for long life expectancy. 11/26/21 update: 2001 additions already have RTU's with ductwork and space is available to run ductwork.

Rating: 3 Needs Replacement

Boilers

Recommendations: Provide for a complete replacement of the building's entire HVAC system due to age & condition and to fully comply with all OSDM standards.

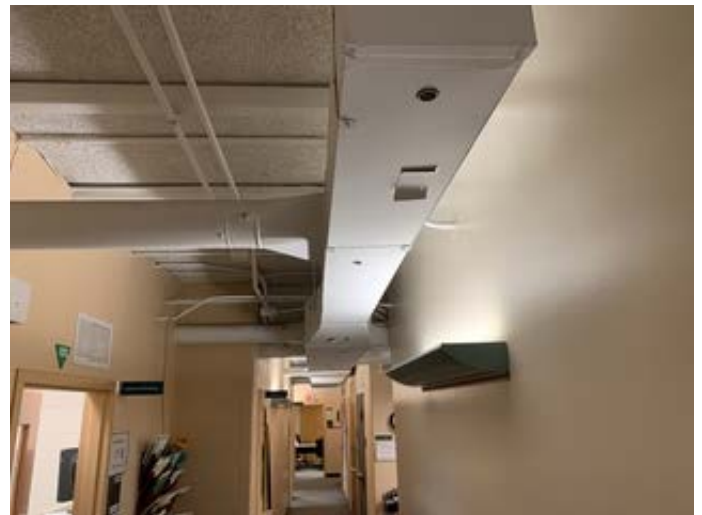
Office exposed ductwork

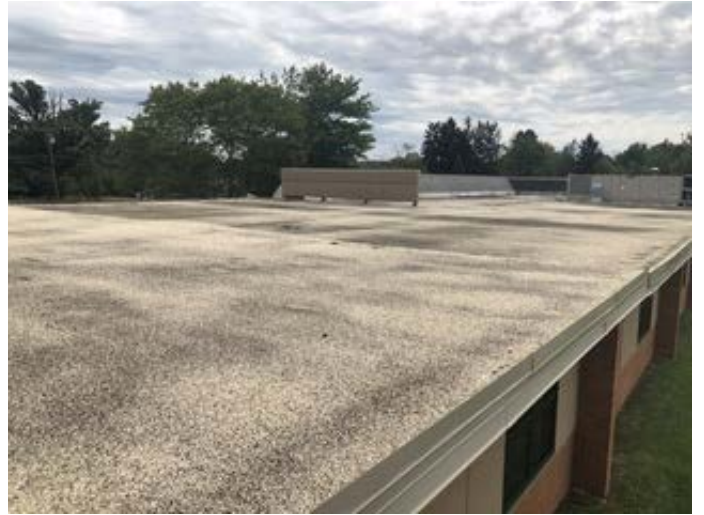
Description: The roof over the overall facility is a ballasted membrane system that was installed over 7 years ago, and is in fair condition. There are no District reports of current leaking. But signs of past leaking were observed during the physical assessment. Access to the roof was gained by access ladder that is in good condition. Fall safety protection cages are not provided. There were no observations of standing water on the roof. Metal cap flashings are in fair condition. Roof storm drainage is addressed through a system of roof drains, which are properly located, and in fair condition. Most of the roof is not equipped with overflow roof drains though they are needed on this building. Note that the roof deck is tectum panels which are also used to create the exterior soffits. Additional roof insulation is required to meet LEED Silver Certification energy requirements. No problems requiring attention were encountered with any roof penetrations. 11/26/21 update: Damage to 500 SF of existing tectum decking, will need replacement.

Rating: 3 Needs Replacement

Ballasted Membrane Roofing

Recommendations: The roof over the overall facility requires replacement to meet Ohio School Design Manual guidelines for age of system and due to condition. Provide for tectum deck replacement at exterior soffits. Provide additional roof insulation to meet LEED Silver Certification energy requirements. 11/26/21 update: Install "Z" furring and spray foam, replace metal soffit/fascia at all perimeter tectum deck soffit locations. Replace additional cap flashing/coping/add additional fascia to new tapered roof insulation and insulation thickness to comply with ASHRE requirements. Replace damaged existing tectum decking.

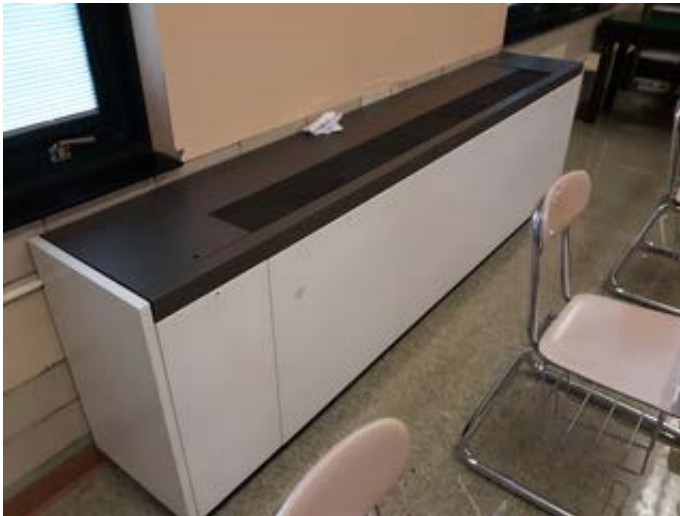
Description: The high school is air conditioned with twenty eight (28) rooftop air handling units. These units are now 18 years old and in poor condition. Condensing units should be replaced with more available R410A refrigerant. Controls at classroom VAV boxes are past their useful life. Each air handling unit brings in code required fresh air. These twenty eight (28) air handlers have economizers which provide "free" cooling on mild days. Since operation of VAV boxes in classrooms provide the required minimum amount of fresh air for occupants, these systems satisfy the Ohio Building Code for ventilation and OSDM standards. Some rooftop units are connected to an original 1960's under floor duct system that feeds unit ventilators in older classrooms. The system can provide simultaneous heating and cooling with the VAV system and is compliant with OSDM requirements when controls are replaced. The ventilation system does not incorporate an energy recovery system. Individual toilet exhaust fans, on the roof, operate in conjunction with their associated air handling unit, but do not recover this lost energy. The technology server room is independently cooled. There is an operating dust collection system in the Shop and the Art Room has exhaust and a kiln hood. There is a large, NFPA, grease hood in the Kitchen along with a dishwasher hood. There are multiple chemical hoods in Science Classrooms. Toilet exhaust fans and other building ventilation fans are on the flat roof areas. 11/26/21 update: Both kilns need new exhaust system. Exhaust fans are 20+ years old, fume hoods were installed in 2001.

Rating: 2 Needs Repair

Unit ventilator

Recommendations: Replace VAV boxes and controllers. Add air conditioning to the replaced make-up air units with refrigerant coils and condensing units. Replace rusting rooftop air handling units with current refrigerant coils. Replacement cost included in Item A, Heating System. 11/26/21 update: Kilns need new exhaust system, four fume hoods need replacement.

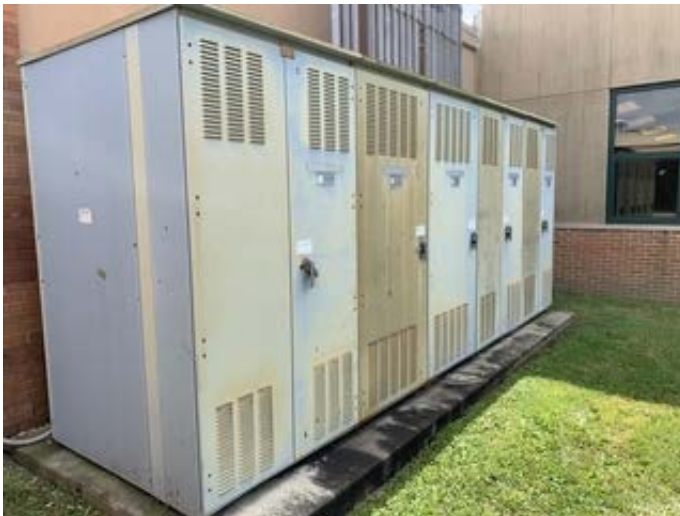
Description: The school has (2) separate electrical services, with (2) pad-mounted transformers on the west side of the building and are primary metered at the south end of the building. The transformers are owned by Nordonia Hills City School District. Two (2) main switchboards serve the building. The first is 480/277 volts, 3phase, 4 wire, 3,000 amps and the other is 208/120 volts, 4,000 amps. The 480/277 volt service generally serves the air conditioning equipment and the 208/120 volt service serves the general power and lighting throughout the entire building. Both services were installed in 2001 and backfed the existing services within the building. The electrical systems were upgraded in 2001 and appear to be in good condition. Many of the branch circuit panels were also replaced in 2001. However, there are some distribution panels and branch circuit panels that were installed in 1960, 1963 and 1970 that should be replaced. Classrooms have an adequate number of general-purpose receptacles. The corridors are equipped with adequate receptacles for servicing and there are GFI protected exterior outlets around the perimeter of the building. The school is not equipped with an emergency generator. Adequate lightning protection safeguards are not provided.

480 and 208 volt services

Recommendations: In general, the overall electrical system meets OSDM requirements in supporting the current needs of this high school and will be adequate to meet the facilities' future needs. However, distribution panels and branch circuit breaker panels in the 1960, 1963 and 1970 portions of the building should be replaced when those areas are renovated. In addition, an emergency generator should be added. 12/8/21 update: Partial system replacement for all buildings except 2001 additions.

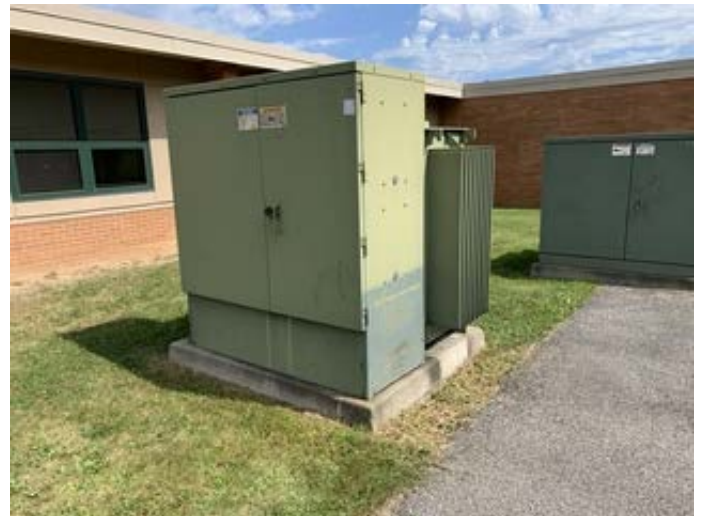
Two transformers

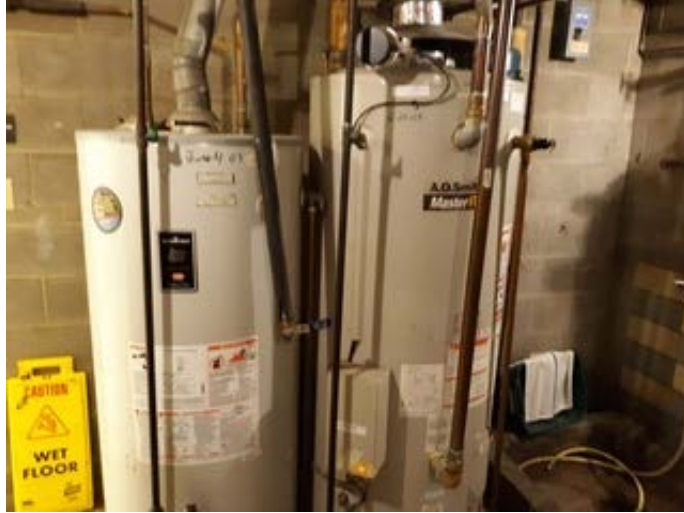
Description: The high school plumbing system meets requirements for plumbing fixtures and backflow prevention. There is a 4" domestic water meter and backflow preventer from the municipal water supply with copper piping properly distributed. The domestic hot water system operates at 140 degrees F. The water heaters have been replaced and there are several systems throughout the building. Lavatories do not have individual mixing valves. The toilet facilities include handicapped fixtures with sensor operated flush valves and faucets used in public facilities. Elsewhere, fixtures are manually operated. Fixtures are not low flow, which does not meet OSDM guidelines. Water closets and urinals are wall mounted throughout with flush valves. Newer sanitary piping is PVC, in good condition. The original (1960) cast iron sanitary piping is over 50 years old and past its useful life. The school contains large group restrooms for boys and large group restrooms for girls. In locker rooms, the shower facility includes individual faucets in group enclosures and adequate drains. The large Kitchen has gas fired appliances, a dedicated gas fired water heater and staff toilet room. Science classrooms include acid resistant sinks, drains, neutralization sumps and emergency shower/eyewash stations. Storm drain pipes have broken and failed. Heavy rains cause overflows in courtyard from broken pipes and water enters adjacent corridor floors.

Rating: 3 Needs Replacement

Water heaters

Recommendations: Replace water closets, urinals and their flush valves with low flow fixtures. Replace the brass (high lead content) faucets and shower valves with lead free faucets. Add mixing valves at each lavatory and replace master mixing valves to deliver 140 degree F domestic hot water thru piping loop. Add tempering valves at eye washes. Replace recirculating pumps. Replace all water heaters. Replace deteriorated cast iron sanitary and storm piping. 11/26/21 update: District does not use showers, do not account for replacing shower valves. 2001 plumbing fixtures are in good shape, SHD recommends replacing existing flush valves with low flow. 12/8/21 update: District does not use showers; shower valves do not need to be replaced.

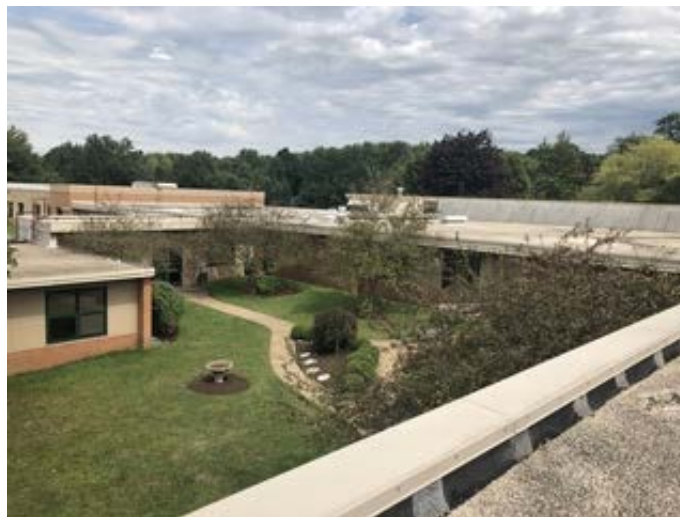
Description: The overall facility is equipped with thermally broken aluminum windows with double glazed insulated glazing window system which was installed in 2000, and is in good condition. Window system seals are in fair condition, with minimal air and water infiltration being experienced. Window system hardware is in fair condition. The window system features integral blinds, which are in fair condition. 12/2/21 update: Existing windows are 20+ years old. District requests replacing all exterior windows per discussion on 9/16/21.

Rating: 2 Needs Repair

Picture With Several Windows

Recommendations: Provide a lump sum dollar amount to replace any faulty hardware. 12/2/21 update: SHD recommends to remove and replace all exterior painted aluminum windows. Replace exterior translucent panel windows in the main and auxiliary gymnasiums.

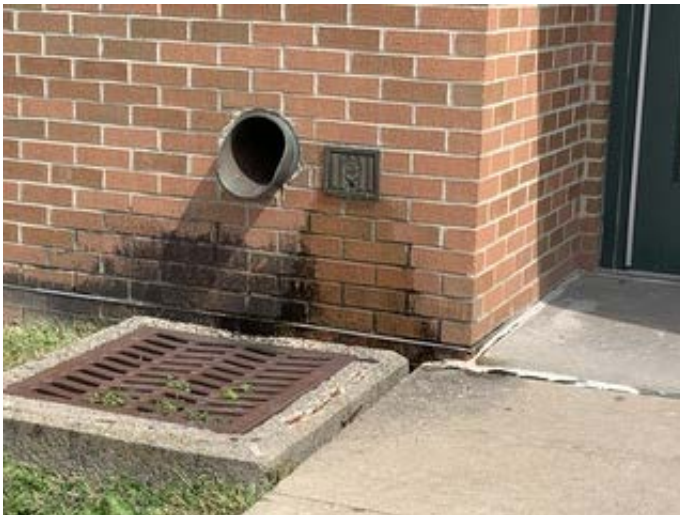
Description: The overall facility has a brick veneer on a masonry bearing wall system, which displayed very minor locations of deterioration, and is in good condition. The exterior masonry appears to have appropriately spaced and adequately caulked control joints in fair condition. Control joints are provided at lintel locations at doors and windows and are in good condition. The school does have sufficient expansion joints, and they are in good condition. The exterior masonry has not been cleaned and sealed in recent years, and shows very minor evidence of mortar deterioration. Interior walls are concrete masonry units and glazed block and are in good condition. Interior masonry appears to have adequately spaced and caulked control joints in good condition. Soffits are in poor condition, see Plate B - Roofing. The window sills are stone and are in good condition. The exterior lintels are steel, and are in good condition. Note that the north wall of the Auxiliary Gym is some sort of insulated plastic that is in poor condition.

Rating: 2 Needs Repair

Masonry That Needs To Be Cleaned

Recommendations: Provide minor tuckpointing in all areas of mortar deterioration as required through the overall facility. Provide masonry cleaning, sealing, caulking as required through the overall facility. Provide for brick infill at the north wall of the Auxiliary Gym. 12/8/21 update: Add insulated metal panel to aux gym in 1971 addition. EIFS coating w/ Lotoson STO product needed throughout entire building.

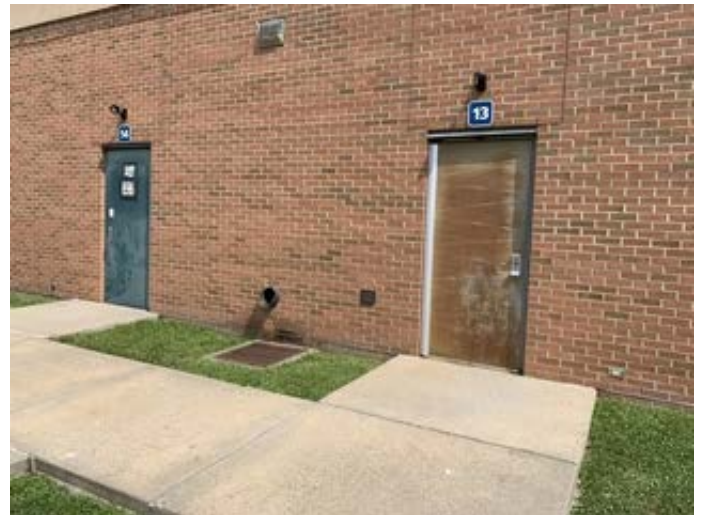
Typical Exterior Masonry

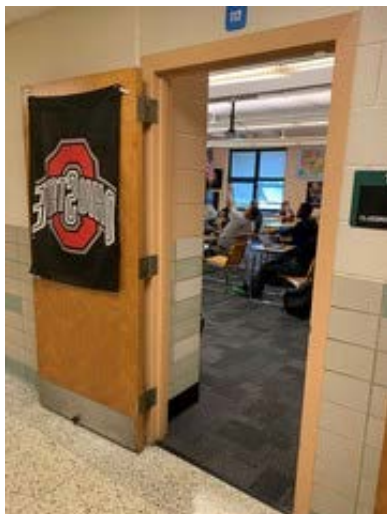
Description: The overall facility features conventionally partitioned Classrooms with VCT/VAT flooring, suspended ceilings, as well as painted wall finishes, and they are in fair condition. The overall facility has Corridors with terrazzo/VCT/VAT flooring, suspended ceilings, as well as tile wall finishes, and they are in good condition. The overall facility has Restrooms with tile flooring, plaster ceilings, as well as tile wall finishes, and they are in fair condition. Toilet partitions are plastic and are in good condition. Classroom casework in the overall facility is wood construction with plastic laminate tops, is adequately provided, and in fair condition. The facility is equipped with wood louvered and non-louvered interior doors that are flush mounted and partially recessed with and without proper ADA hardware and clearances, and in fair condition. The Gymnasium spaces have wood flooring, open ceilings, as well as painted wall finishes, and they are in good condition. Gymnasium telescoping stands are plastic type construction in fair condition. Gymnasium basketball backboards are electrically operated type, and are in good condition. The Media Center has carpet flooring, suspended ceilings, as well as painted wall finishes, and they are in good condition. Student Dining has VCT flooring, suspended ceilings, as well as painted wall finishes, and they are in good condition. The existing Kitchen is full service, is undersized based on current enrollment, and the existing Kitchen equipment, is in fair condition. The Kitchen hood is in fair condition, and is equipped with the required UL 300 compliant wet chemical fire suppression system. 11/26/21 update: Originally 148 doors were in need of replacement to reach ADA standards; district agreed to replace all doors to make them match. Total of 292 doors. Additional wall insulation needed.

Rating: 3 Needs Replacement

Non-recessed Corridor Door

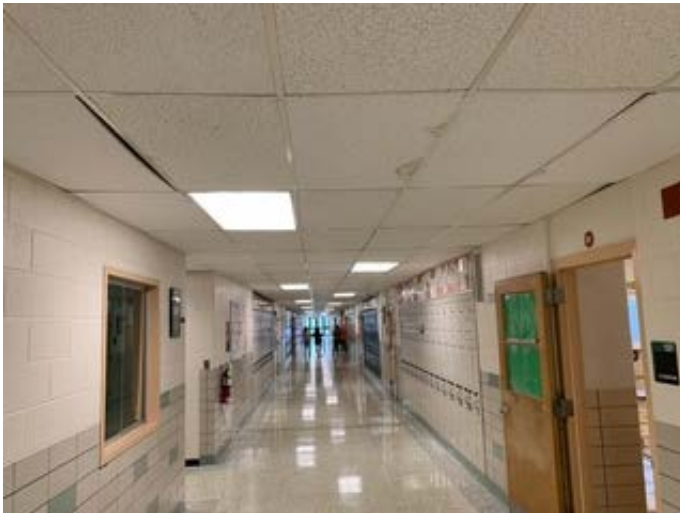
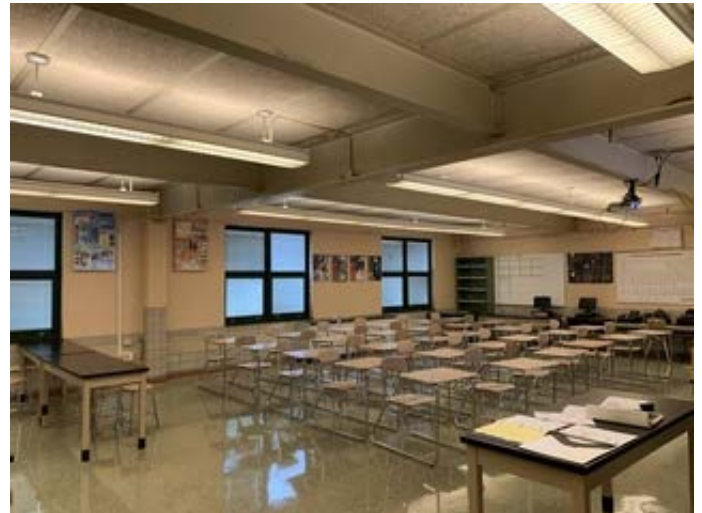
Rating: 3 Needs Replacement

Corridor lighting

Classroom lighting

Recommendations: Completely replace the lighting throughout the building. Replace with LED type fixtures throughout to provide longer life and reduced energy consumption. Update all light levels to meet the current OSDM light level requirements. Provide classrooms lighting with dual level switching and occupancy sensors.

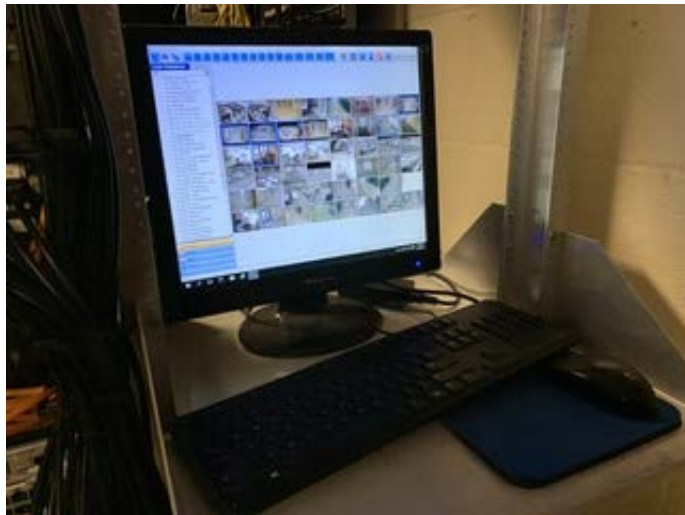
Rating: 3 Needs Replacement

Security monitor

Recommendations: Provide for a complete replacement of the existing security system to meet OSDM requirements.

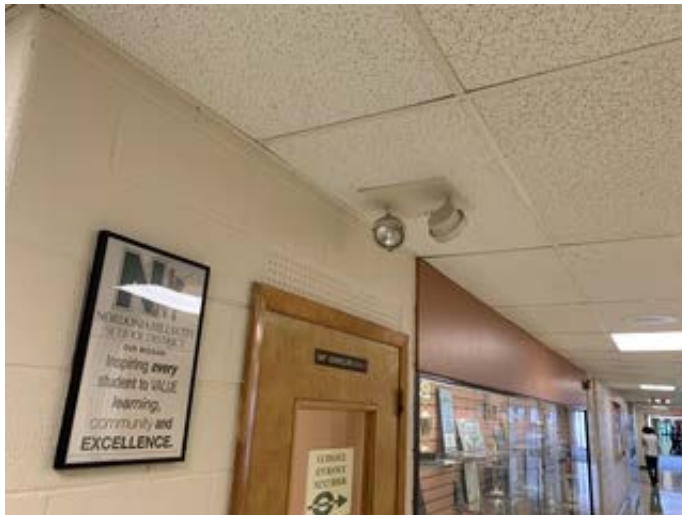
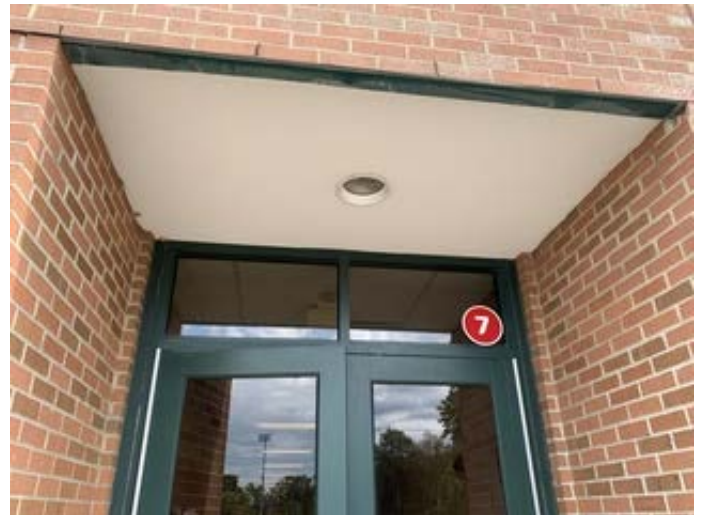
Rating: 3 Needs Replacement

Egress lights

Exterior egress light

Recommendations: The emergency egress lighting needs to meet OSDM guidelines. All fixtures should be LED. Circuit new emergency egress fixtures, as well as new exit signs, from an emergency generator.

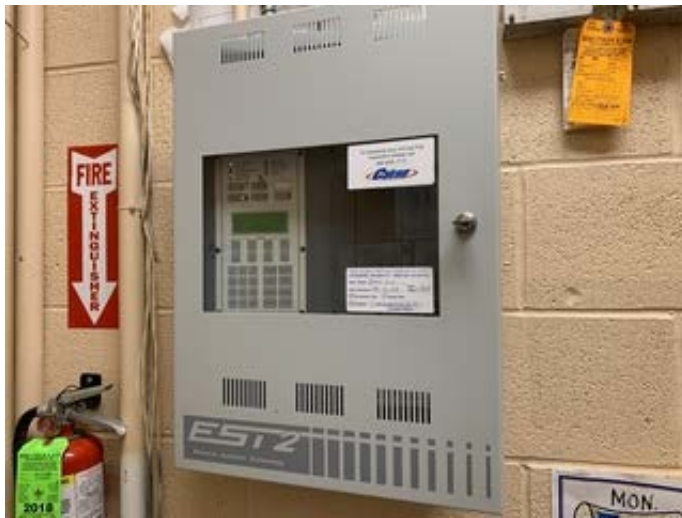
Fire alarm panel

Recommendations: The fire alarm system should be replaced with a fully addressable system that utilizes voice commands. Provide speaker/strobes in classrooms and strobes in all toilet rooms. Provide smoke detectors in corridors and tamper/flow switches to monitor the new fire suppression system. Duct smoke detectors shall be provided for all new air-handling systems, where required by Code.

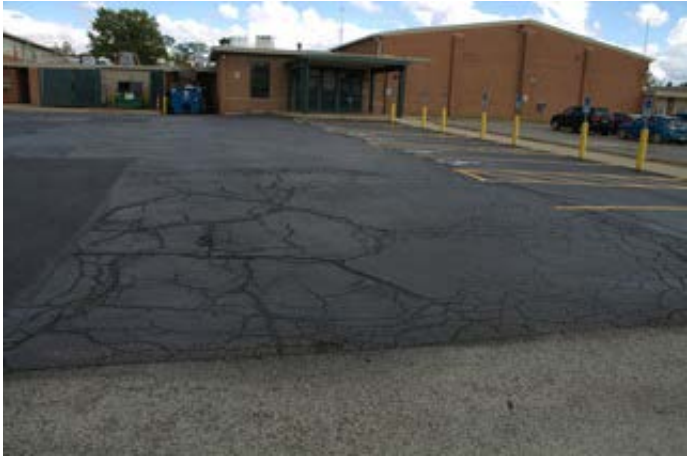
Cracked Asphalt

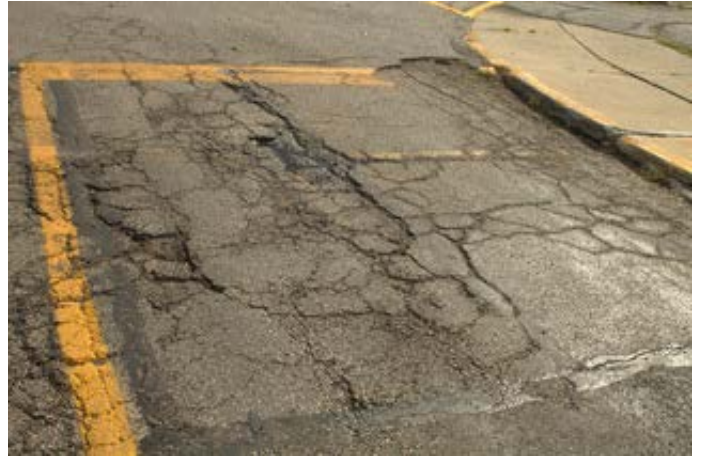
Failing Asphalt and Curb

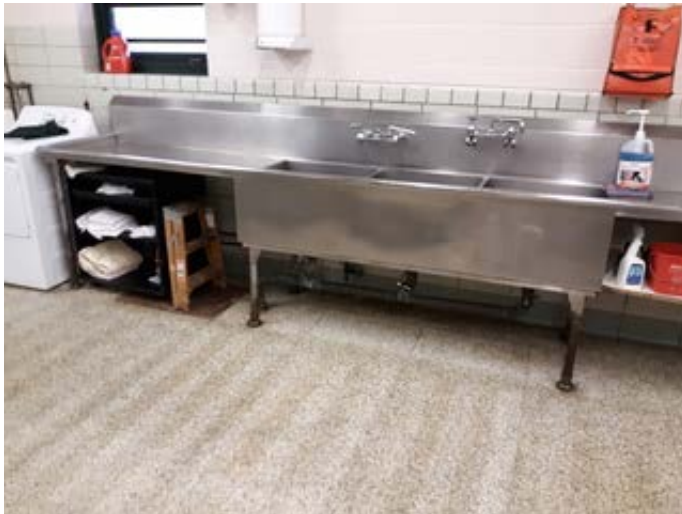
Kitchen grease interceptor

Recommendations: Existing site conditions require replacement of the old cast iron drainage system at the present time. 11/26/21: Add exterior grease interceptor and extend sanitary line, which includes concrete infill.

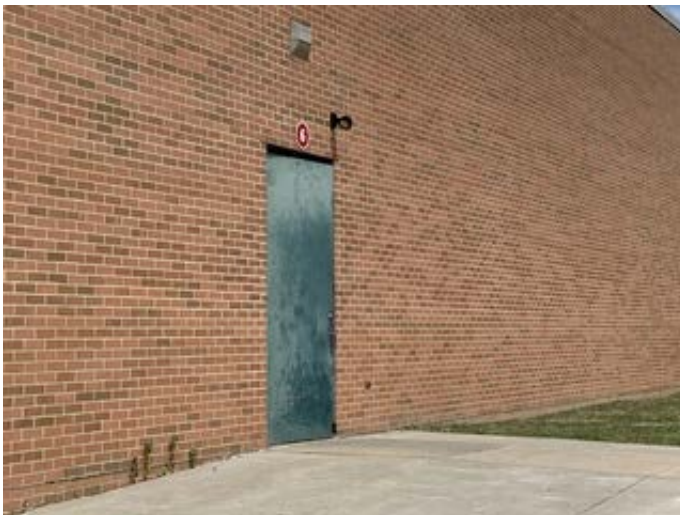
Older Steel Door

Recommendations: Replace the exterior doors as noted below to comply with Ohio Building Code, ADA, and Ohio School Design Manual guidelines.

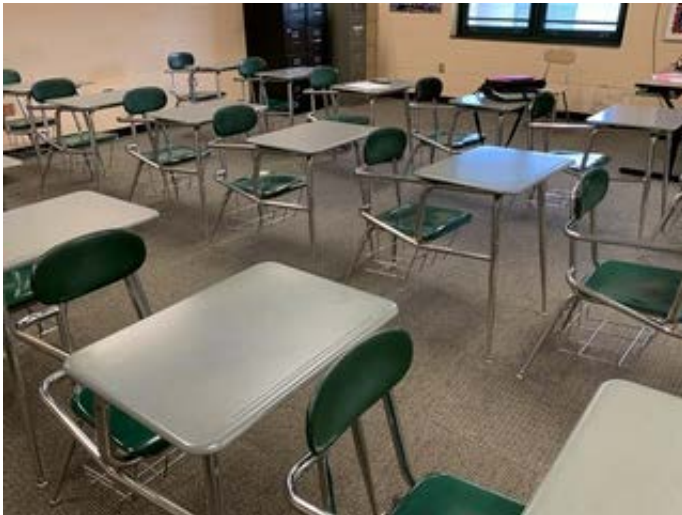
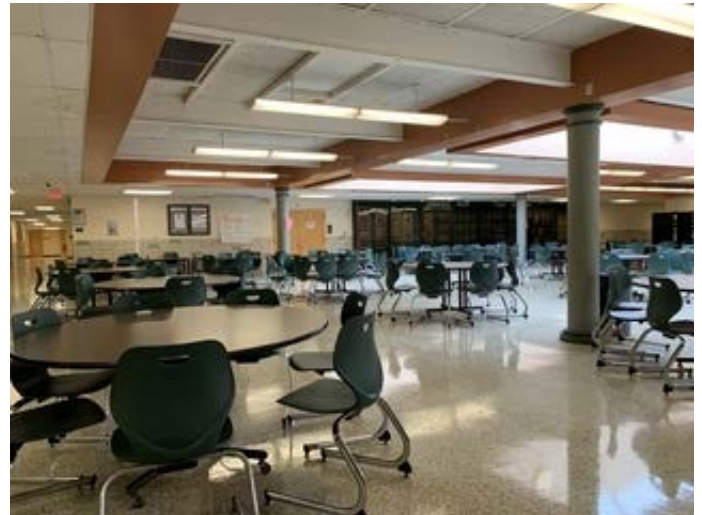
Classroom Desks

Cafeteria Tables

Recommendations: Provide for replacement of outdated or inadequate furniture.
