**Building Information - Nordonias Hills City (50047) - Nordonias Middle**

Program Type	Expedited Local Partnership Program (ELPP)
Setting	Suburban
Assessment Name	Nordonias Middle School (Updated 2021) DRAFT
Assessment Date (on-site; non-EEA)	2019-09-19
Kitchen Type	Full Kitchen
Cost Set:	2021
Building Name	Nordonias Middle
Building IRN	27326
Building Address	73 Leonard Ave
Building City	Northfield
Building Zipcode	44067
Building Phone	330-467-0584
Acreage	10.00
Current Grades:	7-8
Teaching Stations	38
Number of Floors	4
Student Capacity	644
Current Enrollment	603
Enrollment Date	2019-09-19
Enrollment Date is the date in which the current enrollment was taken.	
Number of Classrooms	35
Historical Register	<b>NO</b>
Building's Principal	Mr. Bryan Seward
Building Type	Middle

**Building Pictures - Nordonia Hills City(50047) - Nordonia Middle(27326)**

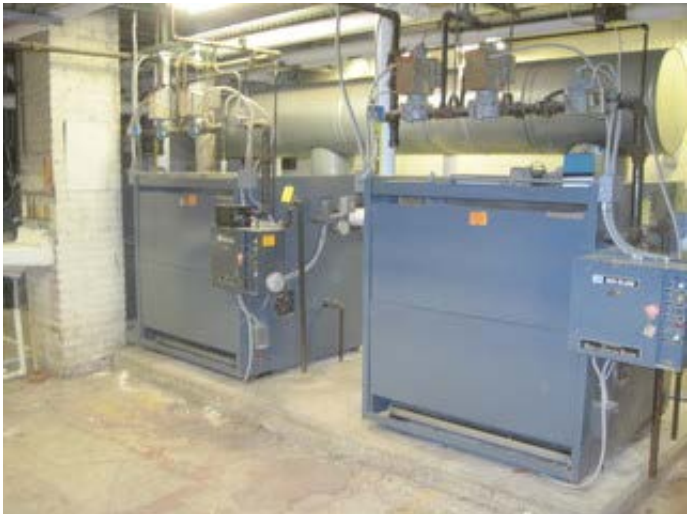
**Description:** There are (2) separate heating water boiler systems in the building. Three Weil-McLain boilers, each with an input rating of 1040 MBH, are located in the Lower Level Mechanical room in the original 1928 portion of the building. These were installed in 1992 and are in fair condition. This system serves the original air handling unit for the 1928 building, plus unit ventilators, convectors, cabinet unit heaters, etc. in the 1928 building and the 1969 west classroom addition. The second boiler system consists of (3) Burnham boilers, each with an input rating of 594 MBH, located in the First Floor mechanical room of the 1969 east addition. These were installed around 2001 and are in fair condition. This system serves the air handling units and perimeter heat for the 1969 east addition. Temperature controls are electronic DDC throughout, but outdated. The 15 CFM per person fresh air requirement of the Ohio Mechanical Code and ASHRAE 62.1 is generally satisfied. 11/29/21 update: Original building is also fed from 2 RTU's located behind the Media Center (old gym) on the roof, and 1969 Addition is partially fed from 2 RTU's. Building is also fed from 2 gas fired RTU's located on the 2001 addition. 2001 additions already have RTU's with ductwork and space to run additional ductwork.

**Rating:** 3 Needs Replacement

Heating water boilers

**Recommendations:** Provide new heating and air handling systems to meet OSDM guidelines.

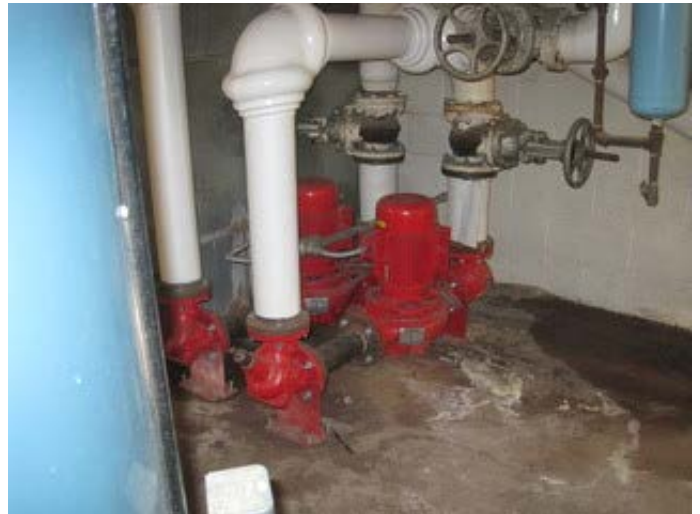
Heating water pumps

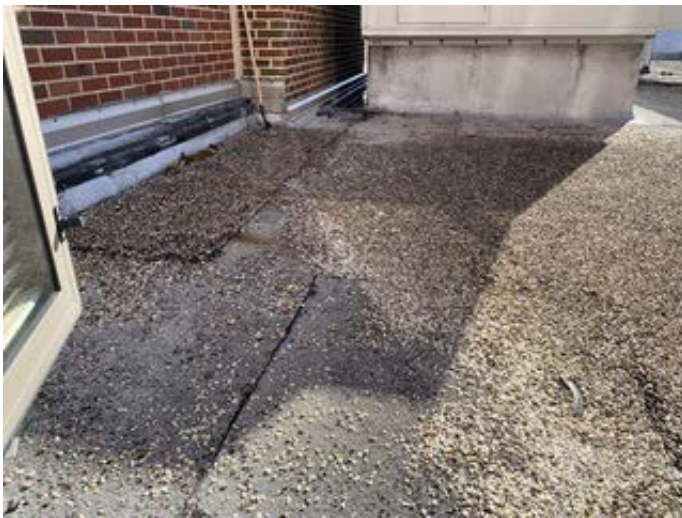
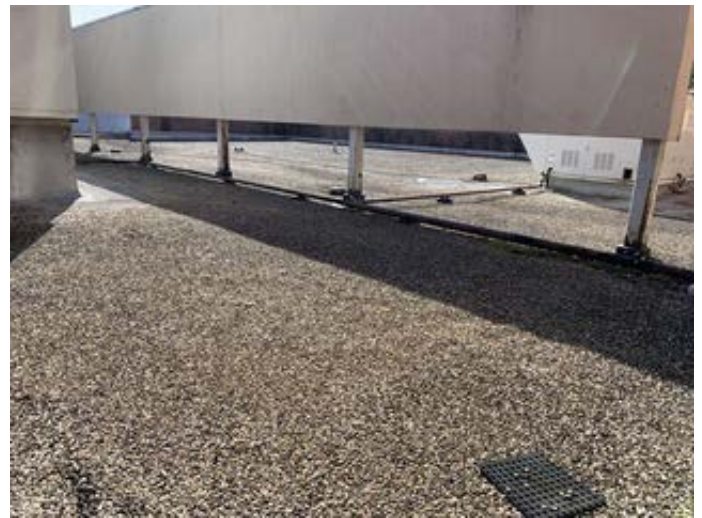
**Description:** The roof over the overall facility is a ballasted membrane system that was installed in over 7 years old, and is in fair condition. There are District reports of current leaking. Signs of past leaking were observed during the physical assessment. Access to the roof was gained by access ladder that is in good condition. Fall safety protection cages are not provided. There were no observations of standing water on the roof. Metal cap flashings are in good condition. Roof storm drainage is addressed through a system of roof drains, which are properly located, and in good condition. The roof is not equipped with overflow roof drains though they are needed on this building. No problems requiring attention were encountered with any roof penetrations. Additional roof insulation is required to meet LEED Silver Certification energy requirements. 12/8/21 update: Amounts for membrane and roof insulation were updated according to most recent evaluation.

**Rating:** 3 Needs Replacement

Ballasted Membrane Roofing

**Recommendations:** The roof over the overall facility requires replacement to meet Ohio School Design Manual guidelines for age of system and due to condition. Also provide roof overflow drains. Provide additional insulation to meet LEED Silver Certification energy requirements. 12/8/21 update: Replace coping & fascia. Install roof ladders for additional roof access, and install safety cages on existing ladders.

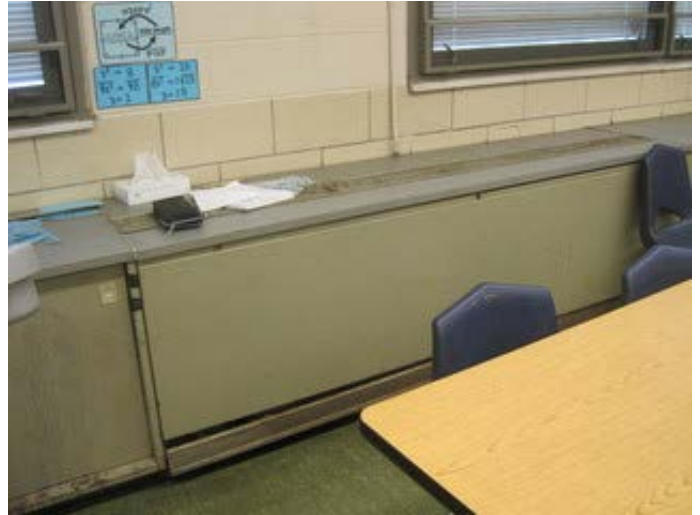
Classroom unit ventilator

**Recommendations:** Due to the age of the HVAC equipment, provide a new air conditioning system throughout that meets OSDM design guidelines. Cost for replacement is included in A. Heating System, above.

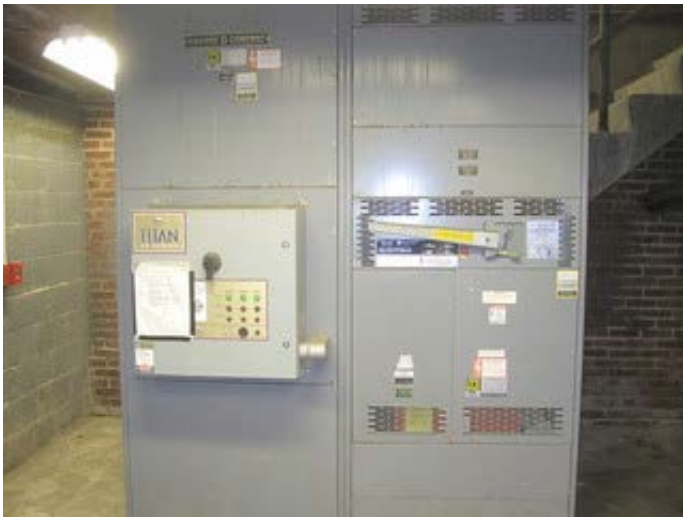
**Description:** The school has (2) separate electrical services, with (2) pad-mounted transformers on the northeast side of the 1928 building. The transformers are owned by Nordonia Hills City School District. (2) main distribution panels, one at 480/277 volts, 1600 amps and the other at 208/120 volts, 1600 amps, are located in the basement of the 1928 building. The 480 volt service generally serves the air conditioning equipment and the 208-volt service serves the general power and lighting throughout the entire building. The electrical systems were upgraded in 2001 and appear to be in good condition. Many of the branch circuit panels were also replaced in 2001. Classrooms have an adequate number of general-purpose receptacles. The corridors are equipped with adequate receptacles for servicing and there are GFI protected exterior outlets around the perimeter of the building. The school is not equipped with an emergency generator. Adequate lightning protection safeguards are not provided.

**Rating:** 2 Needs Repair

208/120-volt main switchgear

**Recommendations:** The (2) electrical services are adequate for the existing building; however, modifications to the distribution network will be necessary to accommodate HVAC renovations. An emergency generator will need to be provided, with cost incorporated in Item U: Life Safety. 12/8/21 update: Replacement of branch circuit panels and distribution network not needed in 2001 addition.

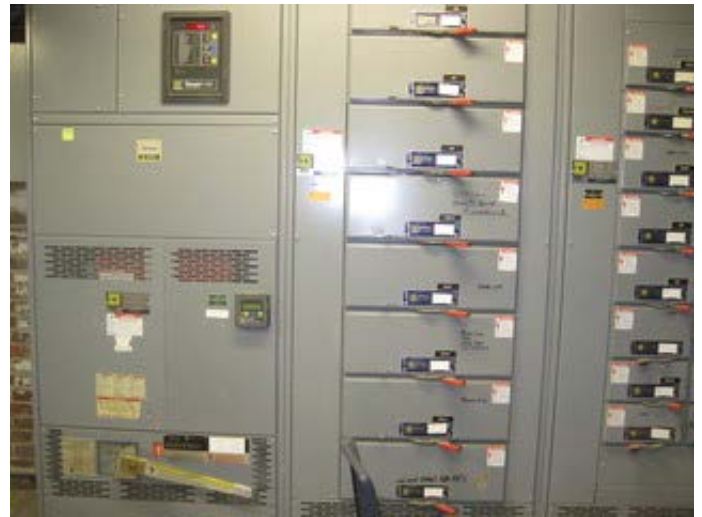
480-volt & 208 volt

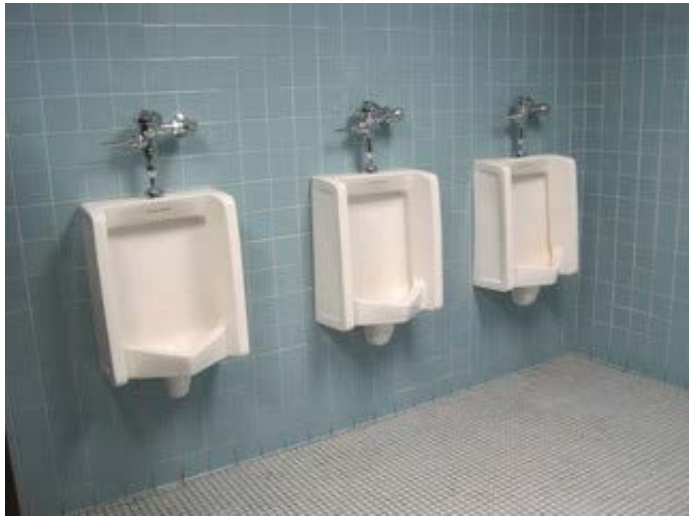
**Description:** The school plumbing system meets current requirements for plumbing fixtures and backflow prevention. There is a 3" domestic water service located in a storage room adjacent to the locker rooms. There is a reduced pressure zone backflow preventer (RPZ-BFP) on the domestic service and a second RPZ-BFP on the limited area sprinkler system serving storage and boiler rooms. Water piping appears to be copper and sanitary piping is predominantly cast iron. The plumbing system was upgraded in 2001 and all fixtures are in good condition, but don't comply with OSDM guidelines. There is an A.O. Smith atmospheric gas-fired domestic water heater in the 1928 boiler room that serves fixtures in the 1928 building and the 1969 west addition. This water heater is located in the 1928 basement boiler room, was installed in May 2019, and is in good condition. There is another water heating boiler located in the east 1969 boiler room, with a storage tank located in a mechanical room on the second floor, above. This serves the toilet rooms and locker rooms. The boiler is in fair condition and the storage tank is in good condition. A third water heater is located in the 1969 second mechanical room and serves the kitchen. The age of this heater wasn't determined, but it is in good condition. There are (6) group restrooms for girls, (6) group restrooms for boys, (4) staff restrooms, (1) restroom in the kitchen, and restrooms with a shower in both the boys' and girl's locker rooms. There is an assortment of both floor-mounted and wall-mounted water closets; some with manual and some with automatic flush valves. Lavatories and wash fountains are wall-mounted, with either manual or automatic faucets. The plumbing fixtures are in good condition and were upgraded at the time of the 2001 addition. The kitchen grease waste interceptor is regularly serviced.

**Rating:** 3 Needs Replacement

wall-hung urinals

**Recommendations:** Replace the cast iron sanitary piping system and supply system piping. Replace plumbing fixtures with wall-hung, low water consumption fixtures that comply with OSDM guidelines. 12/8/21 update: Domestic supply and sanitary waste piping not needed for 2001 addition.

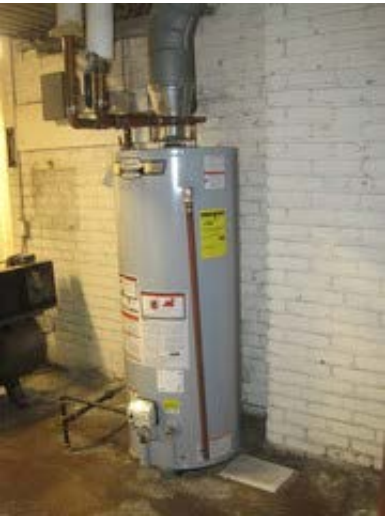
domestic water heater

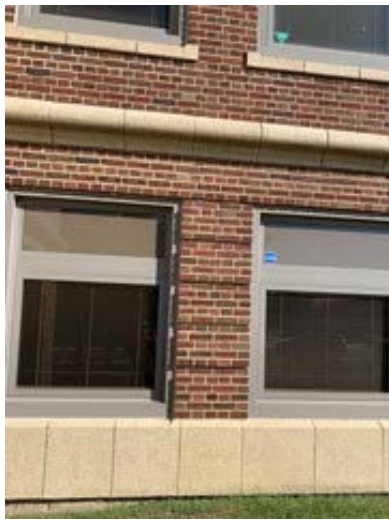
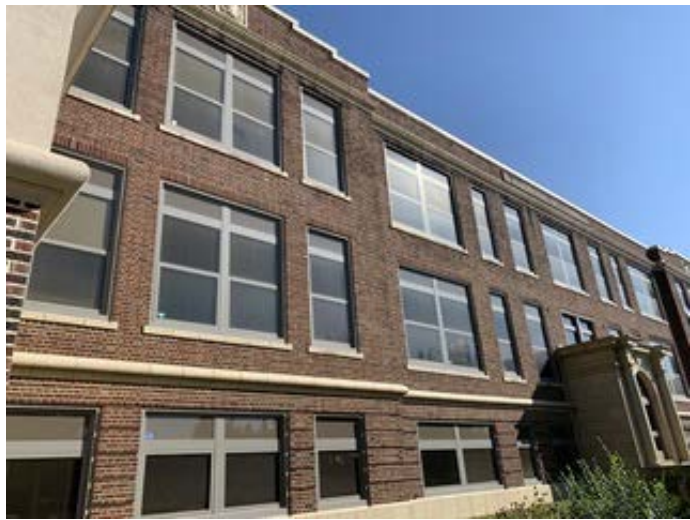
**Description:** The overall facility is equipped with thermally broken aluminum windows with double glazed insulated glazing window system which was installed in 2000, and is in good condition. Window system seals are in fair condition, with minimal air and water infiltration being experienced. Window system hardware is in fair condition. The window system features integral blinds, which are in fair condition.

**Rating:** 3 Needs Replacement

Close Up of a Typical Window

Typical Windows

**Recommendations:** Provide a lump sum dollar amount to replace any faulty hardware. 12/8/21: District requested replacing all exterior windows 9/16/21.

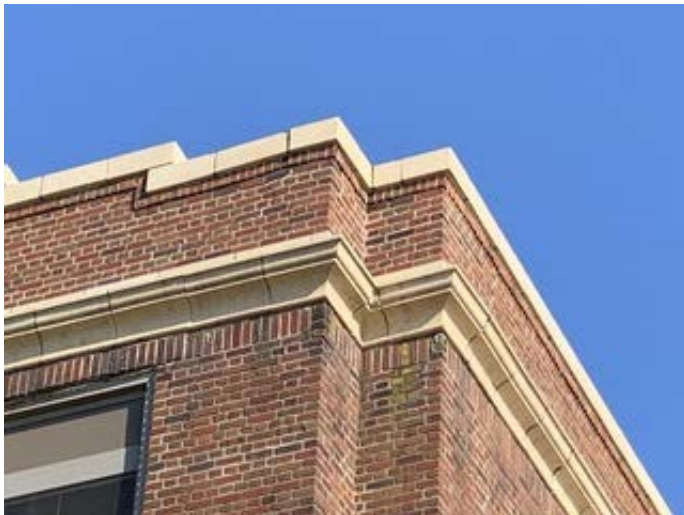
**Description:** The overall facility has a brick veneer on a masonry bearing wall system which displayed very minor locations of deterioration and is in good condition. The exterior masonry appears to have appropriately spaced and adequately caulked control joints in good condition. The exterior masonry has not been cleaned and sealed in recent years, and shows minor evidence of mortar deterioration. Interior walls are concrete masonry units and glazed block and are in good condition.

**Rating:** 2 Needs Repair

Parapet Masonry Needing Repair

**Recommendations:** Provide tuckpointing in all areas of mortar deterioration as required through the overall facility. Provide masonry cleaning, sealing, caulking as required through the overall facility. 12/8/21 update: EIFS coating needed for 1969 and 2001 additions.

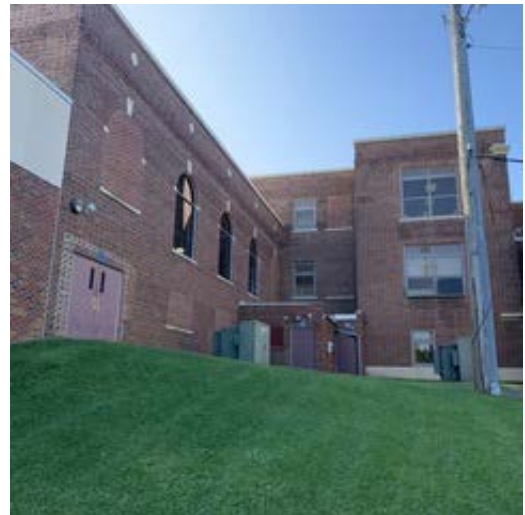
Northwest Side Masonry

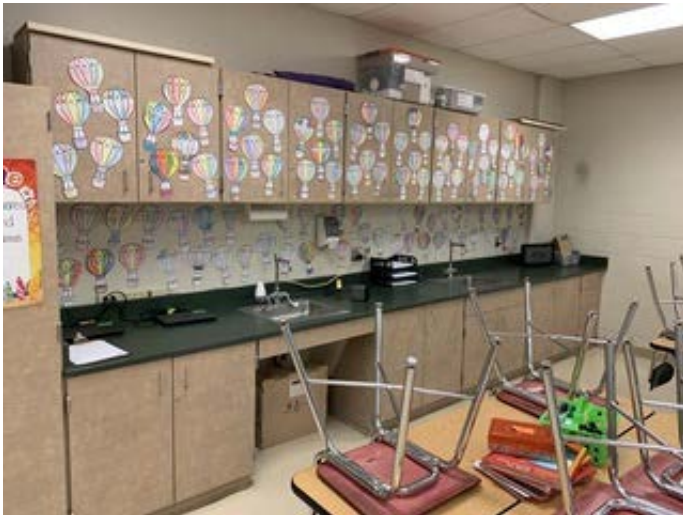
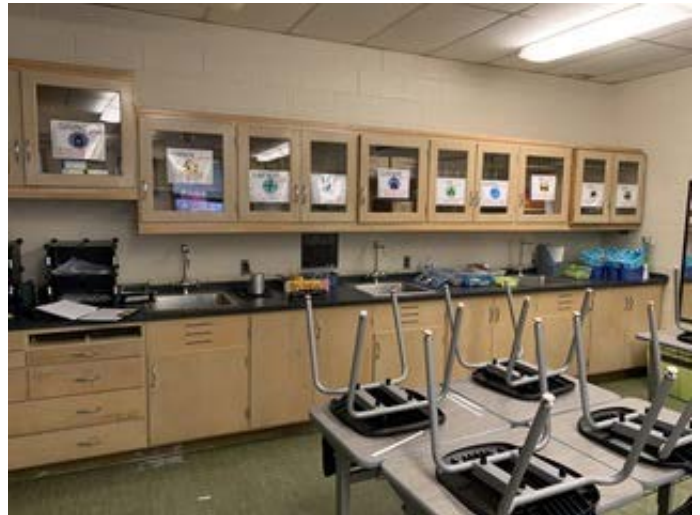
**Description:** The overall facility features conventionally partitioned Classrooms with VCT/VAT flooring, suspended ceilings, as well as painted wall finishes, and they are in fair condition. The overall facility has Corridors with terrazzo and VCT flooring, plaster and suspended ceilings, as well as painted wall finishes, and they are in fair condition. Classroom casework in the overall facility is wood construction with plastic laminate tops, is adequately provided, and in fair condition. The Art program is equipped with a kiln in good condition and existing kiln ventilation is adequate. The facility is equipped with wood non-louvered interior doors that are flush mounted and partially recessed with and without proper ADA hardware and clearances, and in fair condition. The Gymnasium spaces have wood flooring, open ceilings, as well as painted wall finishes, and they are in good condition. Gymnasium telescoping stands are plastic type construction in fair condition. Gymnasium basketball backboards are electrically operated, and are in good conditions. The Media Center has carpet flooring, suspended ceilings, as well as painted wall finishes, and they are in good condition. Student Dining has VCT/VAT flooring, suspended ceilings, as well as painted wall finishes, and they are in fair condition. The existing Kitchen is full service is undersized based on current enrollment, and the existing Kitchen equipment, is in fair condition. The Kitchen hood is in fair condition, and is equipped with the required UL 300 compliant wet chemical fire suppression system.

**Rating:** 3 Needs Replacement

Laboratory Casework

Classroom/Lab Casework

**Recommendations:** Provide a partial replacement of finishes and casework due to installation of systems outlined in Items A, C, D, K, L, M, N, T, U. 12/8/21 update: Gym bleachers need replacement. Add wall cavity insulation to original building and 1969 addition.

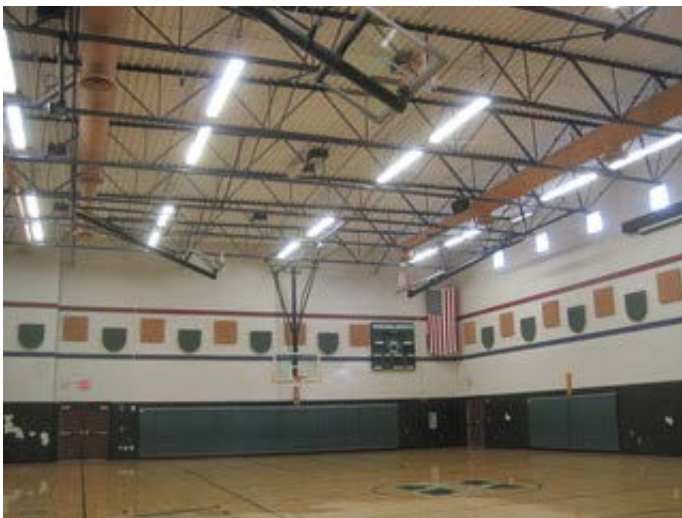
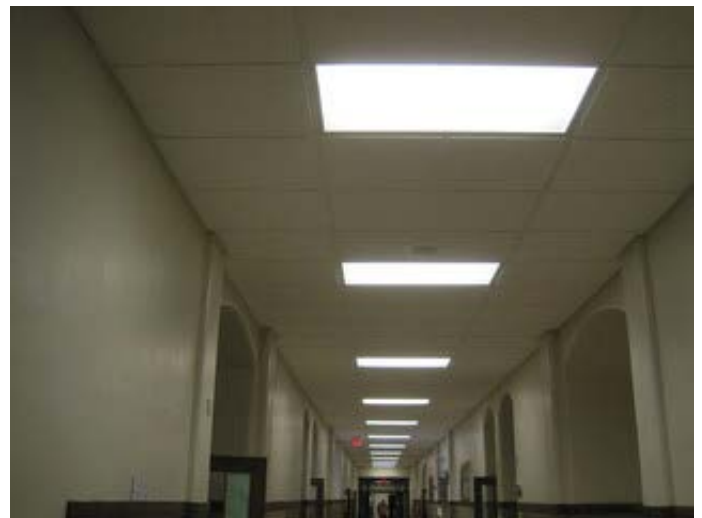
**Rating:** 3 Needs Replacement

Gymnasium high-bay lighting

Corridor lighting

**Recommendations:** Completely replace the lighting due to the installation of a fire suppression system. Utilize LED lamps throughout to provide longer life and reduced energy consumption.

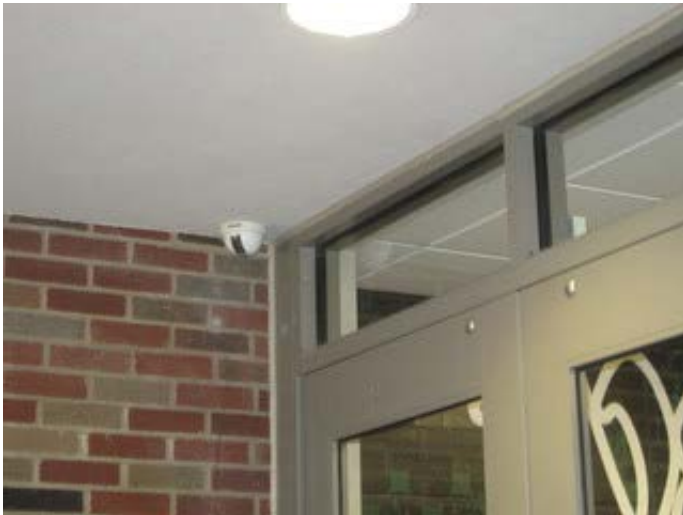
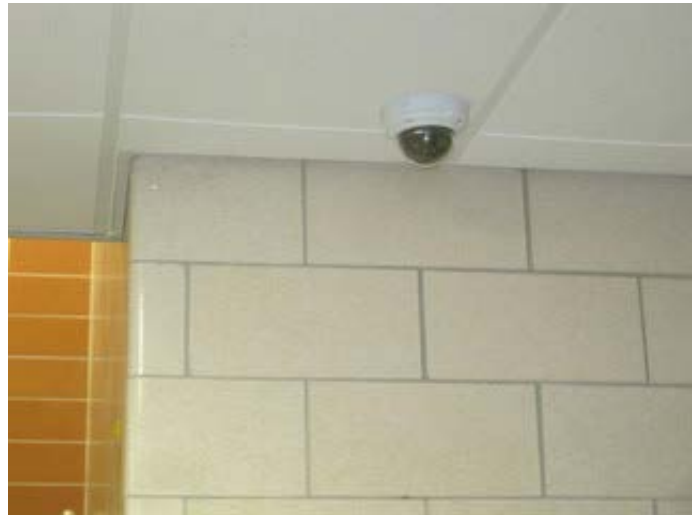
**Description:** The security system is comprised of indoor cameras. Cameras were observed in the main vestibule, in the main Lobby and 1st floor corridor, and in the vestibules of all exterior entrances. There were no motion detectors in the corridors. All exterior doors were locked, and access into the building by visitors was restricted to entry through the front vestibule. There is no central door monitoring; however, several doors have local door release controls with card access. Two-way communication between the central office and classrooms is through the phone system, and there is a public address system in the school. Exterior lighting consists of ground-mounted fixtures around the building and building-mounted fixtures at exterior doors.

**Rating:** 3 Needs Replacement

Main vestibule camera

Camera in corridor

**Recommendations:** Provide new security system to include cameras, motion sensors, door controls and keypads, and video storage. The new security system should fully comply with OSDM guidelines. Exterior lighting should meet OSDM guidelines.

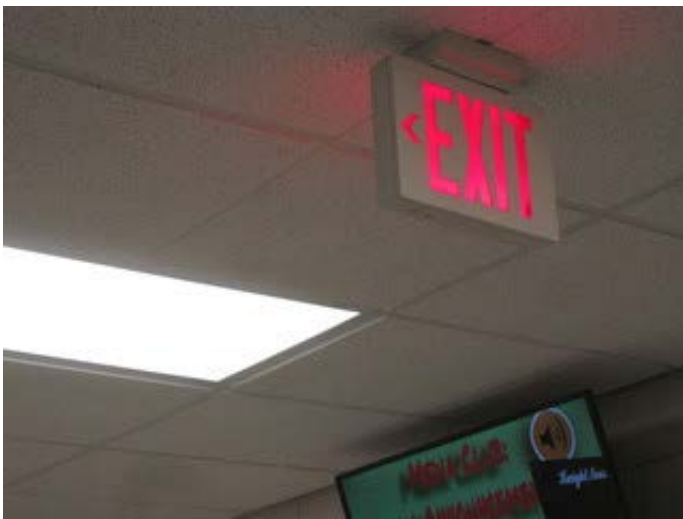
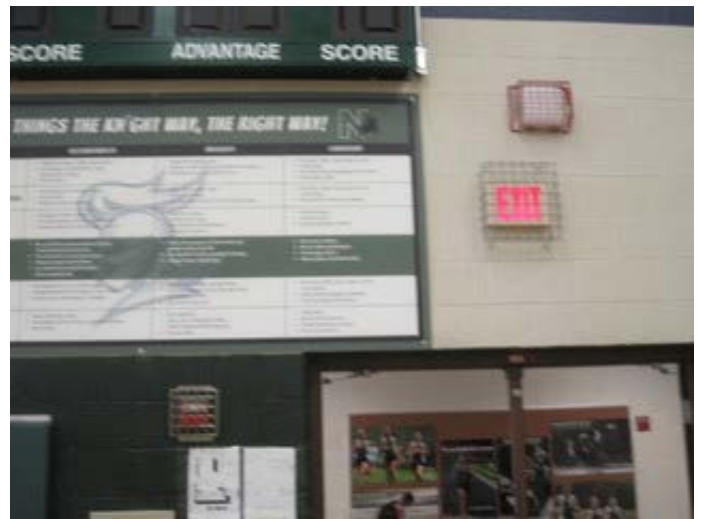
**Rating:** 3 Needs Replacement

Typical exit sign

Exit sign in gymnasium

**Recommendations:** The emergency egress lighting needs to meet OSDM guidelines. All fixtures should be LED. Circuit new emergency egress fixtures, as well as new exit signs, from an emergency generator.

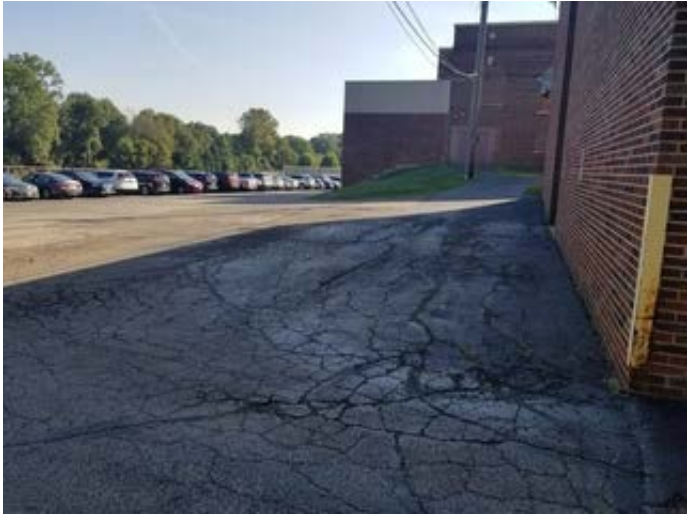
**Description:** The site is sloped so that the east side is lower than the west and the north is lower than the south. The site is located in a small-town commercial setting with moderate tree and shrub landscaping around its property lines. The site is bordered by a heavily travelled city street, residences, and businesses. Multiple entrances onto the site facilitate proper separation of bus & other vehicular traffic, & one-way bus traffic is provided. There is a curbside bus loading & unloading zone in front of the school which is separated from other vehicular traffic. It should be noted, however, that the bus/parent drop off traffic created by this school and Northfield Elementary down the street is constantly violating fire code and causing traffic jams. The west drive also is only wide enough for one vehicle to fit through at a time and experiences water and ice accumulation along the side of the building in the winter or during heavy storms. Parking is facilitated by multiple asphalt parking lots in fair condition, containing 82 spaces which provides adequate parking for staff and visitors, but not enough handicapped parking spots are being provided. The site & parking lot drainage design, consisting of sheet flow, catch basins, and storm sewers provides adequate excavation of storm water in most areas, although the addition of a catch basin by door 20 would help alleviate ponding at the door. Concrete & asphalt curb is used around the site. The concrete curb is in good condition, but the asphalt curb is in need of replacement. Both are appropriately located. Trash pick-up and service drive pavement is in good condition & is equipped with a concrete pad area for dumpsters. One problem to note however is that the ADA ramp on the north end of the building was blocked by a dumpster as the dumpster pad was also the entrance for the ramp. This ramp is in need of replacement as well as it does not meet ADA grading requirements. The school is not equipped with a conventional loading dock. Concrete & asphalt sidewalks are properly sloped in most areas, the exception being the asphalt sidewalks at the north west area of the building where slopes are around 18-21%. They are located to provide adequate & logical flow of pedestrian traffic, and are in fair condition. Several of the stairs outside the school are showing cracks and their handrails, if they have any, are bent and rusting. Site fencing is showing wear, and could use some repairs. This site does not offer any playground equipment. The athletic facilities were not included in the assessment area. Some site features such as the athletic facilities provide space for outdoor instruction, other options are lacking however due to a lack of available space. 12/8/21 update: Asphalt is in bad condition and in need of total removal and replacement.

**Rating:** 3 Needs Replacement

Cracked Asphalt

**Recommendations:** Much of the parking lot and drive that access the rear of the building is in need of repair. The side of the drive that runs along the building is experiencing ponding/ice buildup and the pavement is cracking. The asphalt sidewalks and ADA ramps are also not compliant as they are too steep. Several doors on the outside of the building need to have sidewalk access added for exiting. Exterior stairs are in need of repair or replacement. Not enough handicapped parking spaces are provided on the site. Parent and Bus drop off should be revised as traffic build up from current setup violates fire code. It may help to provide a new bus loop that removes bus traffic from the road. A new storm structure would help to alleviate ponding/ice buildup that occurs around door 20. 12/8/21: Remove/replace all asphalt.

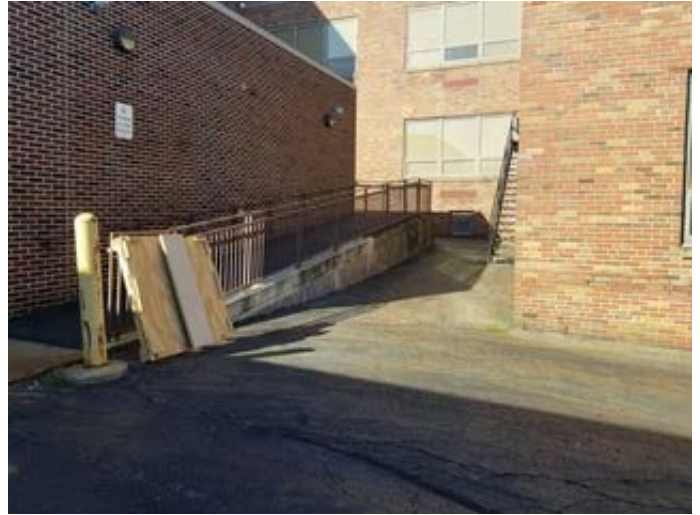
Non-compliant ADA Ramp

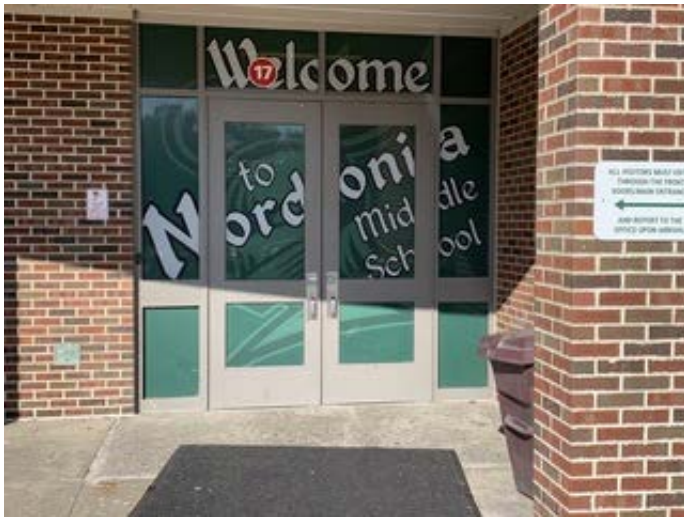
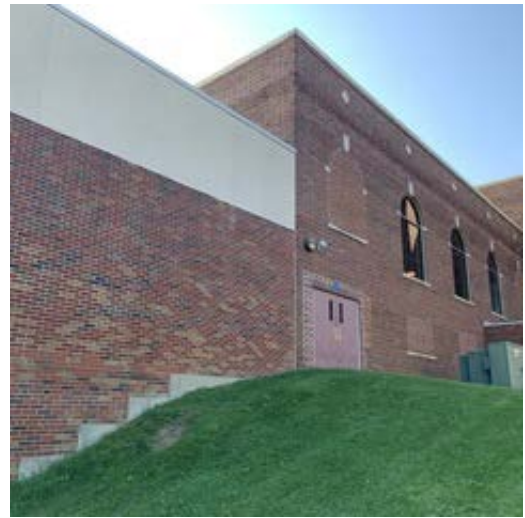
**Rating:** 3 Needs Replacement

2001 Entry Doors

Library Exit Doors

**Recommendations:** Replace exterior doors in the overall facility as noted below due to age and condition.

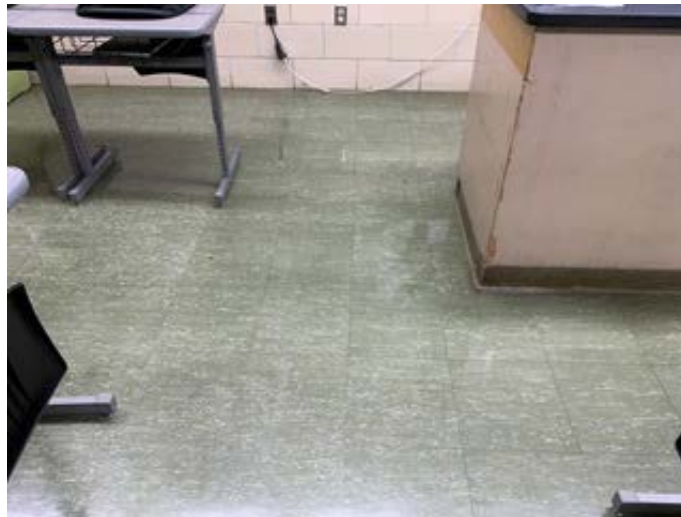
**Rating:** 2 Needs Repair

VAT in a Classroom

**Recommendations:** Remove all hazardous materials, inclusive of asbestos-containing materials in the overall facility as noted in the attached Environmental Hazards Assessment. OFCC to provide an independent EEA assessment.

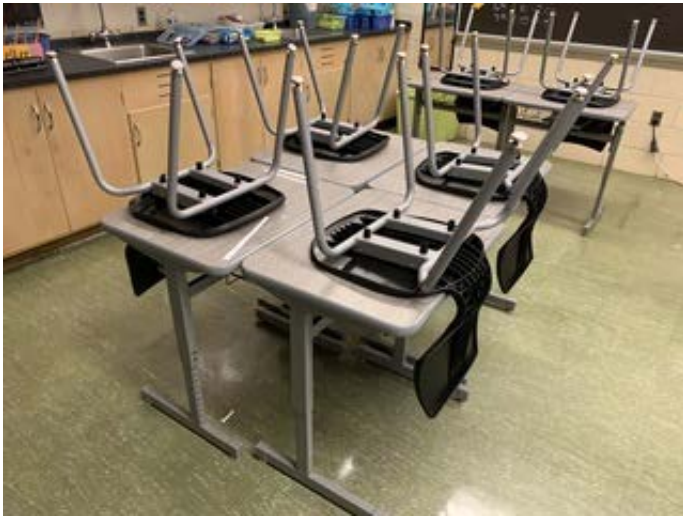
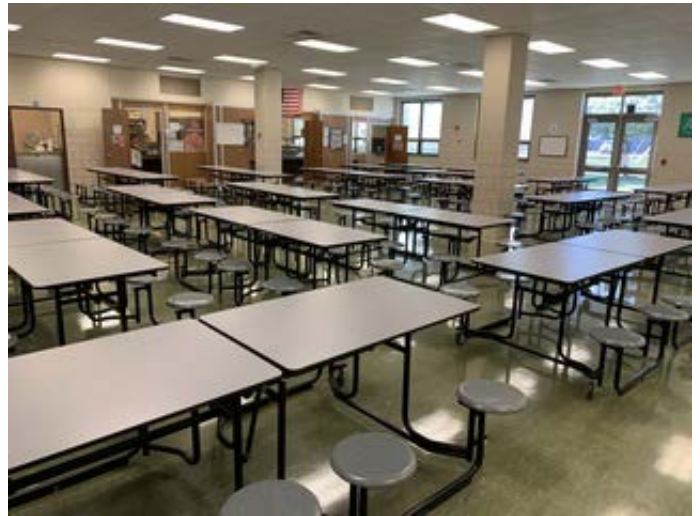
**Rating:** 3 Needs Replacement

Classroom Desks

Cafeteria Tables

**Recommendations:** Provide for replacement of outdated or inadequate furniture.

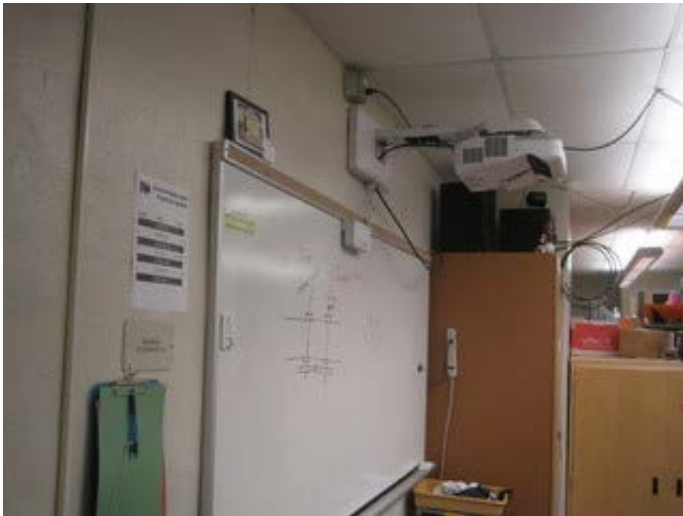
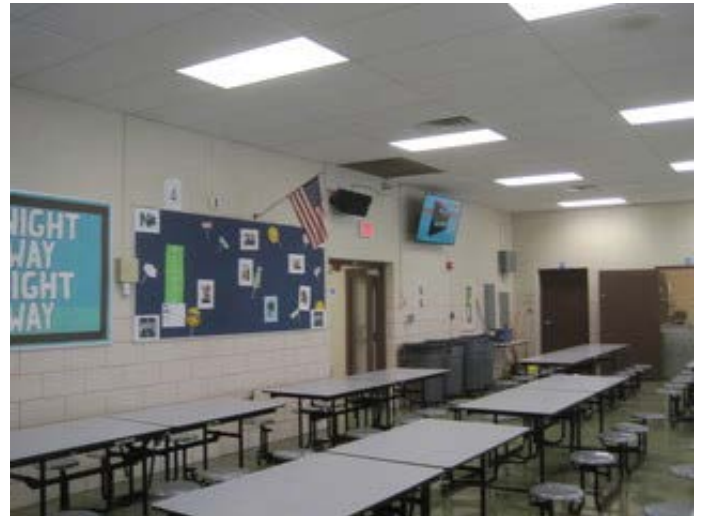
**Rating:** 3 Needs Replacement

Overhead projector

Flat-screen T.V. in cafeteria

**Recommendations:** Provide complete replacement of technology systems to meet current OSDM guidelines, and to sustain the capacity to keep pace with new technology development.
