Building Information - Nordonia Hills City (50047) - Northfield Elementary

Program Type	Expedited Local Partnership Program (ELPP)
Setting	Suburban
Assessment Name	Northfield Elementary School (2021 Update) DRAFT
Assessment Date (on-site; non-EEA)	2019-10-16
Kitchen Type	Full Kitchen
Cost Set:	2021
Building Name	Northfield Elementary
Building IRN	27672
Building Address	9374 Olde Eight Rd
Building City	Northfield
Building Zipcode	44067
Building Phone	330-467-2010
Acreage	8.00
Current Grades:	K-4
Teaching Stations	19
Number of Floors	1
Student Capacity	238
Current Enrollment	390
Enrollment Date	2019-09-06
Enrollment Date is the date in which the current enrollment was taken.	
Number of Classrooms	17
Historical Register	NO
Building's Principal	Mr. Mark Kaminick
Building Type	Elementary

Building Pictures - Nordonia Hills City(50047) - Northfield Elementary(27672)

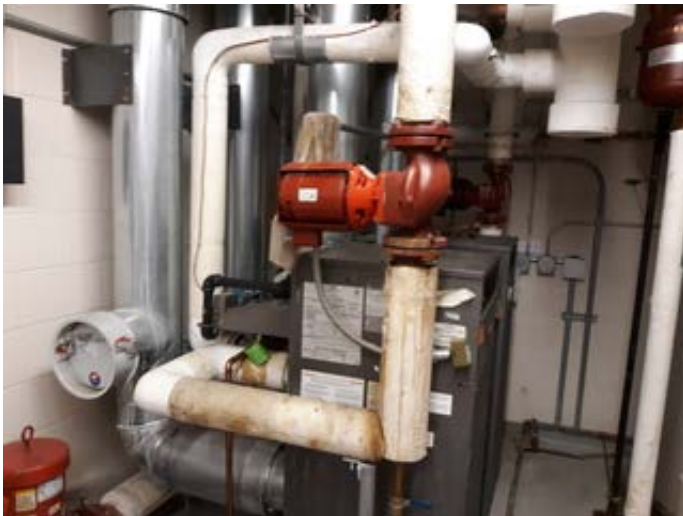
Description: The elementary school is heated with six (6) gas-fired hot water boilers with air handling units and unit ventilators with hot water coils, VAV boxes with hot water coils and perimeter cabinet unit heaters. Original (1963) gas-fired furnaces are used in the kitchen and two for old corridors. Most other equipment was installed when the addition was built in 2001. This 18-year-old equipment is in poor condition and rust is beginning to deteriorate the cabinets. Hot water is distributed through a steel piping system from a pump with a standby pump at each boiler system. The air handling units include refrigerant coils for cooling. The building contains an older central building automation system. It monitors unit ventilators, rooftop air handling units and VAV boxes. The VAV boxes have factory mounted controls that are independent. The 15 CFM per person fresh air requirement of the Ohio Building Code, Mechanical Code and Ohio School Design Manual, OSDM, is satisfied. The floor to roof height is low and cannot accommodate a central system with ductwork. The site does not contain an underground fuel tank. The overall heating system is evaluated as being in a safe working order. The system is also inefficient with non-condensing boilers and much of the system should be replaced for long life expectancy.

Rating: 3 Needs Replacement

Boilers inside electric room

Recommendations: Replace the boilers with condensing boilers and lower the hot water temperature reset schedule to take advantage of thermal efficiency. Replace the VAV boxes and their controls. Replace the old gas-fired furnaces and add air conditioning. Replace the Building Automation System and expand with more capability to meet OSDM standards. Much of the existing heating system can remain without replacement. The central duct distribution can remain and the hot water heating piping and pumps can remain.

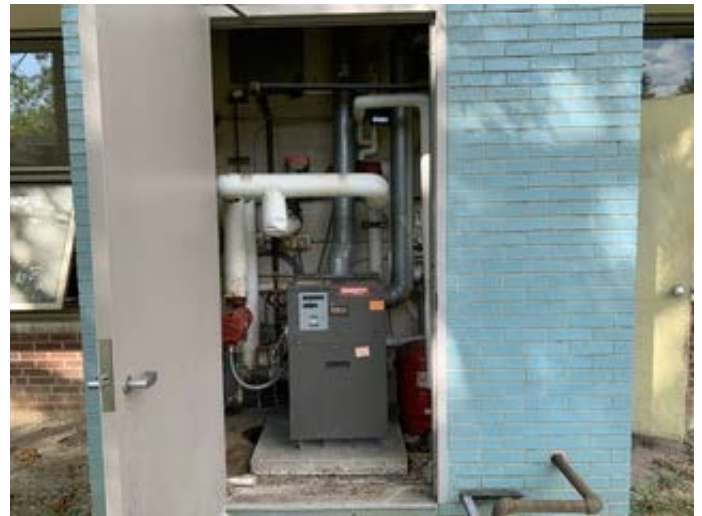
Boiler in outside room

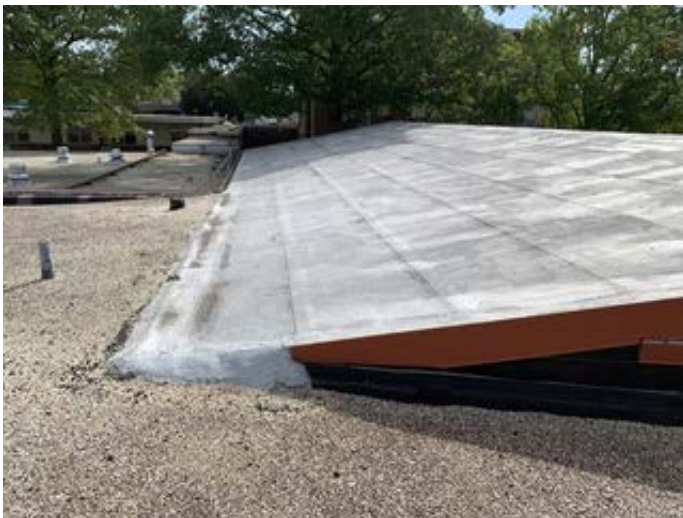
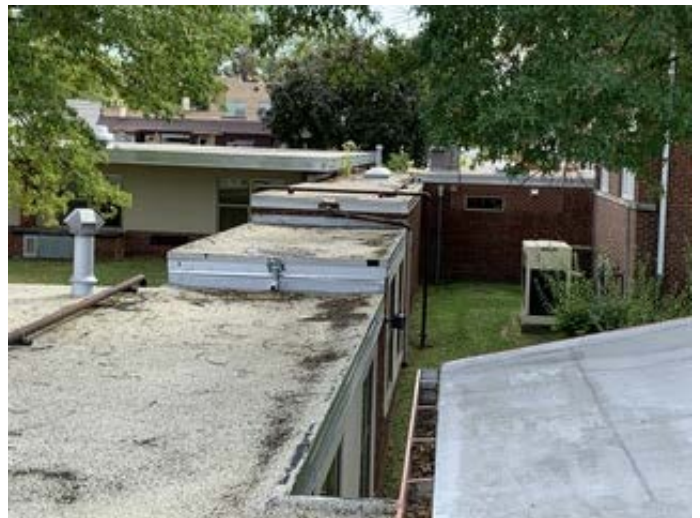
Description: The roof over the overall facility is a ballasted membrane system that was installed over 7 years ago in fair condition. There are District reports of current leaking. Signs of past leaking were observed during the physical assessment. Access to the roof was gained by access hatch that is in good condition. Fall safety protection cages are not provided. There were no observations of standing water on the roof. Metal cap flashings are in fair condition. Roof storm drainage is addressed through a system of roof drains, which are properly located, and in fair condition. The roof is not equipped with overflow roof drains. Provide additional roof insulation to achieve LEED Silver Certification Energy Requirements. There is a covered walkway attached to this structure at the main entrance. 12/8/21: Wet insulation was identified in 23 areas totaling 14,317 sq. ft.

Rating: 3 Needs Replacement

Ballasted Membrane Roofing

Recommendations: The roof over the overall facility requires replacement to meet Ohio School Design Manual guidelines. Add overflow drains where required. Provide additional roof insulation to achieve LEED Silver Certification Energy Requirements. 12/8/21 update: Add parapet, fascia, and coping to meet minimum slope requirements when replacing roof insulation on original building. Replace exterior soffits over z-furring with spray foam insulation in conjunction with new parapet. Add roof drains at low roofs around original building to accommodate new insulation and maintain existing window openings. Add two roof drains to gym roof and remove scuppers.

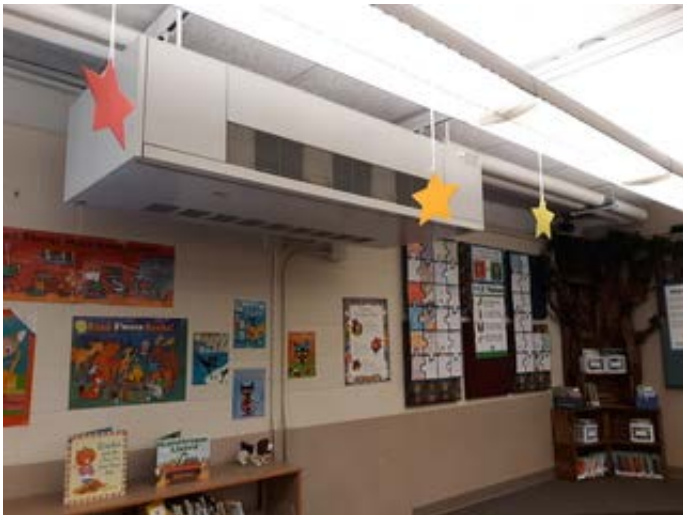
Description: The 2001 Addition, a Gym and Student Dining are air conditioned with rooftop air handling units. These units are now 18 years old and in poor condition. Controls at classroom VAV boxes are past their useful life. The ventilation in remaining areas use furnaces and unit ventilators to bring in code required fresh air. These unit ventilators have economizers which provide "free" cooling on mild days. Operation of VAV boxes in classrooms provide the required minimum amount of fresh air for occupants. The newer systems can provide simultaneous heating and cooling with the VAV system and is compliant with OSDM requirements. The ventilation system does not incorporate an energy recovery system. Individual toilet exhaust fans, on the roof, operate in conjunction with their associated zone units, but do not recover this lost energy. The technology server room is not separately cooled. The Art Room has exhaust and a kiln hood. There is a large, NFPA, grease hood in the Kitchen along with a dishwasher hood and gas-fired rooftop make-up air unit. Toilet exhaust fans and other building ventilation fans are on the flat roof areas.

Unit ventilator in Library

Recommendations: Replace VAV boxes and controllers. Add air conditioning to the unit ventilators with refrigerant coils and self-contained condensing units. Replace old rooftop units and add air conditioning to the replaced kitchen make-up air unit. Existing gas-fired furnaces to be replaced with condensing furnaces with split system air conditioners. Add ductless split air conditioning system to the technology server room. Replacement cost is included in Item A - Heating System.

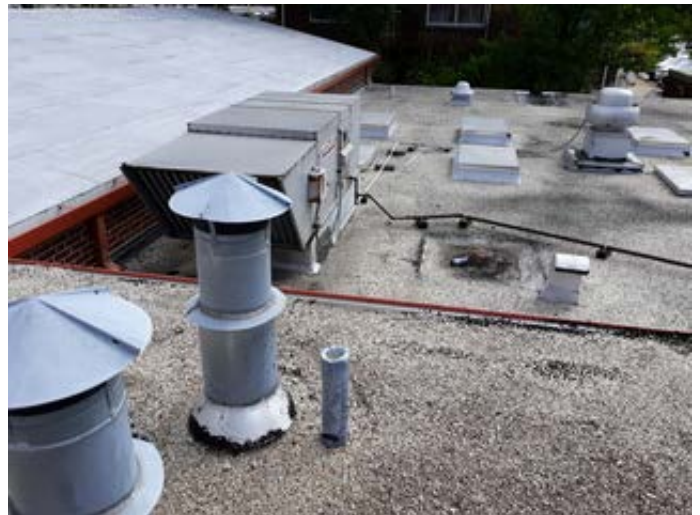
Kitchen make-up air unit

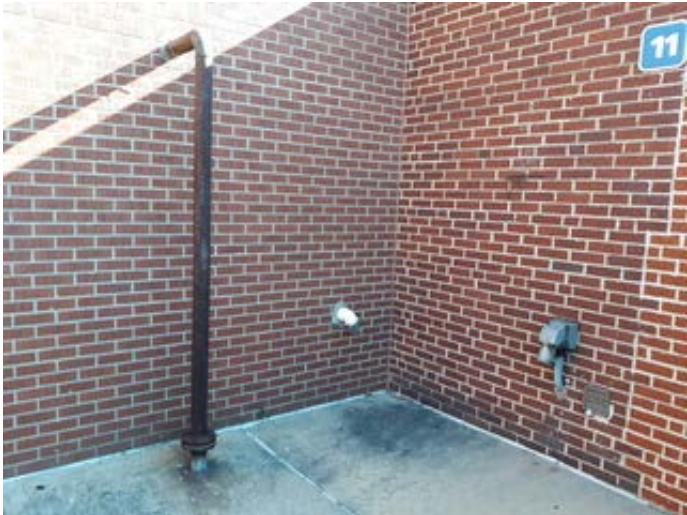
Rating: 3 Needs Replacement

Portable generator plug

Recommendations: Electrical system existing conditions require a upgrade of the existing 1963 distribution system and the addition of an emergency generator.
12/8/21 update: System replacement not necessary for 2001 addition.

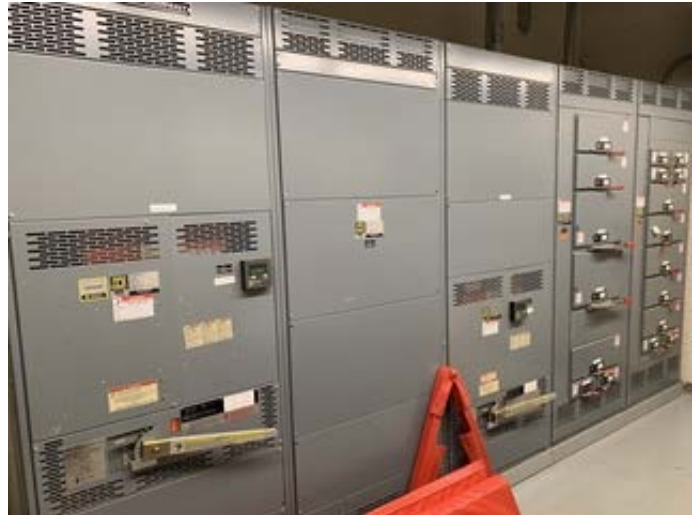
Main electrical service

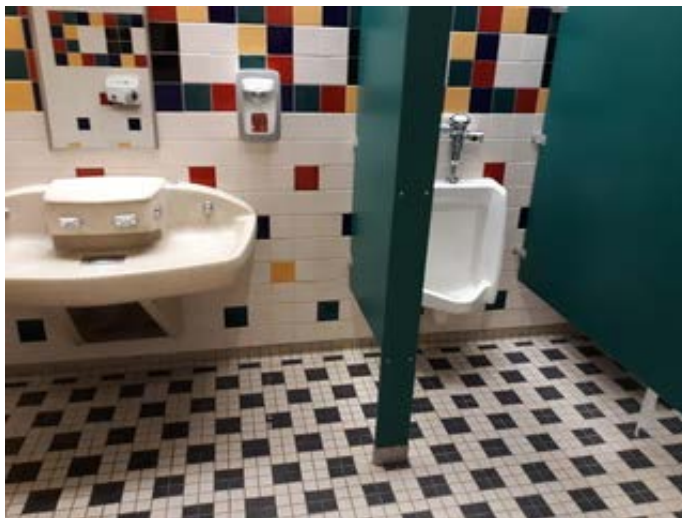
Description: The school plumbing system meets requirements for plumbing fixtures and backflow prevention. There is a 3" domestic water meter in an underground pit near Old Eight Road. There is a backflow preventer inside with copper piping properly distributed. The domestic hot water system operates at 95 degrees F. The water heaters have been recently replaced and there are several systems throughout the building. Lavatories and wash fountains do not have individual mixing valves. The toilet facilities include handicapped fixtures with flush valves and sensor operated faucets used in public facilities. Elsewhere, fixtures are manually operated. Fixtures are not low flow, which does not meet OSDM guidelines. Water closets and urinals are wall mounted throughout with flush valves. Most sanitary piping is cast iron and at the end of useful life. The school contains large group restrooms for boys and large group restrooms for girls. There are no locker rooms or shower facilities. The Kitchen has gas fired appliances, dedicated gas fired water heater and staff toilet room. There is an in-floor cast iron grease interceptor that is periodically cleaned. There is a brick gas house with meter inside that distributes natural gas in steel piping underground and on the roof to boilers, furnaces, rooftop heating units, domestic water heaters and kitchen appliances. There is a mechanical gas shut off valve for appliances under the kitchen hood. Roof drains collect rainwater and are conveyed to the city sewer thru cast iron drain piping. The newer systems use PVC piping. The cast iron drain piping is now over 50 years old.

Rating: 3 Needs Replacement

Boys toilet room

Recommendations: Replace water closets, urinals and their flush valves with low flow fixtures. Replace the brass (high lead content) faucets with lead free faucets. Add mixing valves at each lavatory and replace master mixing valve to deliver 140 degrees F domestic hot water thru piping loop. Replace recirculating pumps. Replace all cast iron drain piping which has reached the end of its useful life. 12/8/21 update: Domestic supply and sanitary waste piping not needed for 2001 addition.

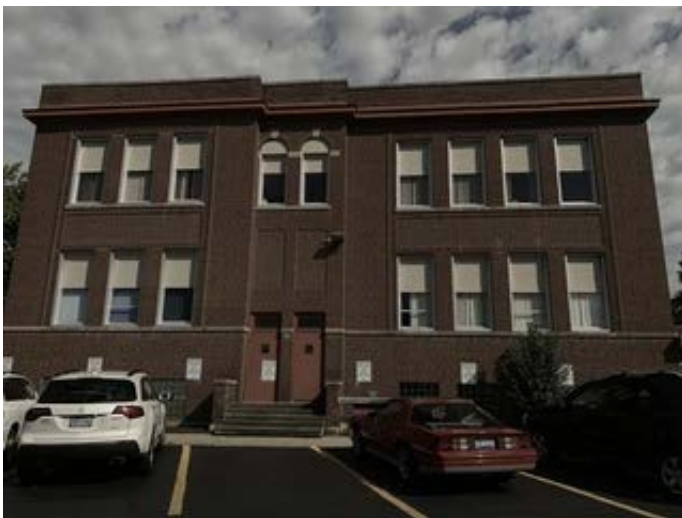
Description: The Original 1916 Building which houses the District Offices needs all of the windows replaced due to age. The 1960, 1963, and 2001 additions are equipped with thermally broken aluminum windows with double glazed insulated glazing windows. Window system hardware is in good condition. The window system features integral blinds, which are in good condition.

Rating: 3 Needs Replacement

1916 Windows

Recommendations: Provide a new insulated window system with integral blinds to meet with Ohio School Design Manual requirements in the Original Building. 12/8/21: Replace 3,664 sf of windows in the 1960 & 1963 additions.

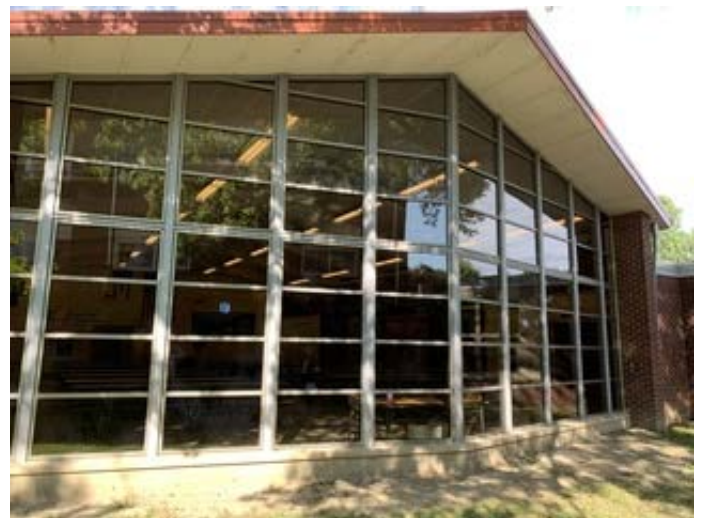
Cafeteria Windows

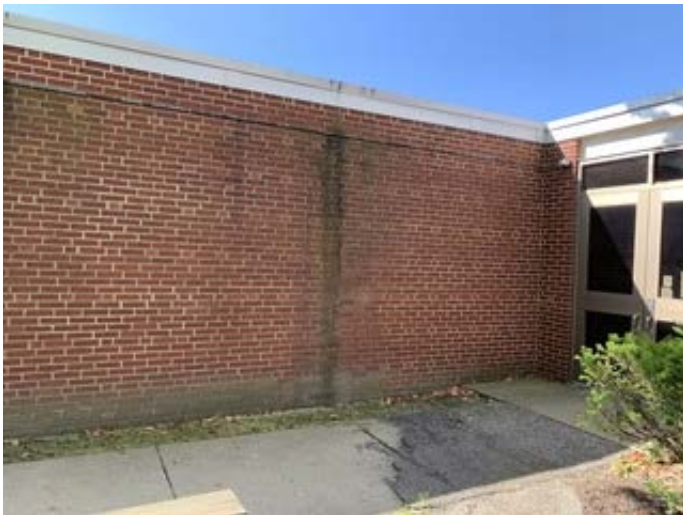
Rating: 2 Needs Repair

Brick Surfacing That Needs To Be Cleaned

Recommendations: Provide minor tuckpointing in all areas of mortar deterioration through the overall facility. Provide masonry cleaning, sealing, caulking as required through the overall facility. 12/8/21 update: Recoat all EIFS.

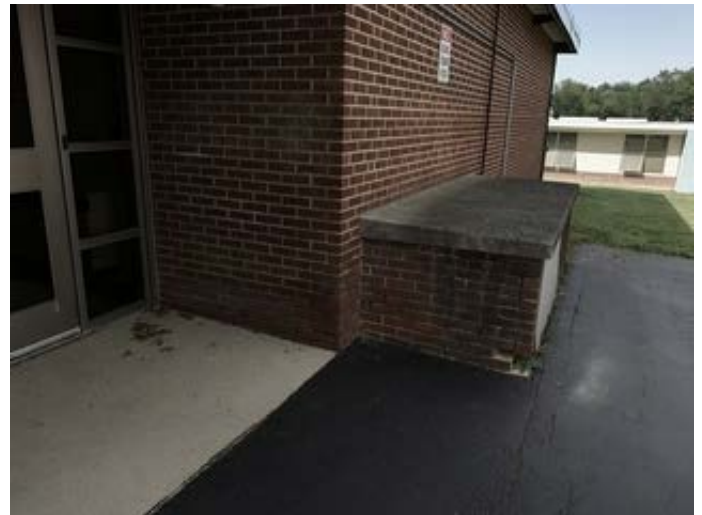
Brick Surface Needing Repair

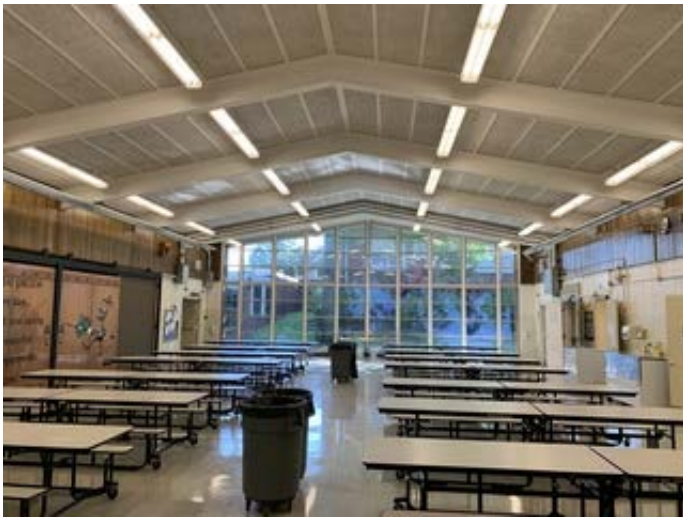
Rating: 3 Needs Replacement

Cafeteria lighting

Recommendations: Completely replace the lighting due to the installation of a fire suppression system. Replace light sources with LED lamps to provide longer life systems and reduce energy consumption. Revise classroom lighting to meet 50 foot candle requirement of OSDM. Revise Gymnasium lighting to reach 60 foot candles recommended in OSDM. Provide classrooms lighting with dual level switching and occupancy sensors. Provide added controls in Gym and Cafeteria to make use of daylight harvesting.

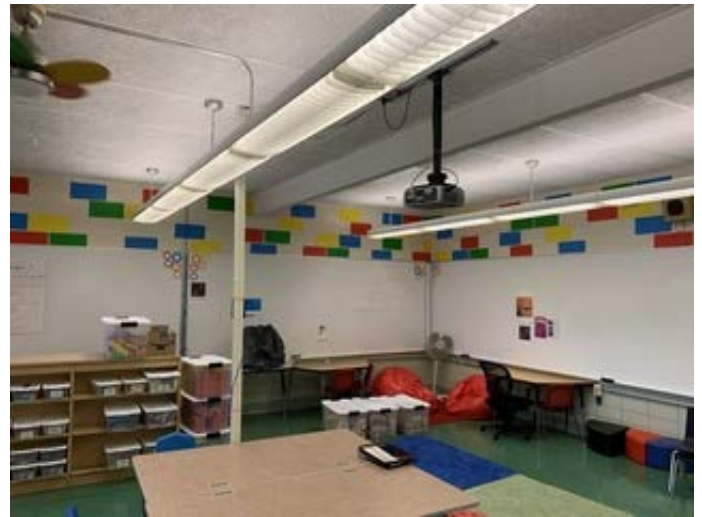
Classroom lighting

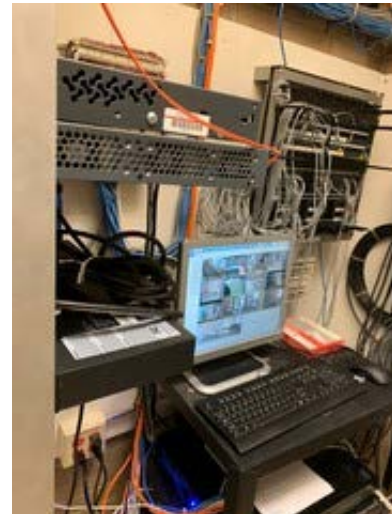
Rating: 3 Needs Replacement

Security system

Recommendations: Provide for a complete replacement of the building's security system to meet all current OSDM requirements.

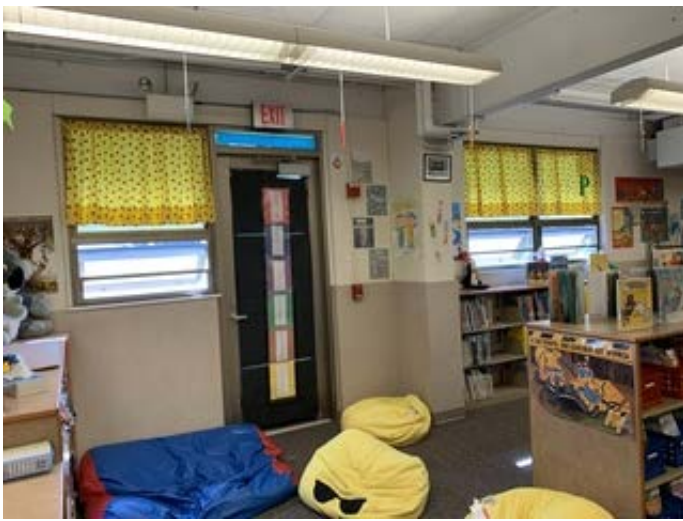
Rating: 3 Needs Replacement

Egress lighting

Recommendations: The exit lights and egress lights should be changed to LED for longer life.

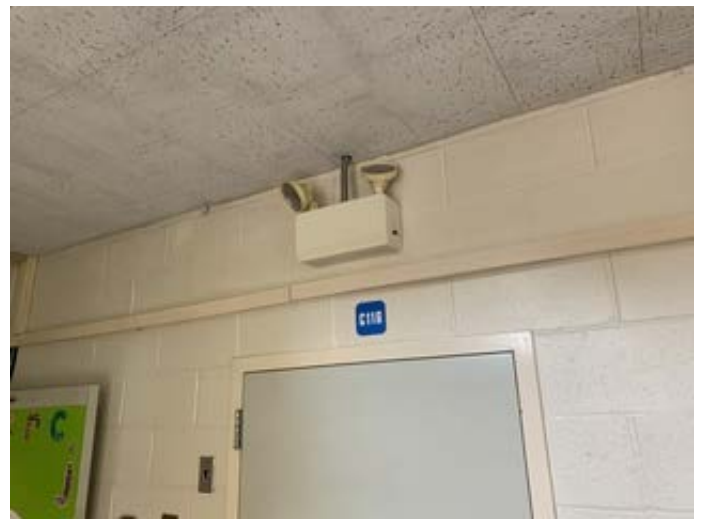
Egress light

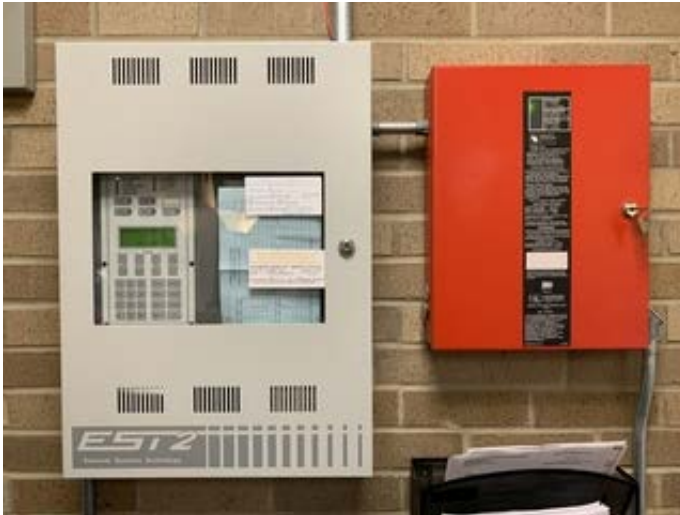
Rating: 3 Needs Replacement

Fire alarm panel

Recommendations: The fire alarm system should be replaced with a fully addressable system that utilizes voice commands. Provide speaker/strobes in classrooms and strobes in all toilet rooms. Provide smoke detectors in corridors and tamper/flow switches to monitor the new fire suppression system. Duct smoke detectors shall be provided for all new air-handling systems, where required by Code.

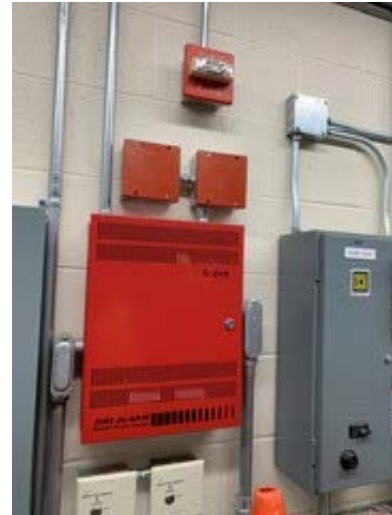
Wall strobe in electric room

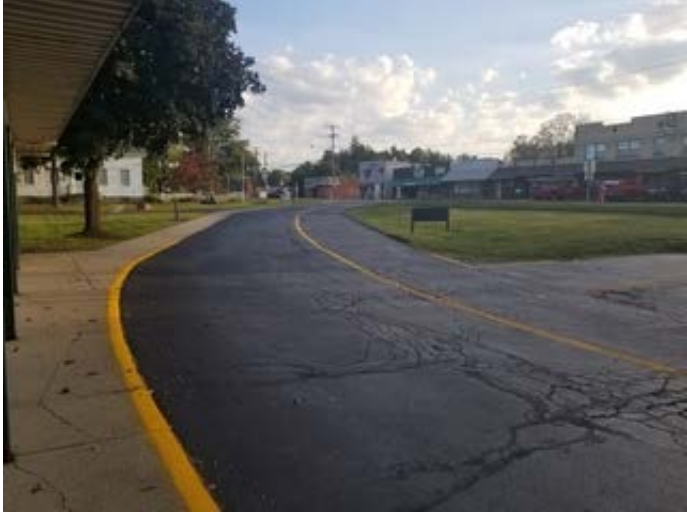
Cracked Asphalt

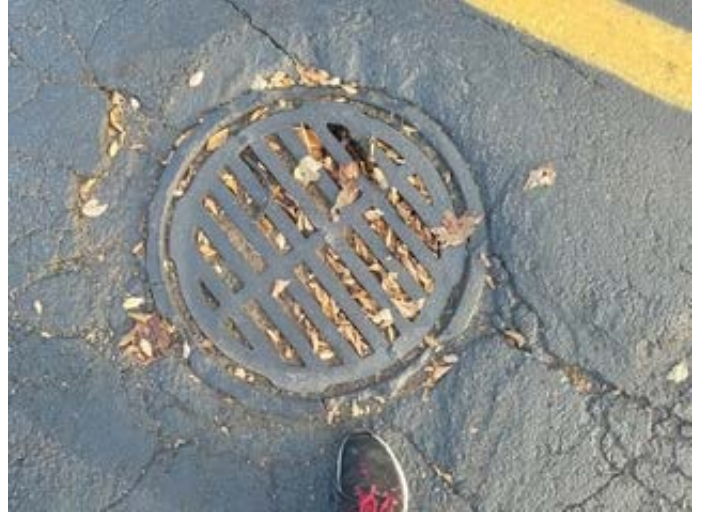
Debris Filled Catch Basin

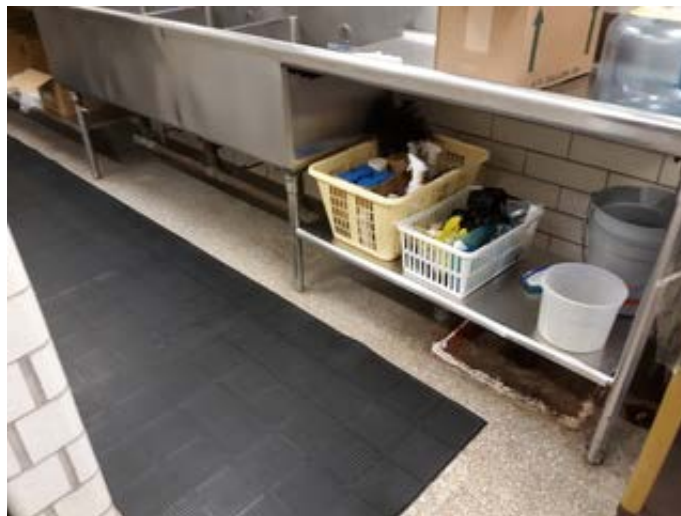
Grease trap

Recommendations: Existing site conditions require replacement of the original cast iron sanitary and storm piping system.

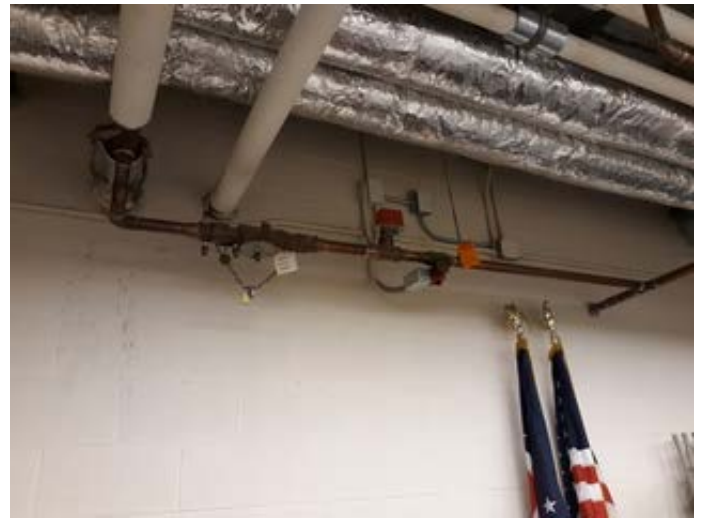
Limited area sprinkler piping

Recommendations: Add a complete sprinkler system and remove the old limited area sprinkler systems. Add an emergency generator with automatic transfer switch and connect to life safety fixtures. Provide a new backflow preventer and a new water service line to meet the needs of the new sprinkler system.

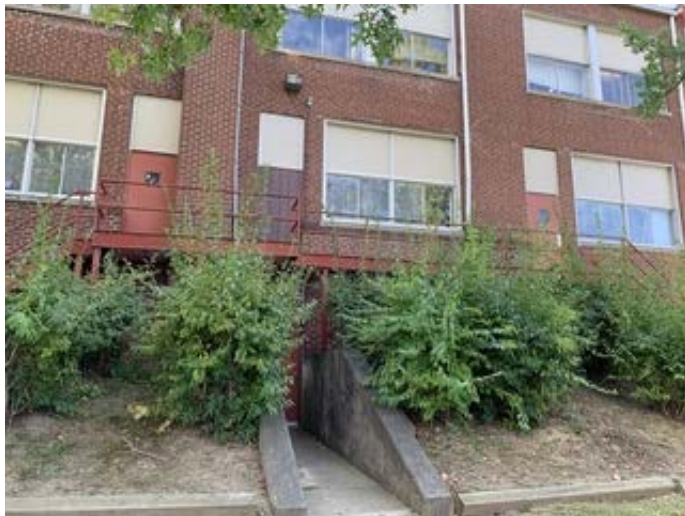
Exterior Doors - 1916 Building

Recommendations: Replace those exterior doors noted below due to poor condition and/or age.

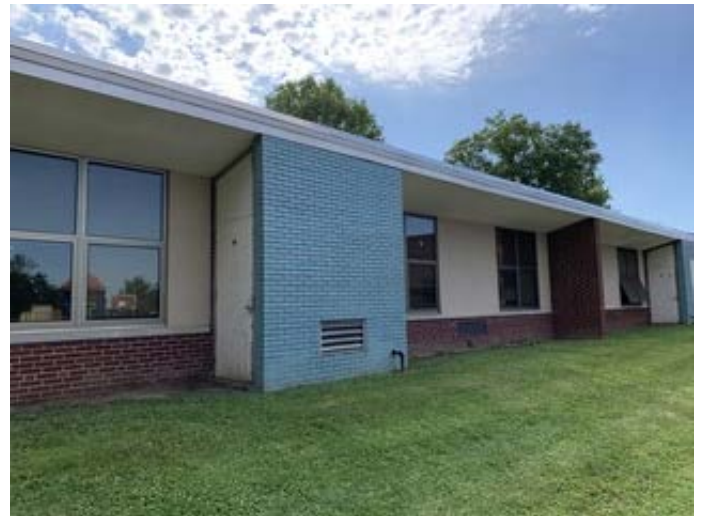
Exterior Doors - 1960 Building Addition

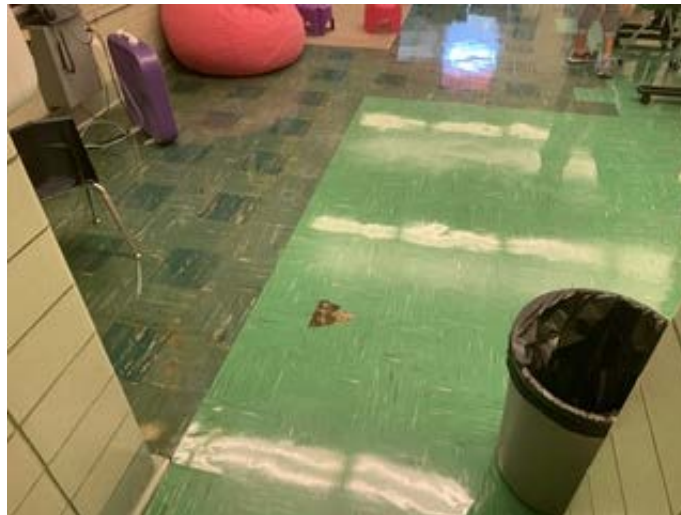
Classroom VAT

Recommendations: Remove all hazardous materials, inclusive of asbestos-containing materials in the overall facility, as noted in the attached Environmental Hazards Assessment. OFCC to provide independent EEA with scope & budget to be included in assessment findings.

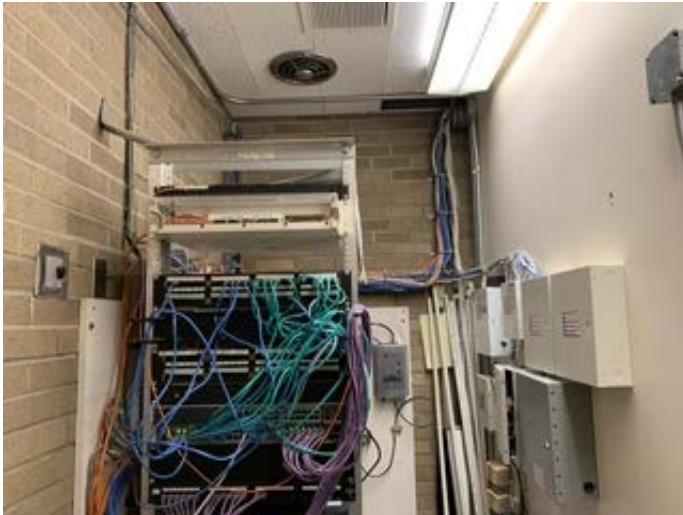
Main tech closet

Recommendations: Provide complete replacement of technology systems to meet OSDM guidelines, and to sustain the capacity to keep pace with technology development.
