Building Information - Nordonias Hills City (50047) - Rushwood Elementary

Program Type	Expedited Local Partnership Program (ELPP)
Setting	Suburban
Assessment Name	Rushwood Elementary School (Updated 2021) DRAFT
Assessment Date (on-site; non-EEA)	2019-09-19
Kitchen Type	Full Kitchen
Cost Set:	2021
Building Name	Rushwood Elementary
Building IRN	61473
Building Address	8200 Rushwood Lane
Building City	Northfield
Building Zipcode	44067
Building Phone	330-467-0581
Acreage	22.00
Current Grades:	K-4
Teaching Stations	23
Number of Floors	1
Student Capacity	350
Current Enrollment	335
Enrollment Date	2019-09-19
Enrollment Date is the date in which the current enrollment was taken.	
Number of Classrooms	18
Historical Register	NO
Building's Principal	Ms. Jackie O'Mara
Building Type	Elementary

Building Pictures - Nordonia Hills City(50047) - Rushwood Elementary(61473)

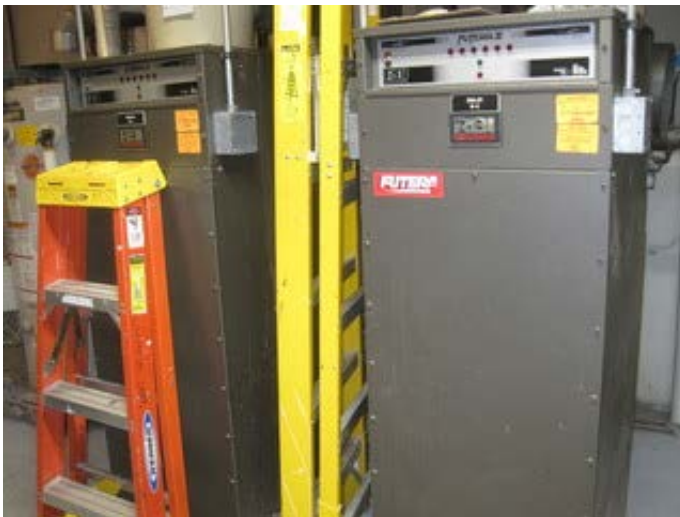
Description: The existing heating system consists of (2) gas-fired, RBI hot water boilers and (2) separate zone circulating pumps. Heating water is circulated to unit ventilators in the Music & Arts Classroom, and finned-tube radiation, convectors and cabinet unit heaters throughout the building. There are also reheat coils in air terminals on three of the rooftop air handling systems. The boilers and reheat terminal boxes were installed around 2003 and are in good condition. Other components of the heating system, including most of the piping, is original to the 1969 construction and in fair condition. The system does comply with the 15 CFM per person fresh air requirements of the Ohio Mechanical Code (OMC) and the Ohio School Design Manual (OSDM). The existing system is ducted, but the ductwork cannot readily be adapted for a possible future indoor air handling system. There is a direct digital controls (DDC) system, but it is outdated and would need to be upgraded. The building is air conditioned by rooftop HVAC units.

Rating: 3 Needs Replacement

Heating water boilers

Recommendations: Provide new overall heating, ventilating, and air conditioning system to achieve compliance with the OSDM guidelines. 12/8/21 update: 2001 addition doesn't need to be converted to ducted system, already has RTU's with ductwork.

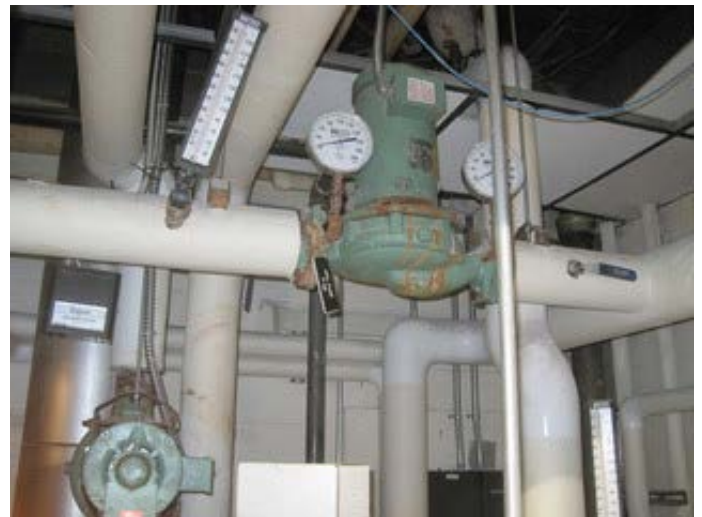
Heating system circulating pump

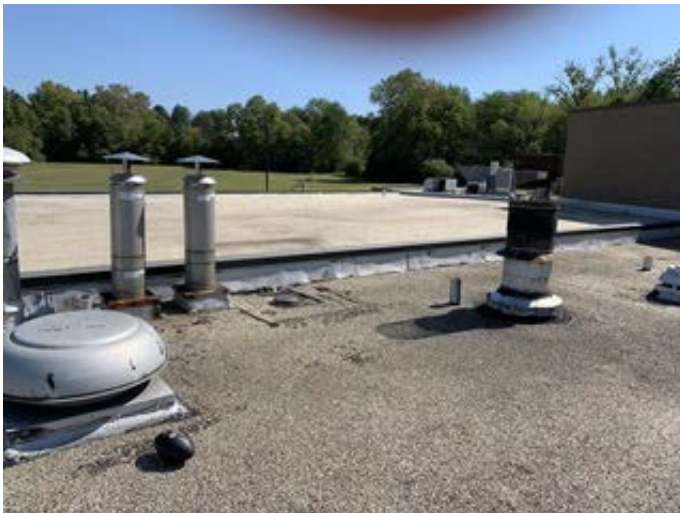
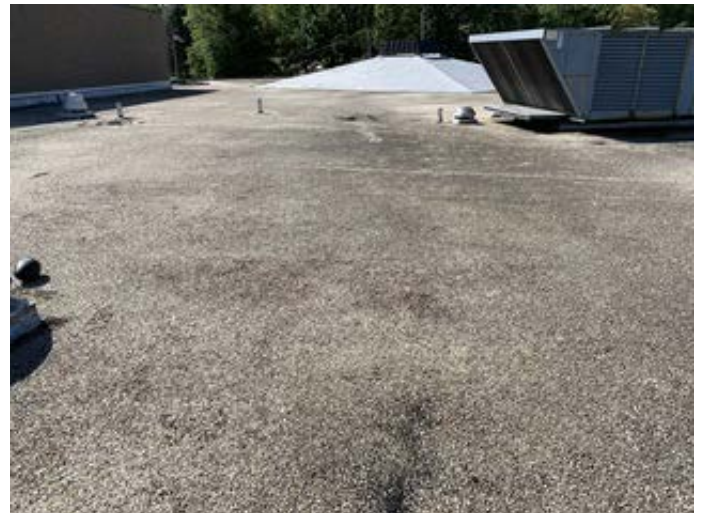
Description: The roof over the overall facility is a ballasted membrane system that was installed over 7 years ago and is in fair condition. There are District reports of current leaking. Signs of past leaking were observed during the physical assessment. Access to the roof was gained by access hatch and access ladder that is in good condition. Fall safety protection cages are not provided. There were no observations of standing water on the roof. Metal cap flashings are in good condition. Roof storm drainage is addressed through a system of roof drains, which are properly located, and in good condition. The roof is not equipped with overflow roof drains, though they are needed on this building. No problems requiring attention were encountered with any roof penetrations. Additionally, there are curved exterior metal soffits that need attention. Provide additional roof insulation to achieve LEED Silver Certification Energy Requirements. 12/1/21 update: 16 areas with a total of 3,747 sf of wet insulation were identified.

Rating: 3 Needs Replacement

Ballasted Membrane Roofing

Recommendations: The roof over the overall facility requires replacement to meet Ohio School Design Manual guidelines due to the age of system and due to condition. Add overflow drains as required. Provide maintenance painting on the noted metal soffits. Provide additional roof insulation to achieve LEED Silver Certification Energy Requirements. 12/6/21 update: Need partial deck replacement, tapered roof insulation replacement, skylight removal and infill, and roof knee wall insulation and roof membrane when re-roofing.

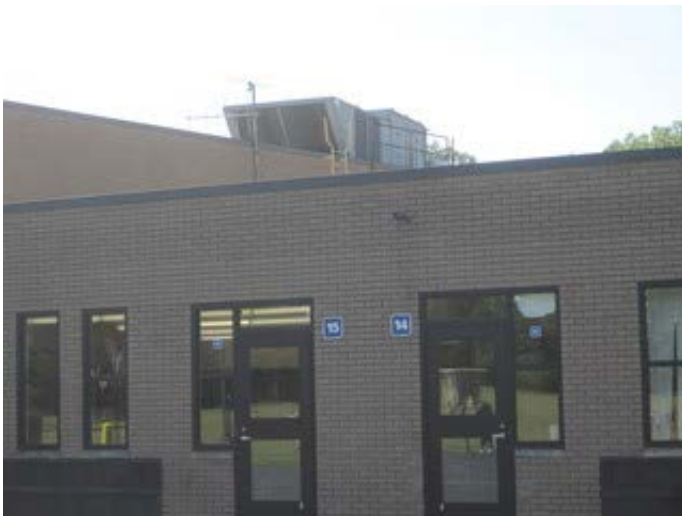
Description: The building is air conditioned from (4) rooftop HVAC units, except for the Music and Art Classrooms. These (2) Classrooms are served by heating & cooling unit ventilators. The RTU's were installed around 2001 and are in fair condition. Separate RTU's serve the north and south classroom clusters, each with (2) zones of control. A separate RTU with VAV terminal boxes serves the west 2001 classroom addition and the central core. A single-zone RTU serves the gymnasium and student dining. The Art program is equipped with a kiln.

Rooftop HVAC unit

Recommendations: Replace all of the packaged rooftop HVAC units, since these systems are not compliant with current OSDM guidelines. Due to the age of the duct distribution systems and air devices, provide a new central air conditioning system throughout. Cost for replacement included in A. Heating System, above.

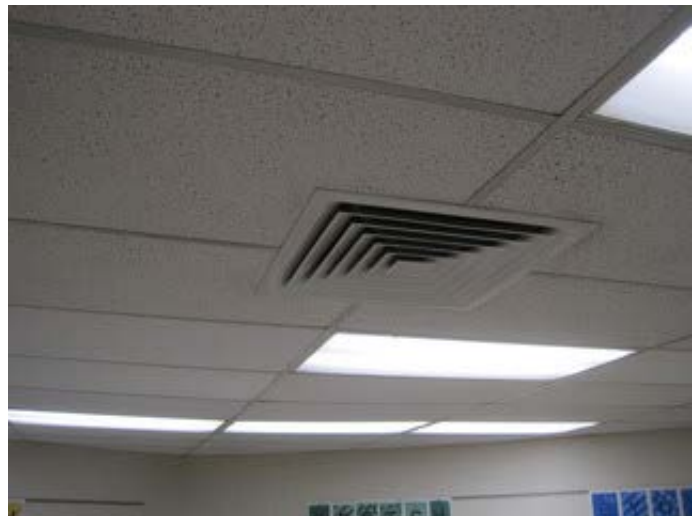
Air-distribution supply diffuser

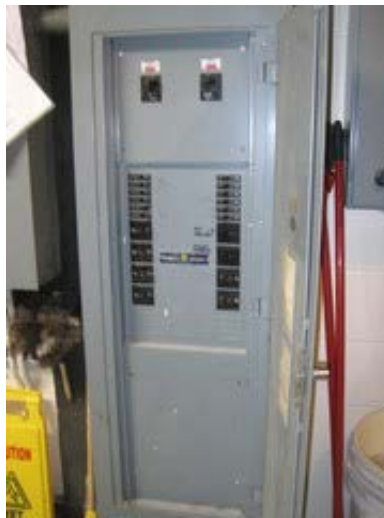
Description: The school has a 480/277 volt, 3 phase, 4 wire, 1,600 amp service, located in a weatherproof enclosure outside of the Kitchen. There is a 480/277 volt distribution panel located adjacent to the main service disconnect in this outdoor enclosure. An adjacent pad-mounted transformer is owned by a Nordonia Hills City School District. There are 480 volt-to-208 volt transformers and distribution panels located inside the building. Most equipment was installed in 1969 and is in fair condition. Classrooms have an adequate number of general-purpose receptacles. The corridors are equipped with adequate receptacles for servicing and there are adequate GFI protected exterior outlets around the perimeter of the building. The school is not equipped with an emergency generator. Adequate lightning protection safeguards are not provided.

Rating: 3 Needs Replacement

Branch circuit panel

Recommendations: Provide a minimum 2000 Amp, 480/277 volt, 3 phase electrical service. Provide new transformer to accommodate new electrical service. Provide new electrical distribution to include panels, receptacles, conduit, and wiring. 12/8/21 update: System replacement not needed for 2001 addition.

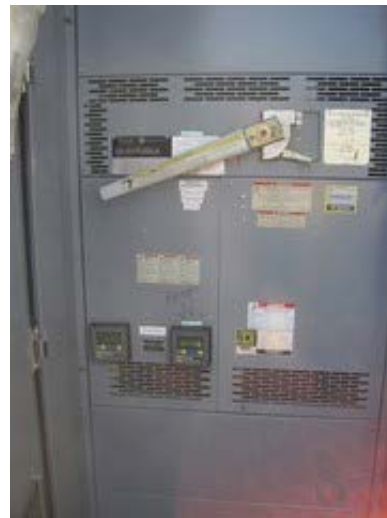
Main switchgear

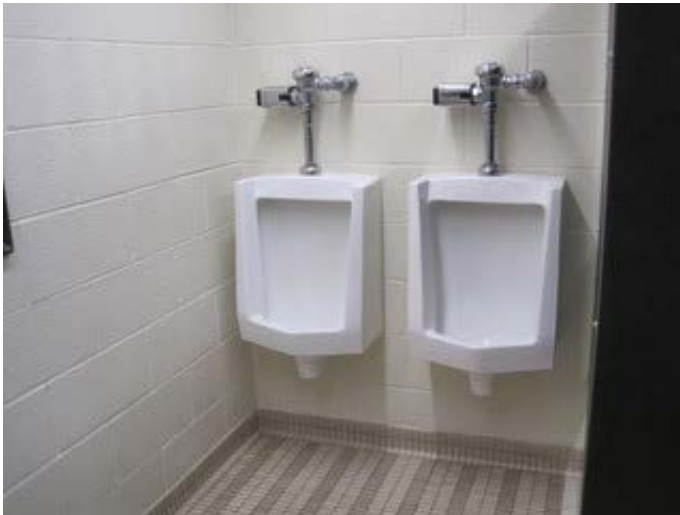
Rating: 3 Needs Replacement

Wall-mounted urinals

Recommendations: Replace the cast iron sanitary piping system. Replace plumbing fixtures with wall-hung, low water consumption fixtures that comply with OSDM guidelines. 12/8/21 update: Domestic supply and sanitary waste piping not needed for 2001 addition. 2001 addition needs faucets and flush valves replaced with low flow.

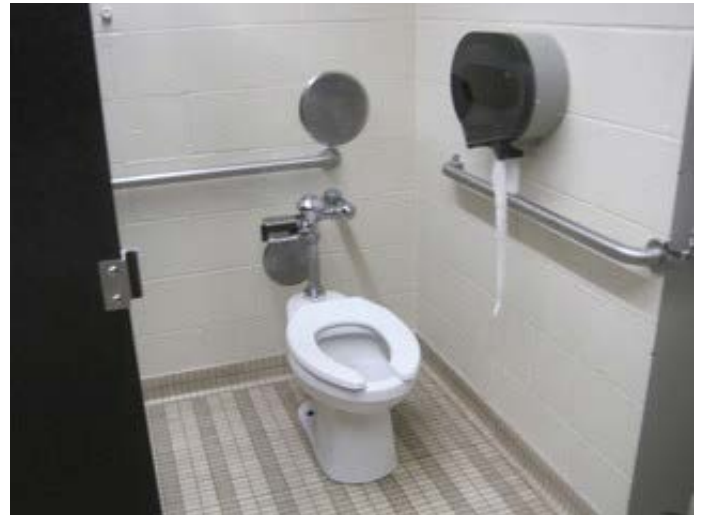
Floor-mounted water closet

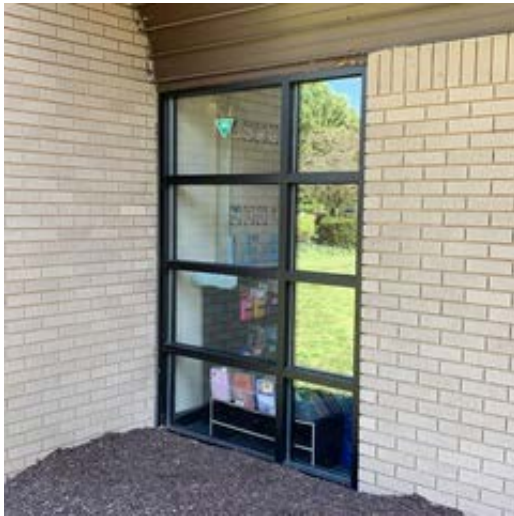
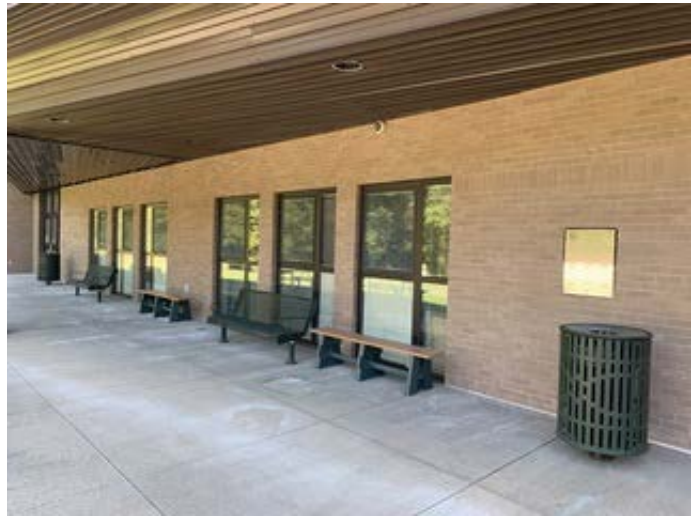
Description: The overall facility is equipped with thermally broken aluminum windows, they are in good condition. Window system seals are in good condition, with no air and water infiltration being experienced. Window system hardware is in good condition. The window system features integral blinds. 11/23/21 update: Only windows in 2001 addition have integral blinds.

Rating: 2 Needs Repair

Windows

Recommendations: 11/23/21 update: Replace windows on original building.

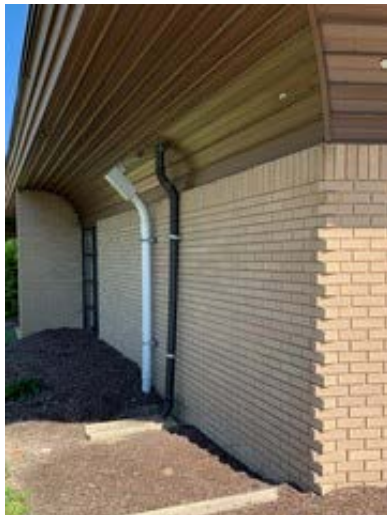
Description: The overall facility has a brick veneer on a masonry bearing wall system, which displayed no locations of deterioration, and is in good condition. The exterior masonry appears to have appropriately spaced and adequately caulked control joints in fair condition. The exterior masonry needs to be cleaned and sealed, and very minor tuckpointing is required. Interior walls are concrete masonry units and are in good condition.

Rating: 2 Needs Repair

Metal Soffits & Brick Masonry

Recommendations: Provide tuckpointing in all areas of mortar deterioration as required through the overall facility. Provide masonry cleaning, sealing, caulking as required through the overall facility. 11/23/21 update: Add insulation to exterior walls of existing building (1970).

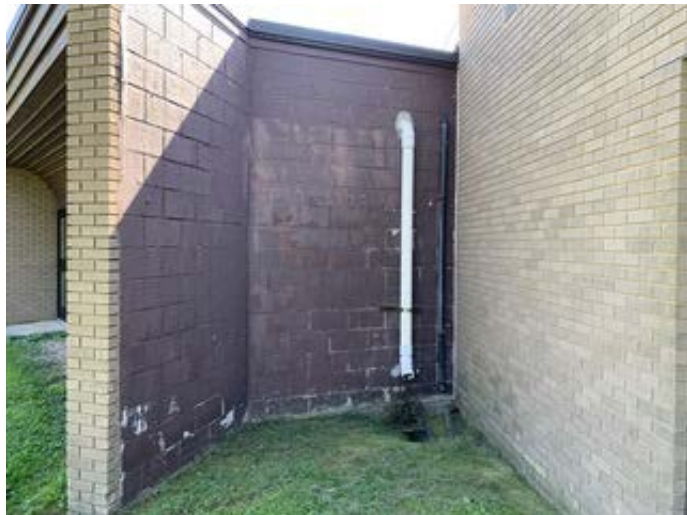
CMU wall

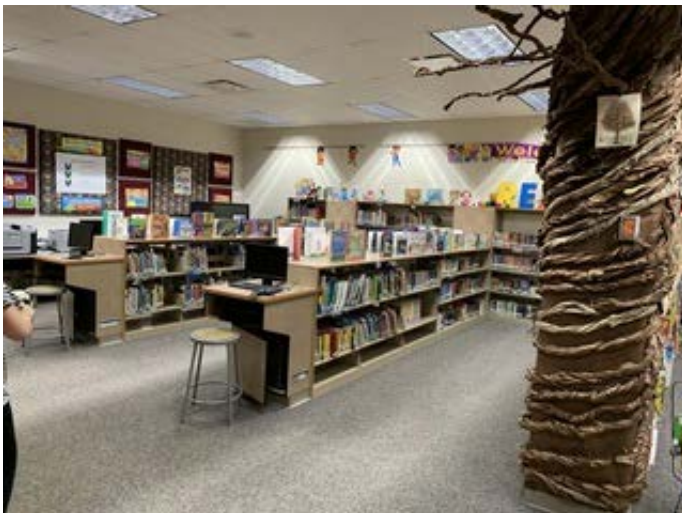
Description: The overall facility features Open Space Classrooms with carpet flooring, some suspended ceilings, as well as painted wall finishes, and they are in good condition. The overall facility has Corridors with terrazzo and VCT flooring, suspended ceilings, as well as painted wall finishes, and they are in good condition. The overall facility has Restrooms with ceramic tile flooring and they are in good condition. Toilet partitions are plastic and are in good condition. Classroom casework in the overall facility is wood construction with plastic laminate tops, is adequately provided, and in fair condition. The art program has a properly vented kiln. Some interior doors are recessed with proper ADA clearances and some are not. Most are in fair condition. Not all have lever hardware. The Gymnasium space has a rubber flooring, open ceilings, as well as painted wall finishes, and they are in good condition. The Media Center, located in the 2001 Addition, has carpet flooring, suspended ceilings, as well as painted wall finishes, and they are in good condition. Student Dining has VCT flooring. The existing Kitchen is a full service unit, and is undersized based on current enrollment, and the existing Kitchen equipment, is in fair condition. The Kitchen hood is in fair condition, and is equipped with the required UL 300 compliant wet chemical fire suppression system. 12/8/21 update: Finishes are 20 years old, show signs of wear. Outdated and in need of replacement.

Rating: 3 Needs Replacement

Library

Recommendations: Provide a partial replacement of finishes and casework due to installation of systems outlined in Items A, C, D, K, L, M, N, and U. Provide for new kitchen equipment. Also, provide for the open space classrooms to be eliminated. 12/8/21: Complete replacement of finishes for entire building.

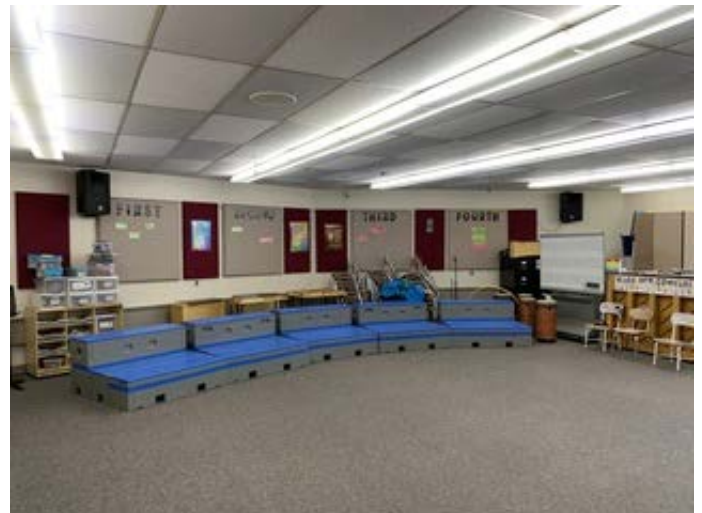
Music Room

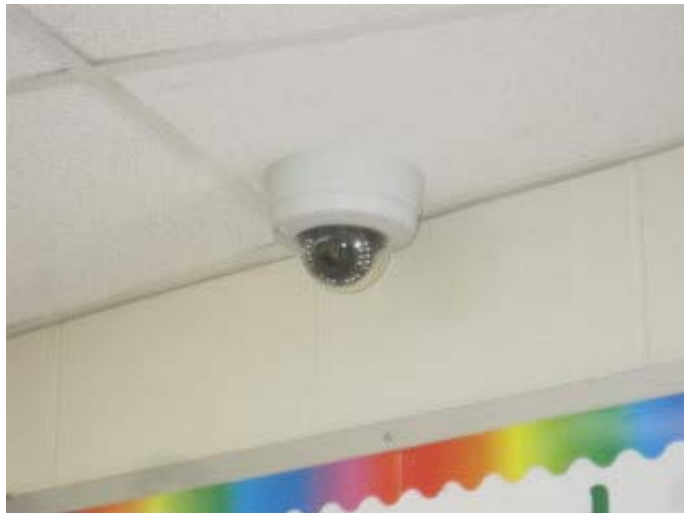
Description: The security system is comprised of indoor and exterior cameras. Cameras were observed outside of the main entrance, in the main vestibule, in the main Lobby, outside of the southwest door, and in the vestibules of all exterior entrances. There were no motion detectors in the corridors. All exterior doors were locked, and access into the building by visitors was restricted to entry through the front vestibule. There is no central door monitoring; however, several doors have local door release controls with card access. Two-way communication between the central office and classrooms is through the phone system, and there is a public address system in the school. Exterior lighting consists of pole-mounted LED fixtures in the parking lot and building-mounted fixtures at exterior doors.

Rating: 3 Needs Replacement

Corridor camera

Recommendations: Provide new security system to include cameras, motion sensors, door controls and keypads, and video storage. The new security system should fully comply with OSDM guidelines. Exterior lighting should meet OSDM guidelines.

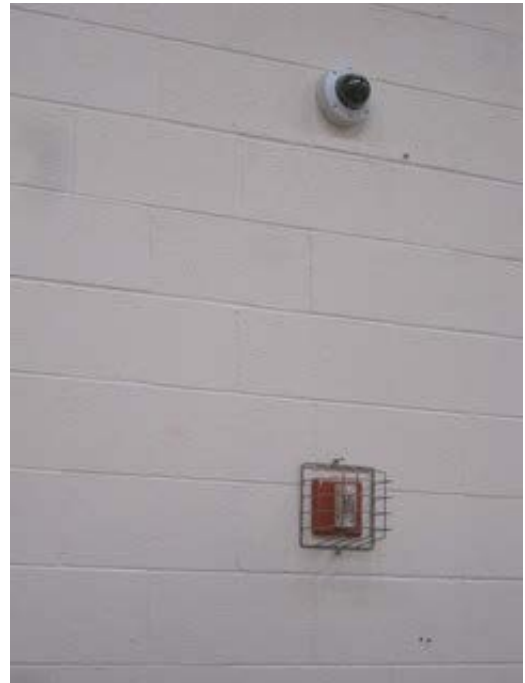
Gymnasium camera

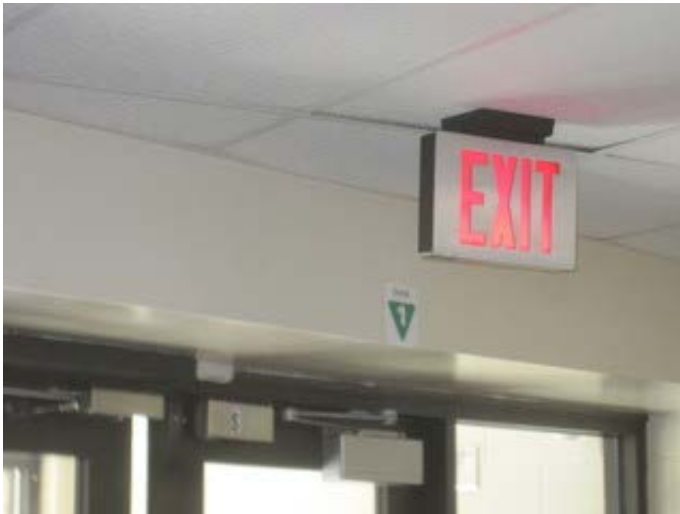
Rating: 3 Needs Replacement

Exit sign

Recommendations: The emergency egress lighting needs to meet OSDM guidelines. All fixtures should be LED. Circuit new emergency egress fixtures, as well as new exit signs, from an emergency generator.

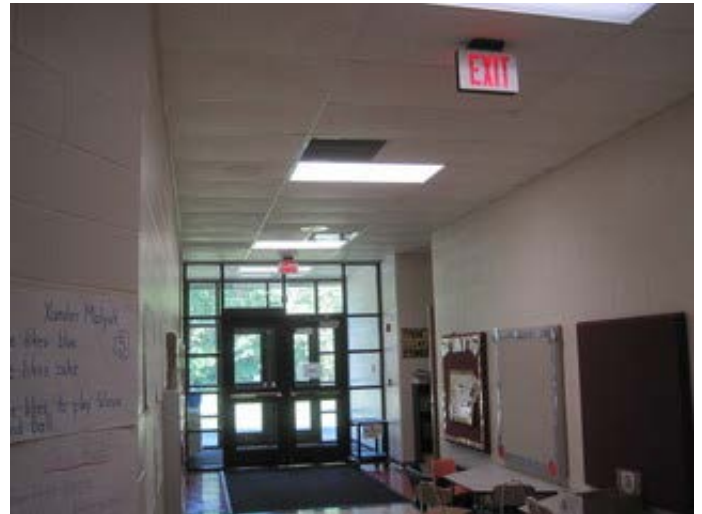
Exit signs in corridor

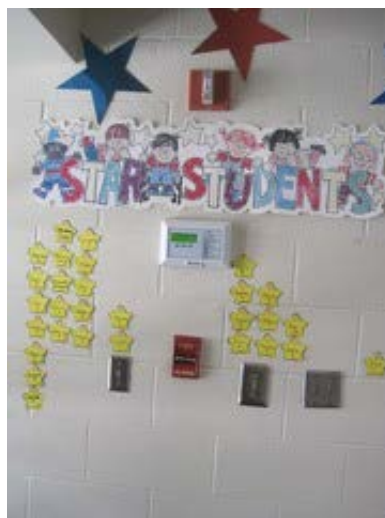
Rating: 2 Needs Repair

F.A. pull station & speaker/strobe

Recommendations: Provide additional speaker/strobes in classrooms and strobes in all toilet rooms. Provide smoke detectors, and tamper/flow switches to monitor the new fire suppression system.

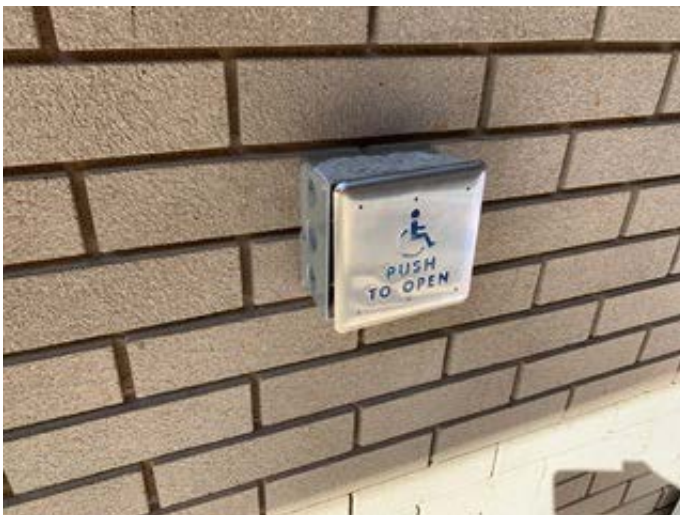
Description: At the site, there is an accessible route provided from the public right-of-way, the accessible parking areas, and from the passenger unloading zone to the main entrance of the school. Access from the parking/drop-off area to the building entries is not compromised by steps or steep ramps. Adequate handicap parking is provided. Exterior doors are equipped with ADA hardware. The main entry is equipped with an ADA power assist door, which is in fair condition. Playground layout and equipping are mostly compliant. On the interior of the building, space allowances and reach ranges are mostly compliant. There is an accessible route through the building which does not include protruding objects. Ground and floor surfaces are compliant. Special provisions for floor level changes in this single story structure are not required. Interior doors are recessed, are provided adequate clearances, and are generally provided with ADA-compliant hardware. Older ADA compliant toilets are provided. ADA signage is provided on both the interior and the exterior of the building, but needs to be replaced.

Rating: 2 Needs Repair

Older Automatic Door Opener

Recommendations: Provide ADA-compliant signage, a new power assist door opener, toilets, sinks, urinals, toilet accessories, and door hardware in the overall facility to facilitate the school's meeting of ADA requirements.

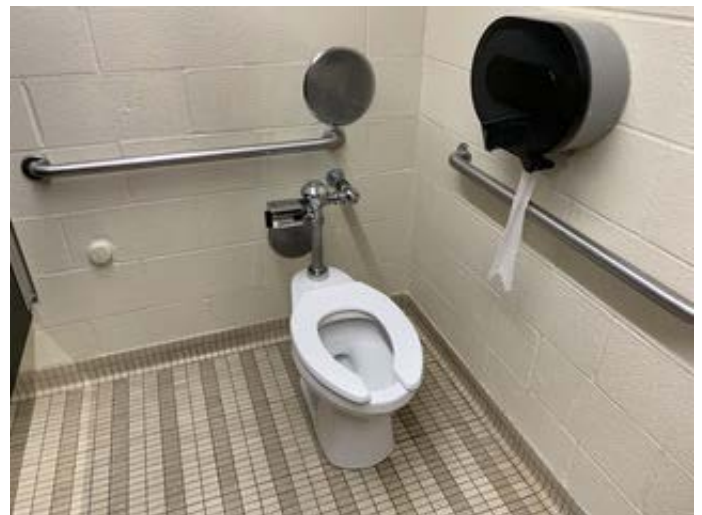
ADA Toilet

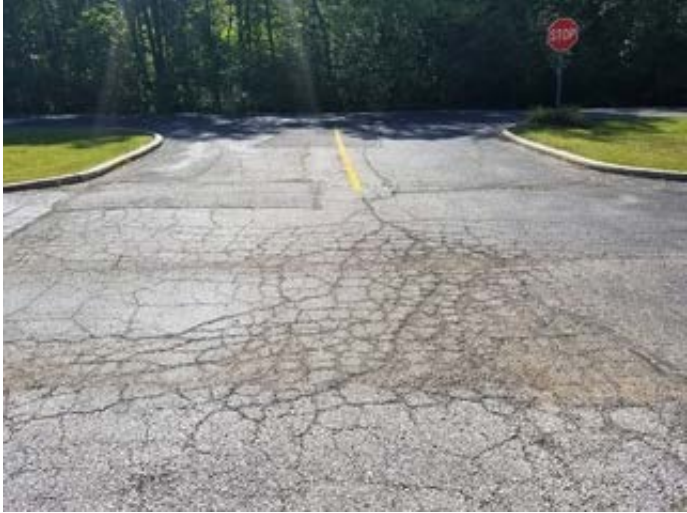
2 Needs Repair

Cracked Asphalt

Much of the sites asphalt parking lots and hard surface playground area are in need of repair. The site does not offer enough handicapped parking spots and the ones they do offer do not comply with ADA requirements including slope or spacing. There are many doors that exit the building that need to be given access to sidewalk paths. It would also be recommended to provide a sidewalk for pedestrian access to the site from S Gannett Rd. On the entrance drive from S Gannett, there is a small area above the head wall on the south side of the drive where the pavement is failing and caving in. This needs to be removed, regraded, and replaced. The playground is in need of replacement for its soft surface and equipment (11/24/21 equipment is being replaced). Finally, some of the curb is also in need of repair and two dumpster pads are needed. 12/6/21 update: Full asphalt replacement needed. Playground equipment no longer in need of replacement.

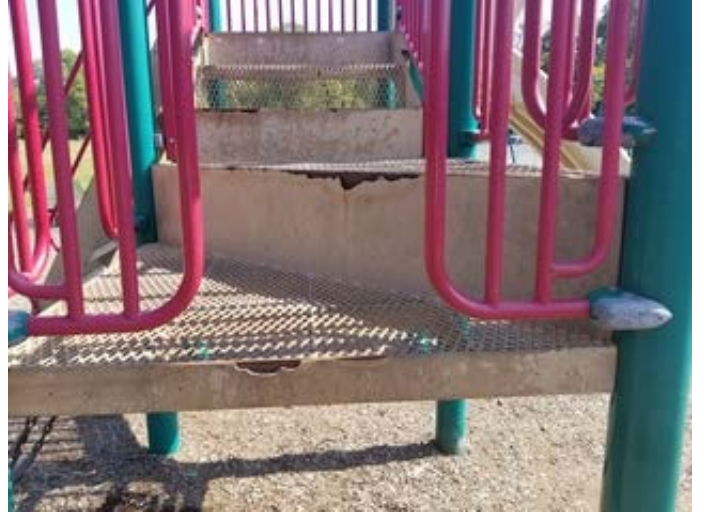
The relatively flat site is located in an urban residential setting with generous tree and shrub landscaping. The area around the building's old waste water plant was not included in this assessment. The site is bordered by moderately travelled residential streets. Two entrances onto the site facilitate proper separation of bus & other vehicular traffic, & one-way bus traffic is provided. There is a curbside bus loading & unloading zone adjacent to the school which is not separated from other vehicular traffic. Parking is facilitated by multiple asphalt parking lots in fair condition, containing 120 spaces which provides adequate parking for staff and visitors, but there are not enough handicapped parking spots provided, and the ones that are do not meet ADA requirements. Two need restriped, two need replaced, and one needs added. The site & parking lot drainage design, consisting of sheet flow, swales, catch basins, storm sewer, and detention basins provides adequate excavation of storm water. Some problems with erosion or ponding were observed. In one area on the west driveway, the asphalt is collapsing along a headwall. Concrete curbs are in fair condition & are appropriately located. Trash pick-up and service drive pavement is in fair condition but is not equipped with a concrete pad area for dumpsters. The school is equipped with a conventional loading dock. Concrete sidewalks are properly sloped, are located to provide adequate & logical flow of pedestrian traffic, and are in good condition. There are several doors without adequate sidewalk access however that must be established. The playground equipment is in poor condition, & on a combination of hard & compliant soft surfaces, with a basketball court being provided on an asphalt surface. The equipment is showing wear and rust. The athletic facilities were not included in the assessment area. Site features are suitable for outdoor instruction and even includes a mock city and covered area with picnic tables for the students. 11/24/21 update: Playground equipment is currently being replaced.

Aging Playground Equipment

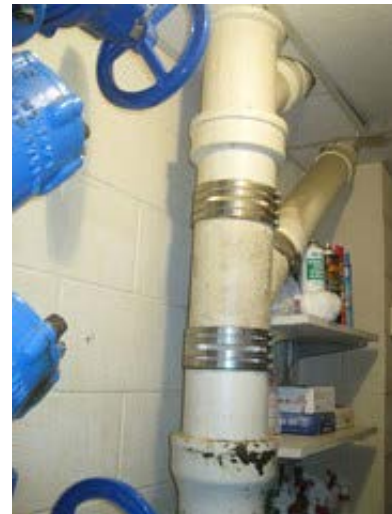
Rating: 3 Needs Replacement

Cast iron sanitary piping

Recommendations: Provide new sanitary piping from the building to the lift station. Provide emergency power to the lift station whose costs are included in Plate D.

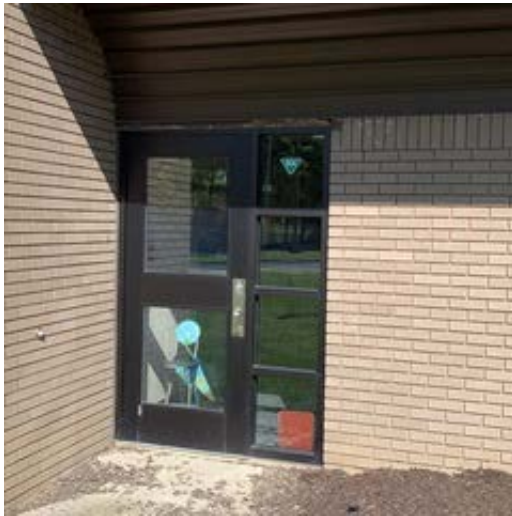
Description: Typical exterior doors in the overall facility are aluminum type construction, installed on aluminum frames, and in good condition. Typical exterior doors feature insulated glass vision panels.

Rating: 3 Needs Replacement

Aluminum Framed Door

Recommendations: Replace exterior doors due to poor condition as noted below.

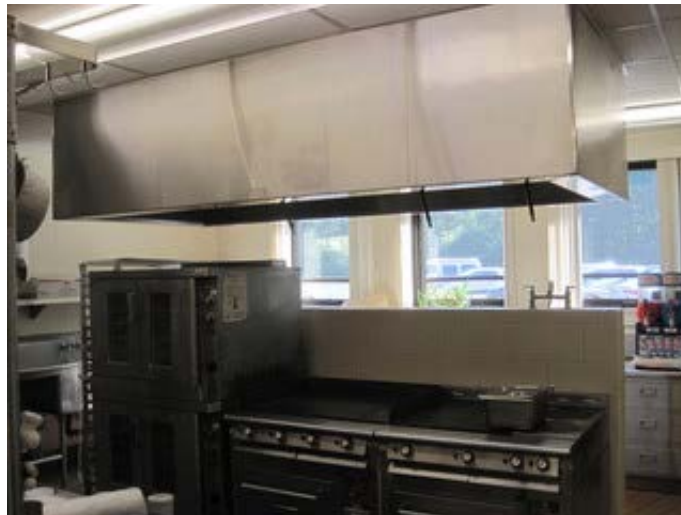
Rating: 3 Needs Replacement

Kitchen hood with suppression system

Recommendations: Provide an automatic fire suppression system throughout the school to meet OSDM guidelines. Provide an emergency generator with funding included in the complete replacement of the electrical system in previous Item D. Provide a new water service line and backflow preventer to meet sprinkler capacity requirements.

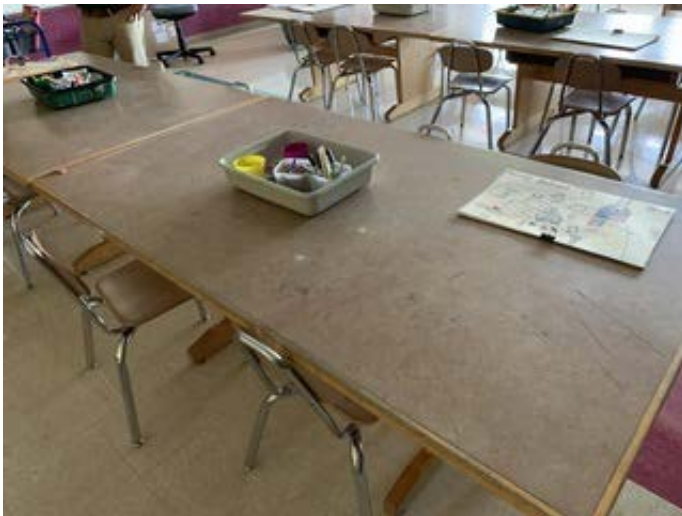
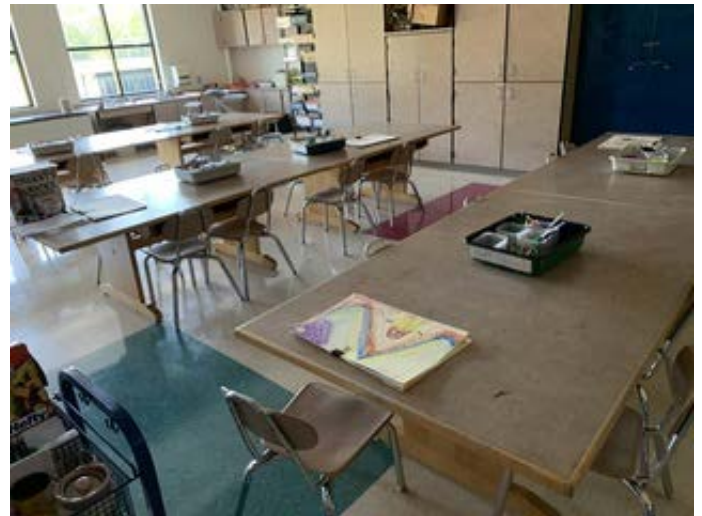
Description: The typical Classroom furniture is mismatched, and in generally fair condition. The facility's furniture and loose equipment were evaluated in item 6.17 in the CEFPI section of this report, and on a scale of 1 to 10 the overall facility received a rating of 5 due to observed conditions, and due to the fact that it lacks some of the Design Manual required elements. 11/24/21 update: CEFPI rating changed to 0 to 3.

Rating: 3 Needs Replacement

Classroom Tables

Recommendations: Provide for replacement of outdated or inadequate furniture.
